**PUBLIC AGENDA
EXECUTIVE COMMITTEE**

Nutana Slope Failure – Options Matrix

This report is intended to present the results of the in-depth geotechnical investigation of the Nutana Slope Failure, including causes, potential remediation options and relative remediation costs. The report also provides an update on the current situation with the riverbank slope failure occurring in Nutana between 11th Street East & Saskatchewan Crescent East.

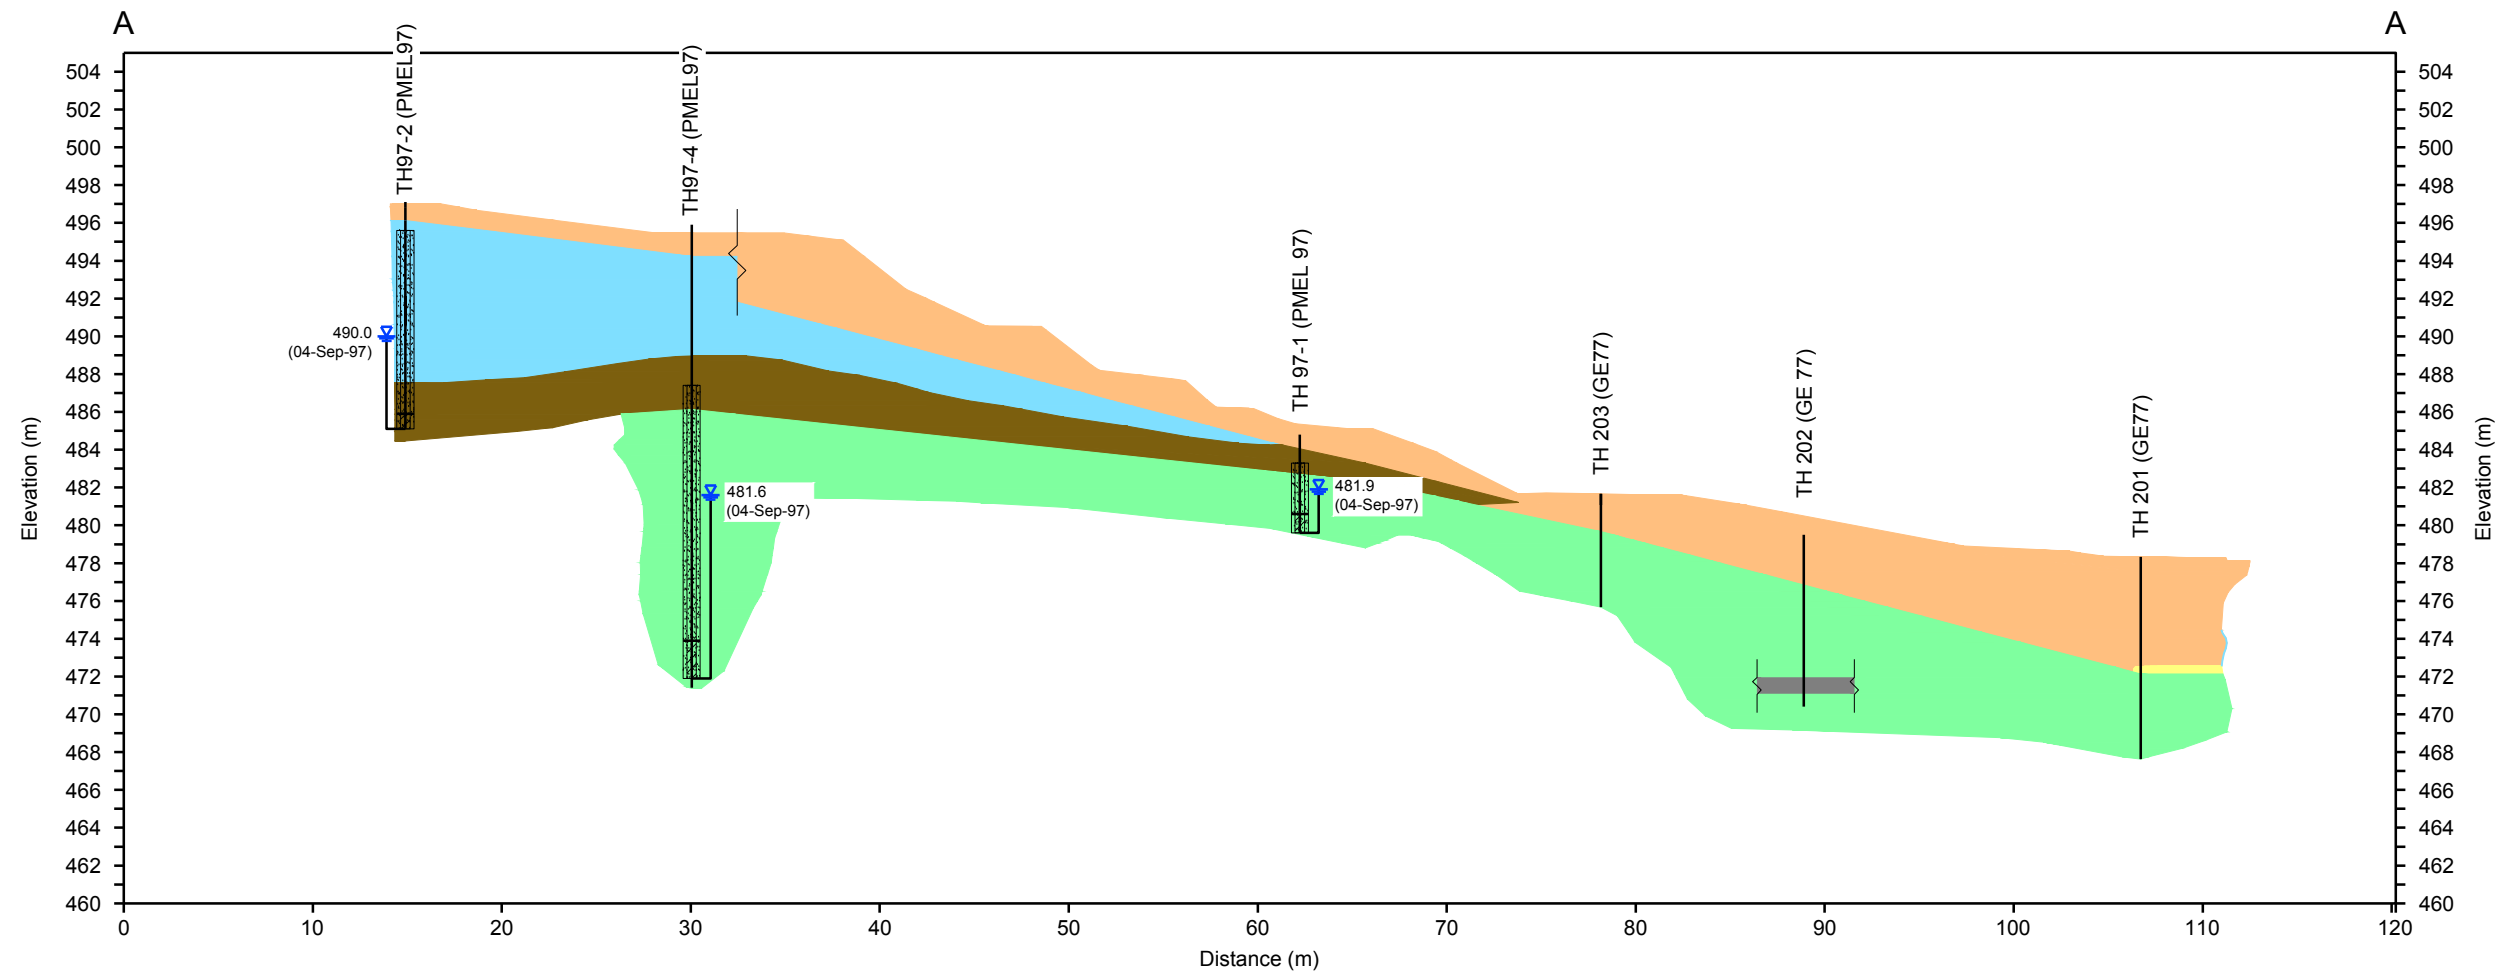
CHERRY LANE SLOPE INSTABILITY	
CROSS SECTION A-A (WEST FAILURE)			
PROJECT	11-1362-0057	FILE No.	
DESIGN	LM	08/05/14	SCALE AS SHOWN REV. 0
CADD	BDS/JDS	08/05/14	
CHECK	HV	08/05/14	
REVIEW	PGB	08/05/14	
		FIGURE: 12

The sand layers within the SSD were typically described as wet in the borehole logs reviewed. High sand content and layers of cobbles were noted in the silty clay till material at elevation approximately 467 masl below the SSD (at the TH 101 location).

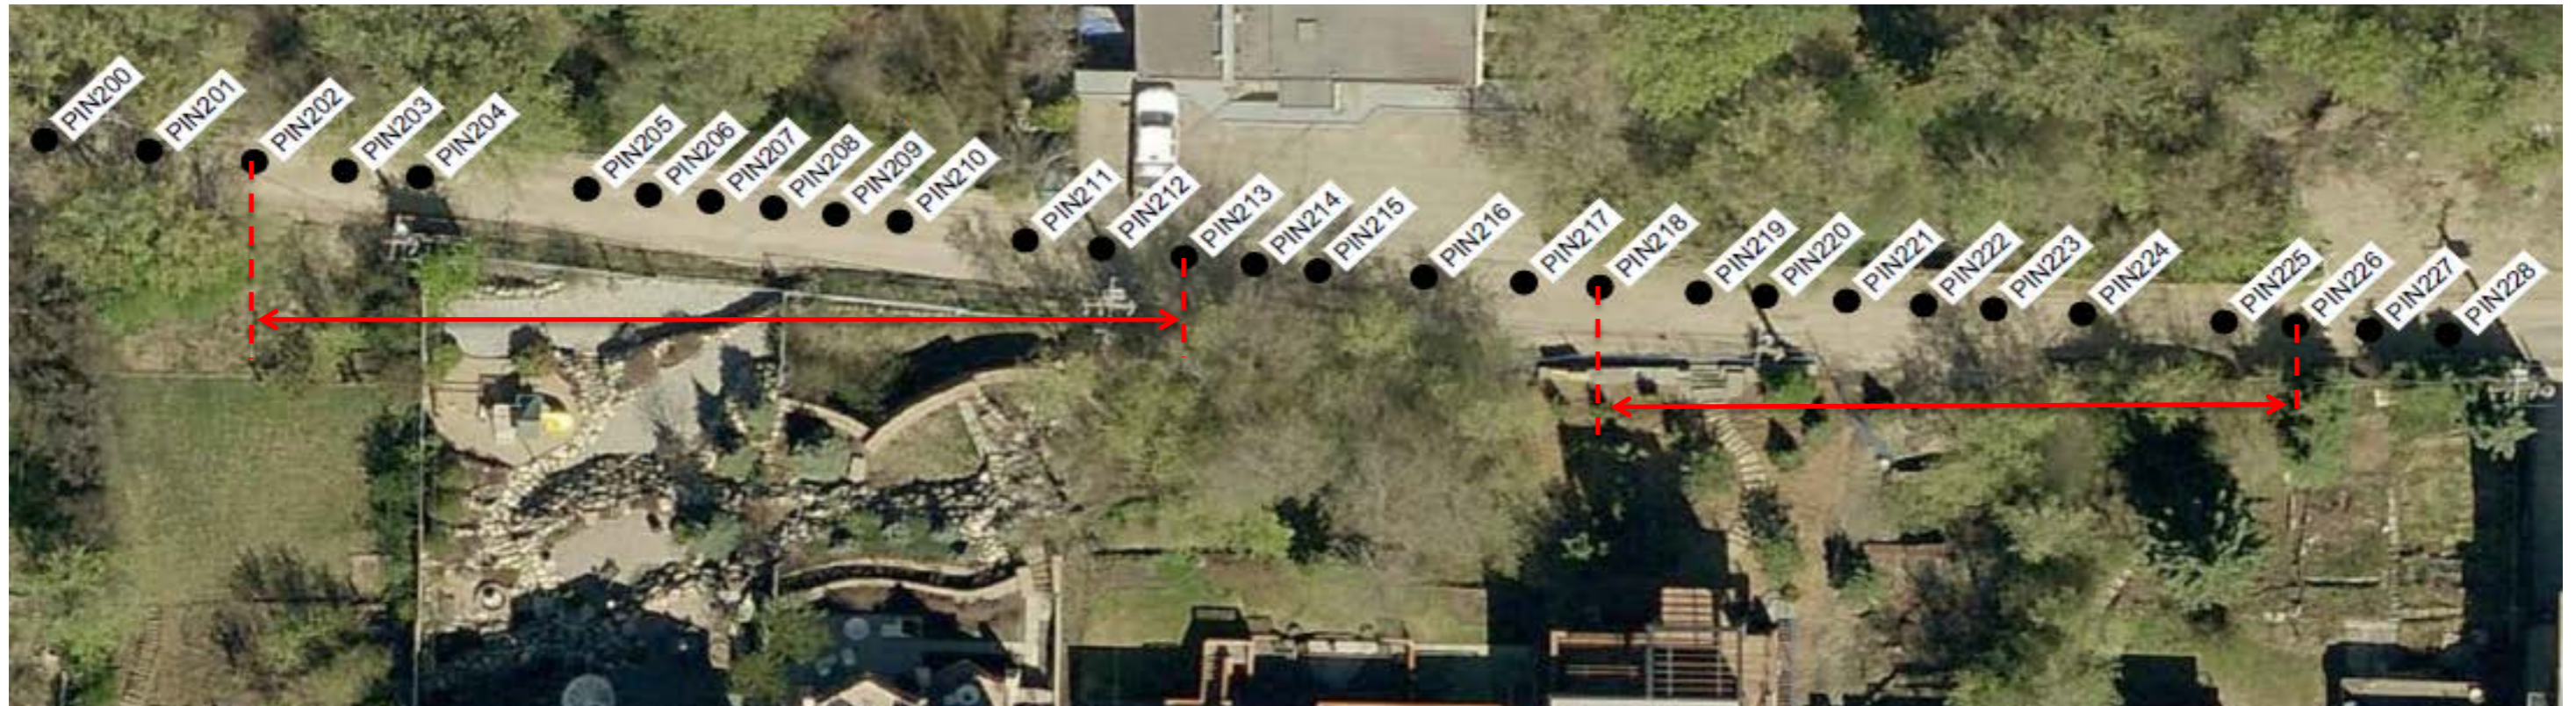
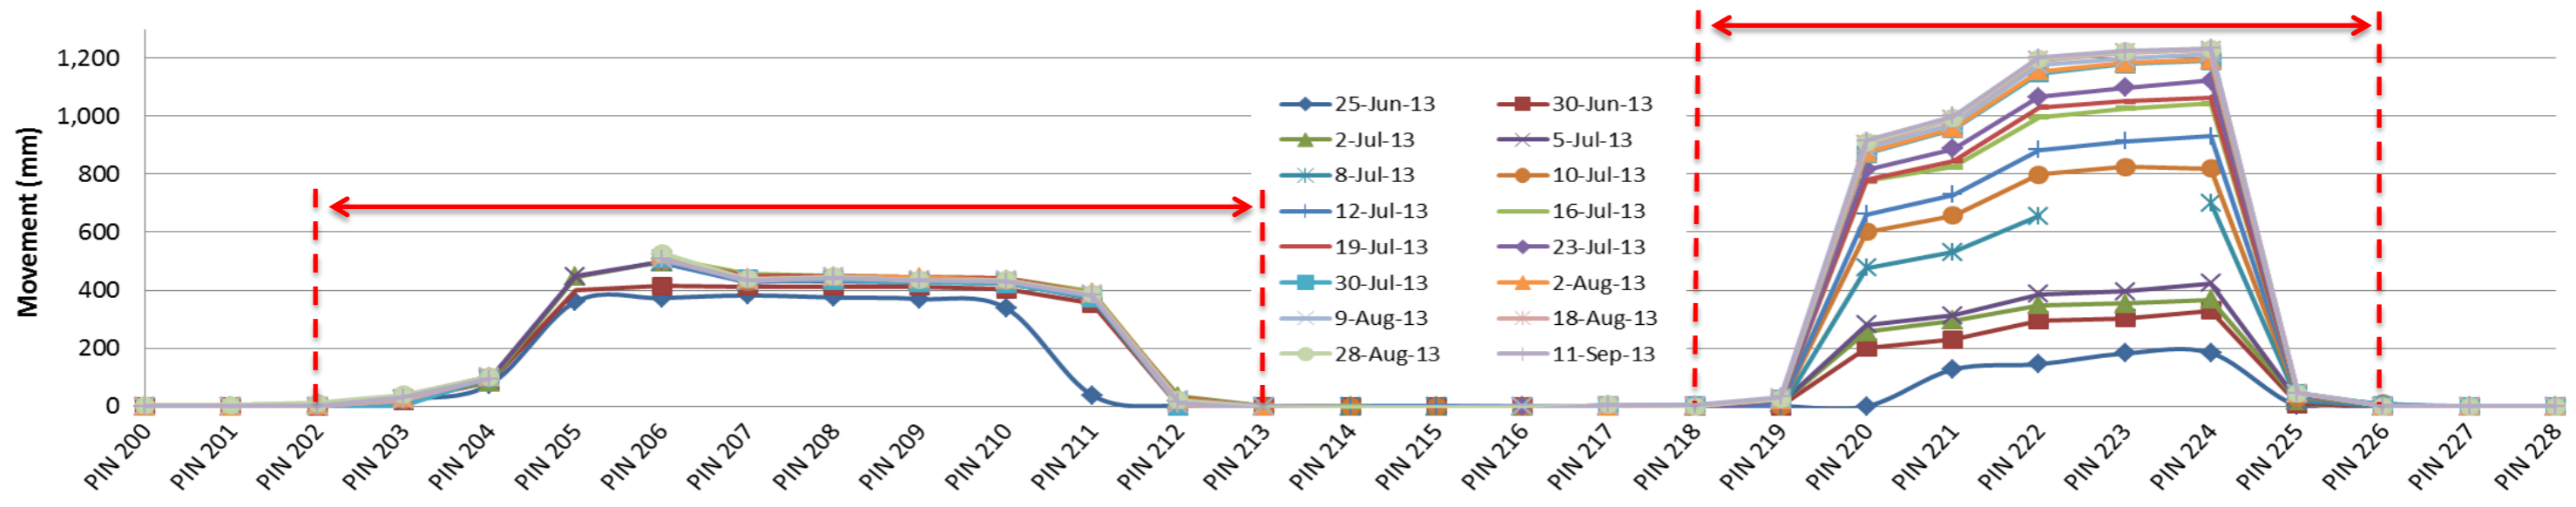
The rate of movement for the 200 series of pins has been less than 5 mm since July 2013 at the West Failure and since August 2013 at the East Failure.

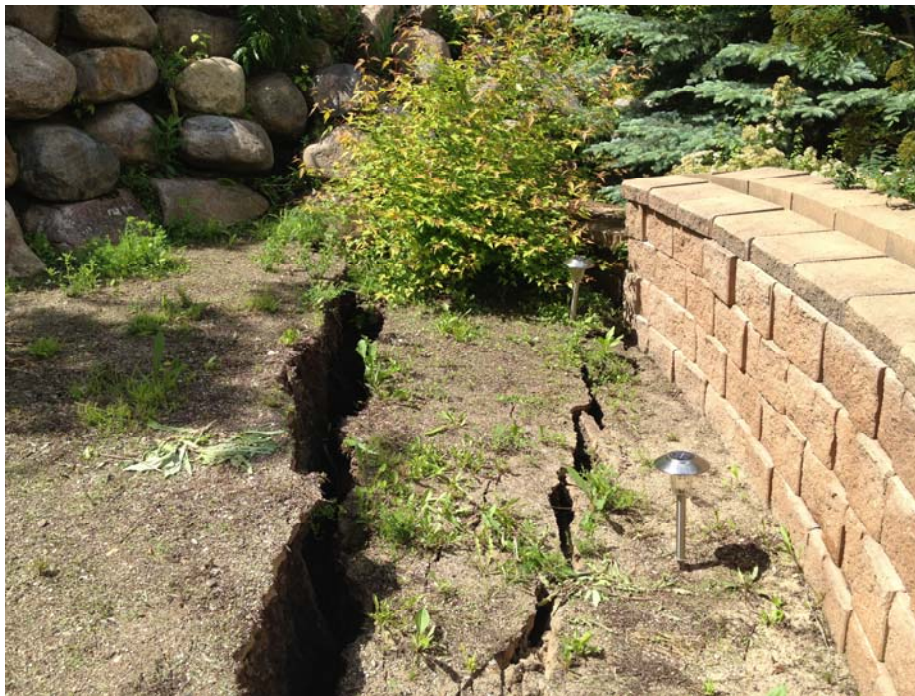
Photo C.7. Bulging Toe of Slide below Cherry Lane (June 21, 2012)

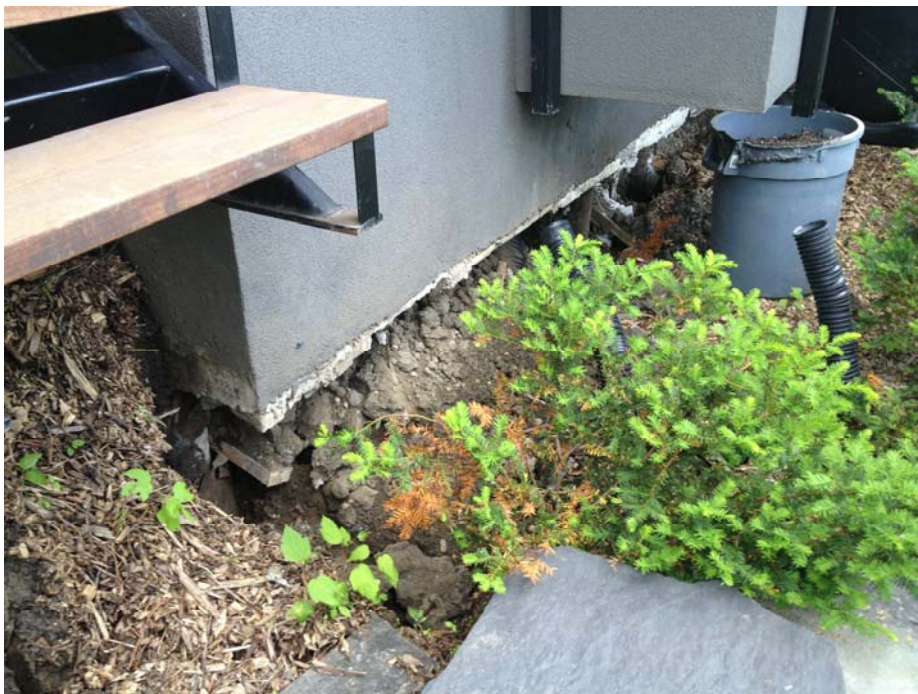
Photo C.12. Looking East at Headscarp of East Failure in Backyard of 305 11th St. E.; Approx. 90 cm Drop (June 24, 2013)

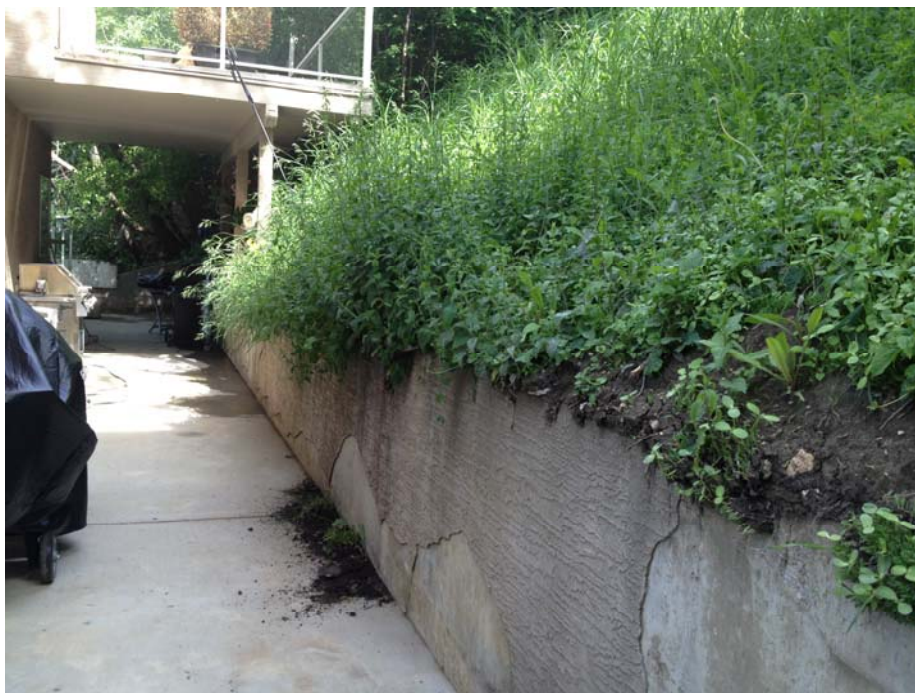
Photo C.13. Headscarp of East Failure in Backyard of 303 11th St. E.; Approx. 60 cm Drop (June 24, 2013)

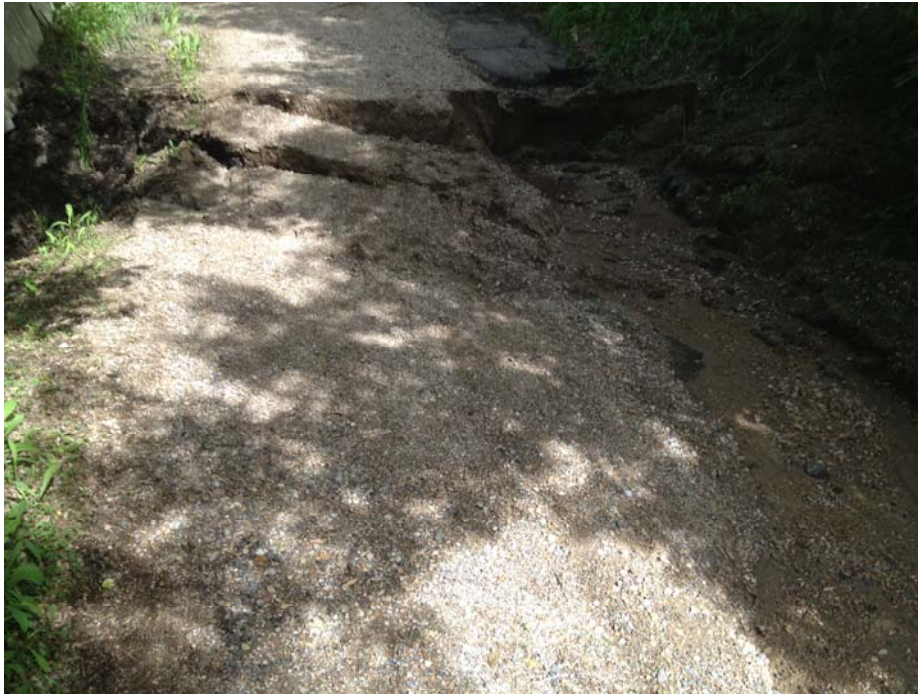
Photo C.14. Looking East at Bulging Toe of Slide above Retaining Wall behind 306 Sask. Cres. E. (June 24, 2013)

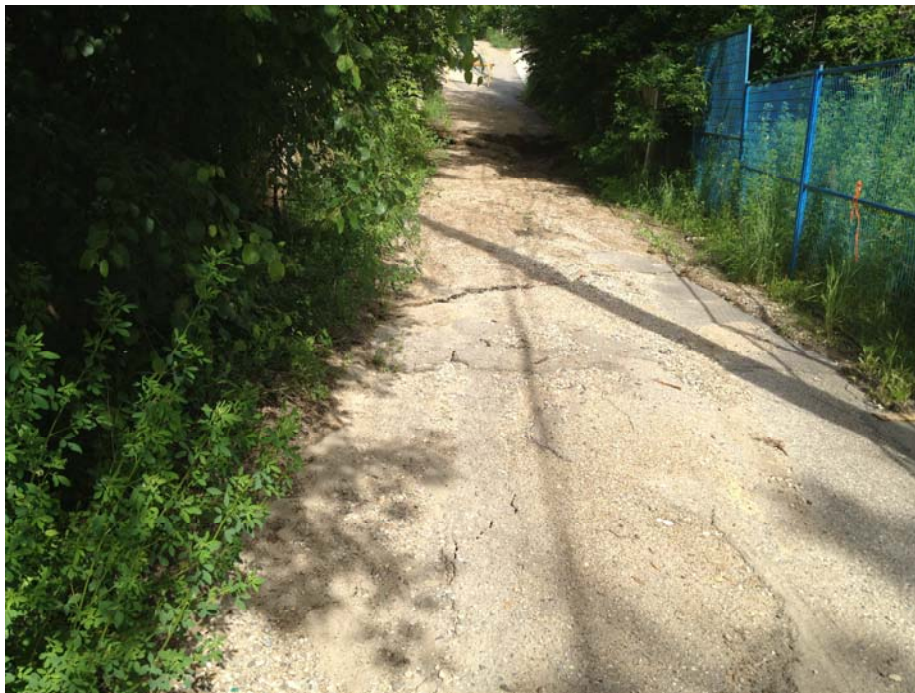
Photo C.15. Looking East at Severe Cracking across Cherry Lane, Pavement; Approx. 50 cm Drop (June 24, 2013)

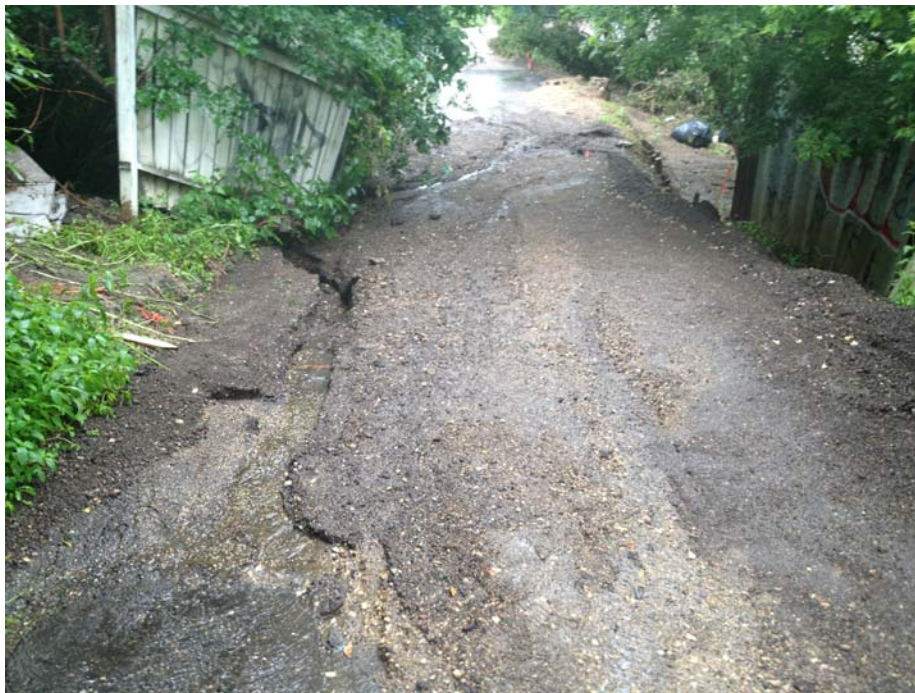
Photo C.22. Looking West at Erosion along Cherry Lane (June 6, 2013)

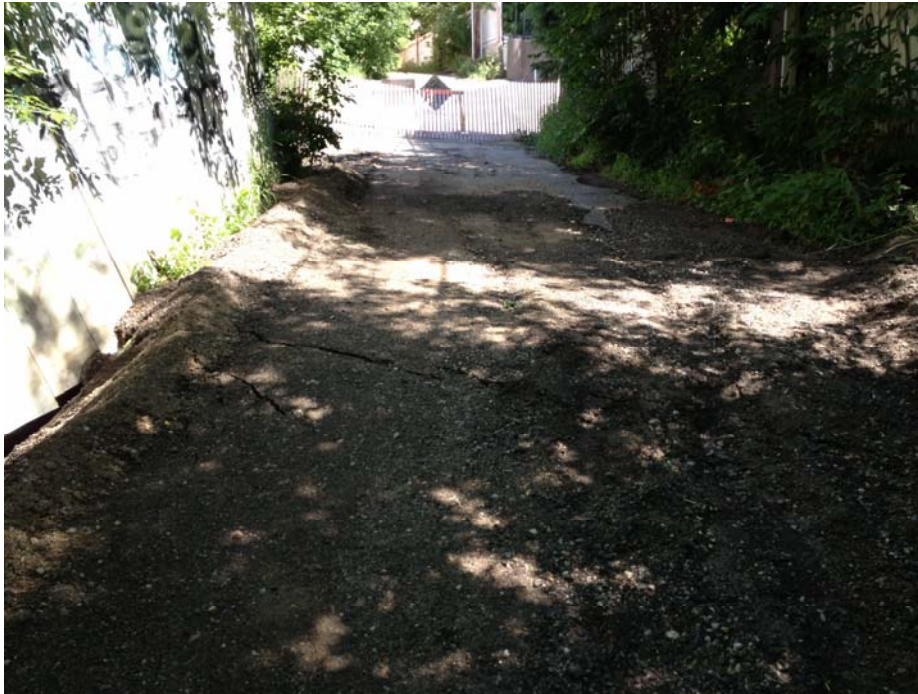
Photo C.27. Looking East at New Tension Cracking Forming on Regraded Lane (July 7, 2013)
