TECHNICAL MEMORANDUM

Reference No. CA0029692.9234-TM-01-Rev0

NUTANA SLOPE STABILITY UPDATE – MAY 2024

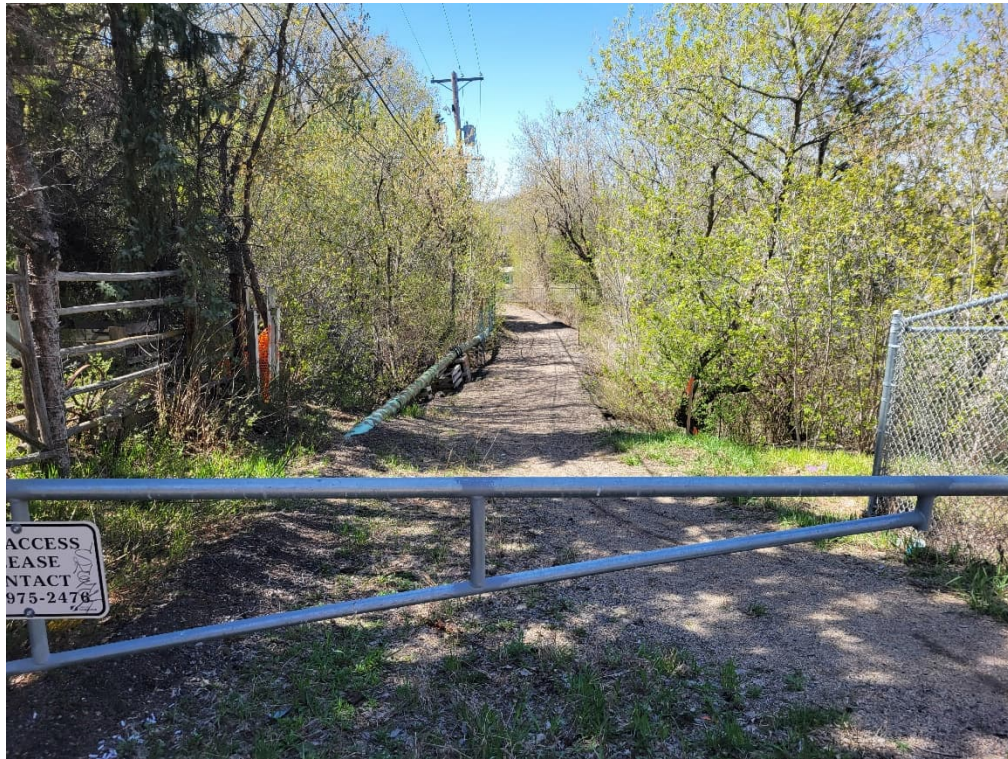
Photograph 1: Looking west down the back alley at the East Failure (May 8, 2024)

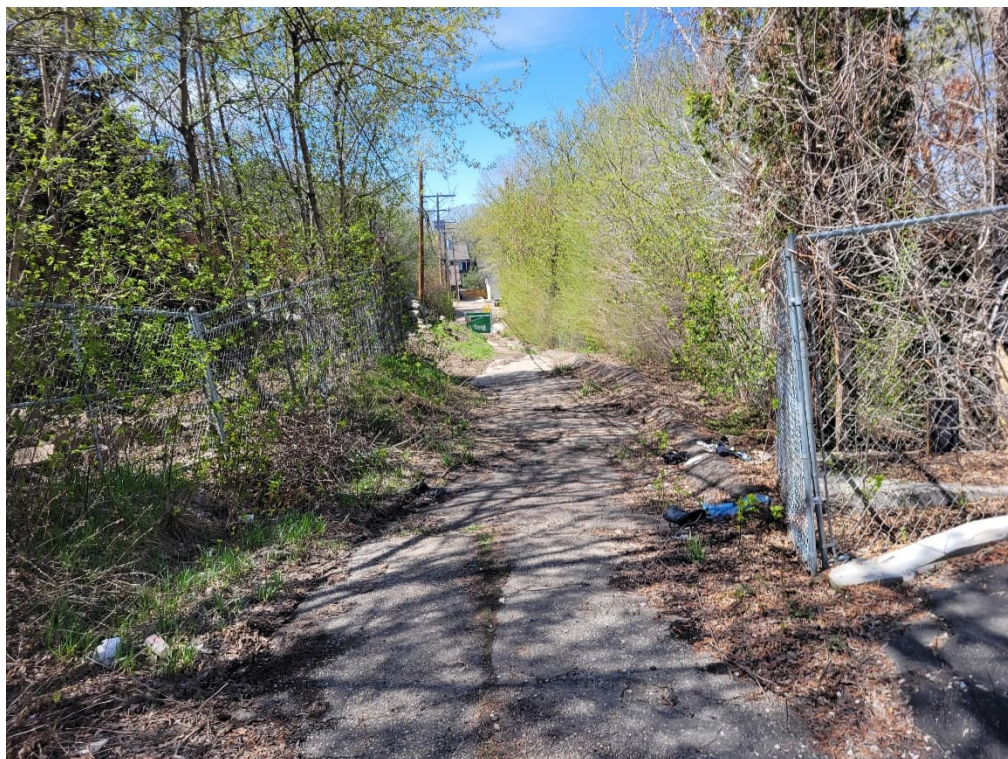
Photograph 2: Looking west down the back alley at the West Failure (May 8, 2024)

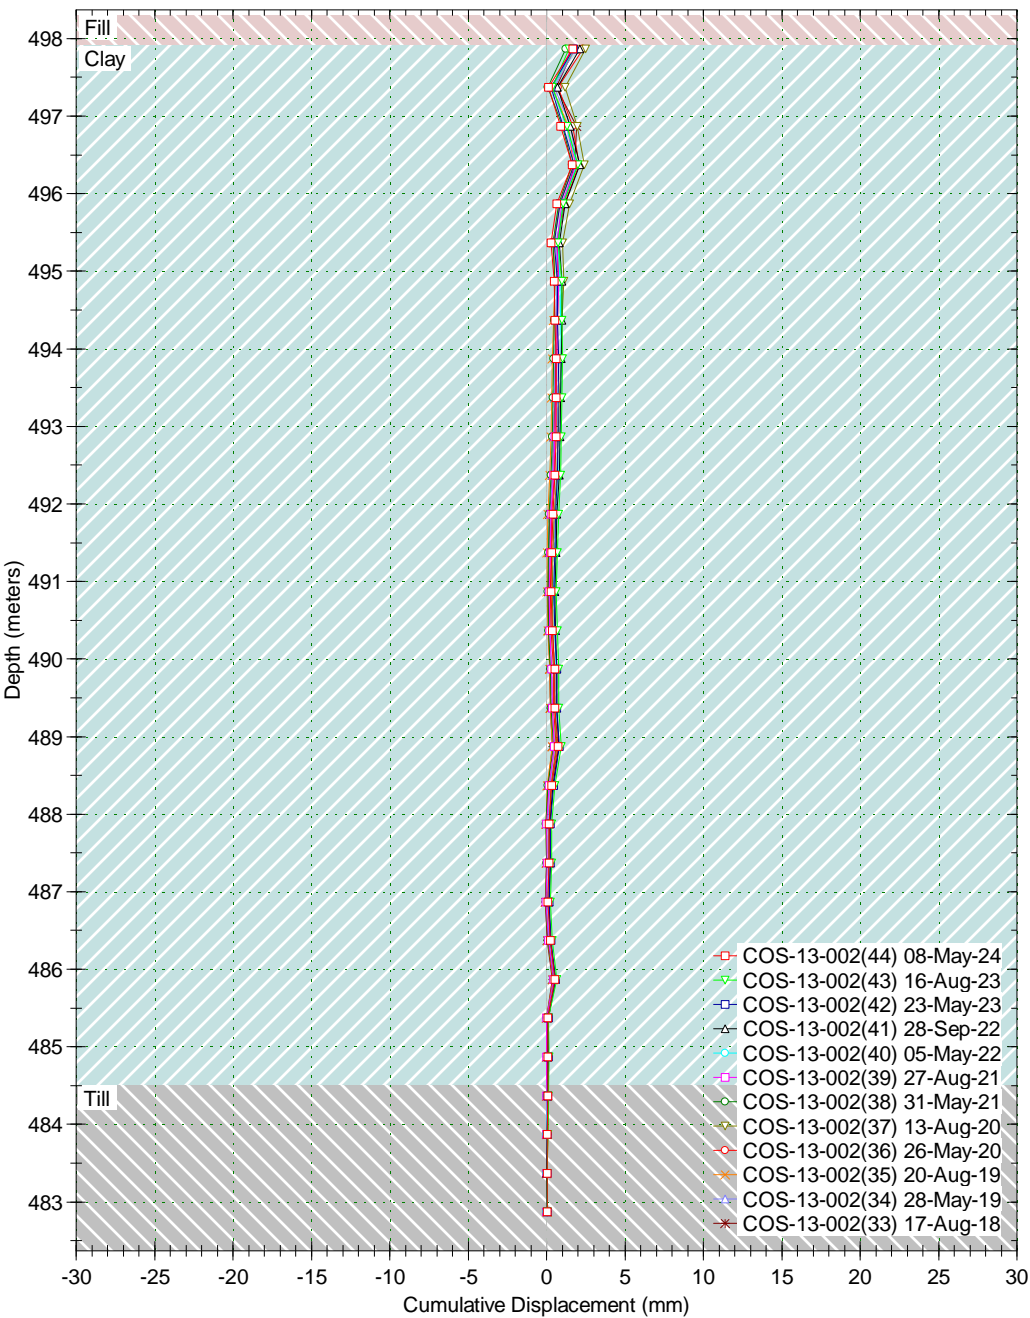
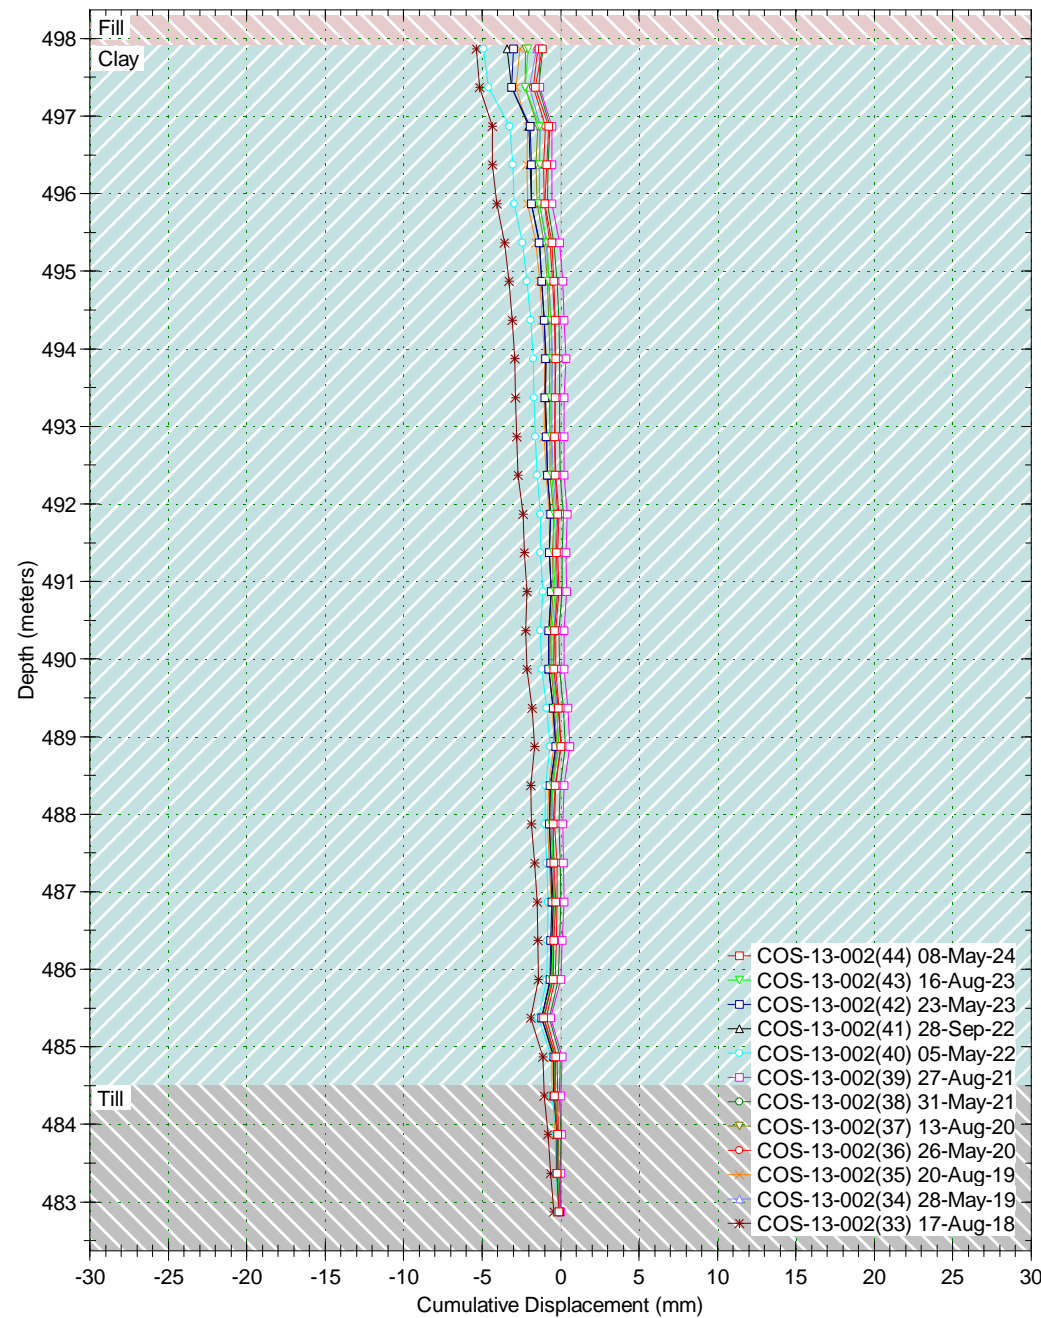
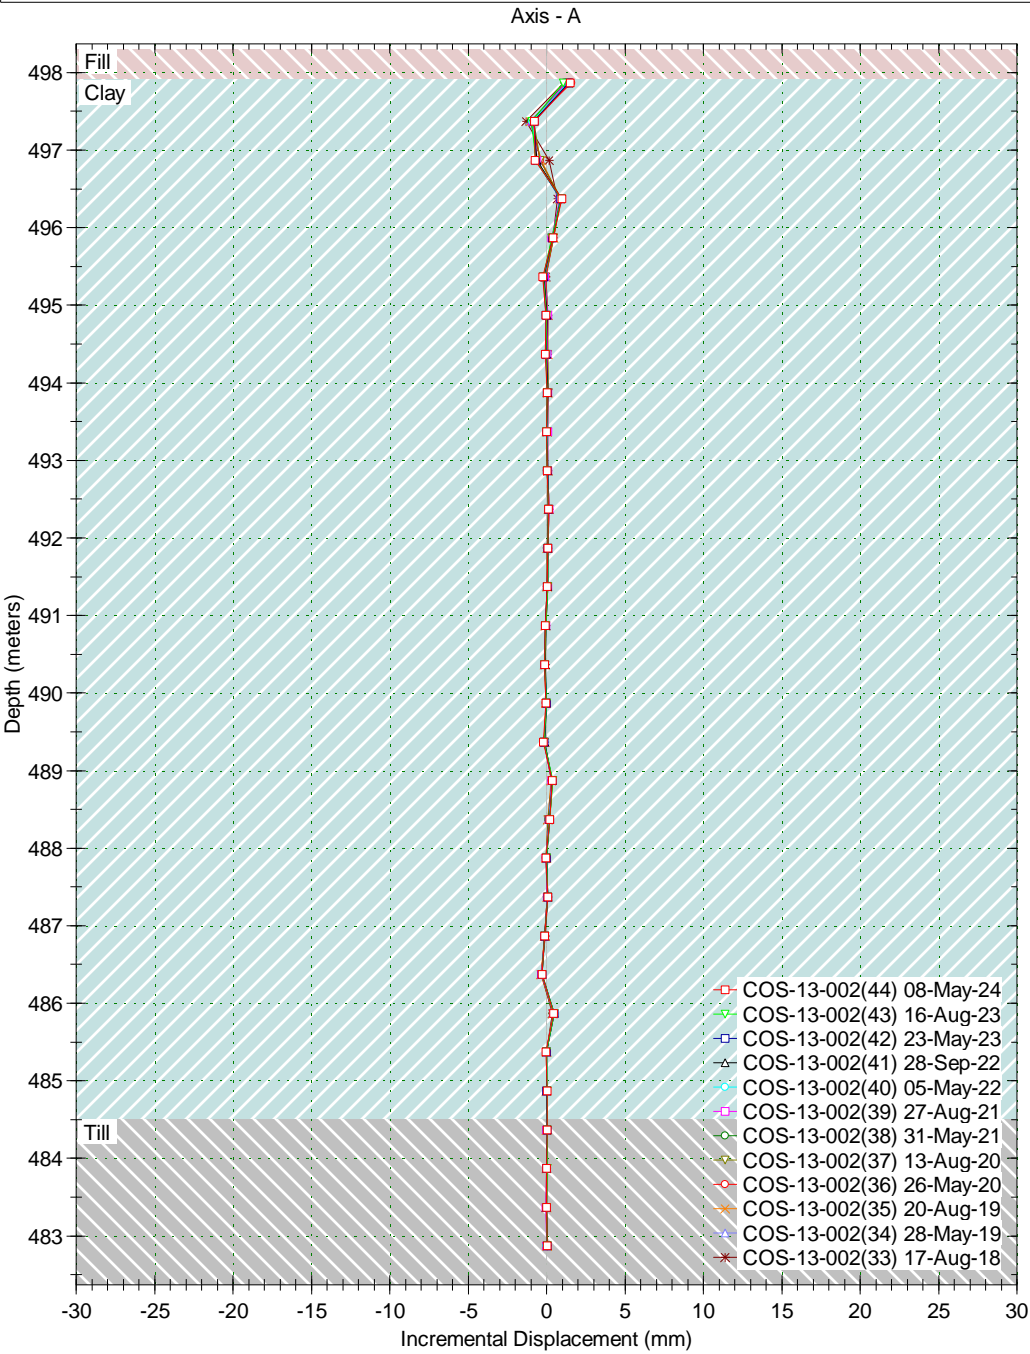
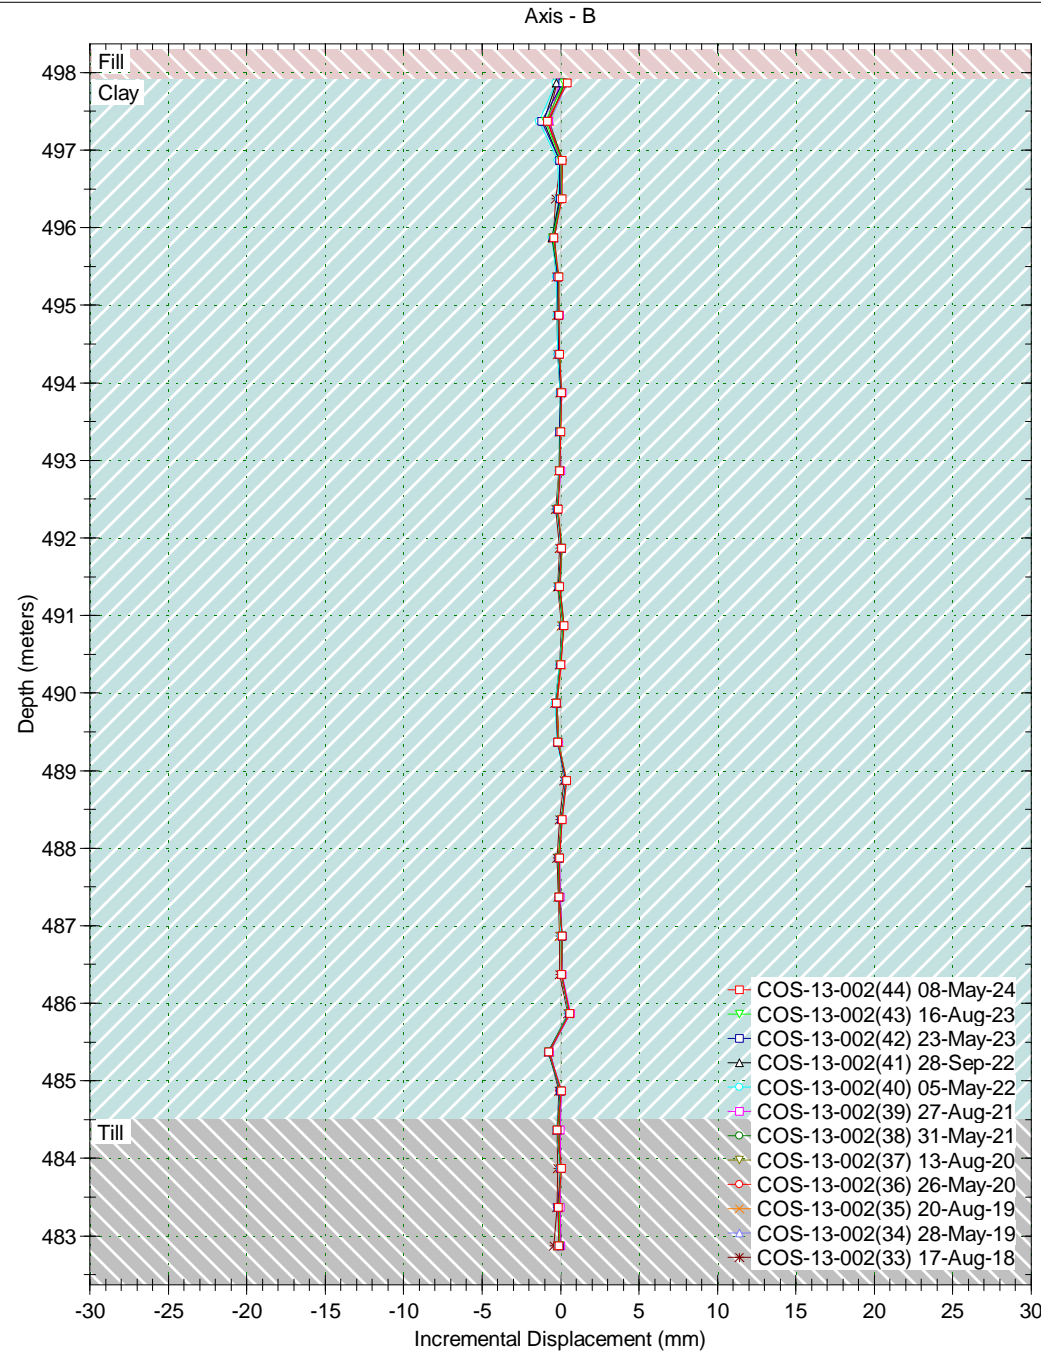
Borehole : COS-13-002
 Project : Nutana Slope
 Location : 307 11th St. E. (Front)
 Northing : 5775567.41
 Easting : 386043.54
 Collar : -0.113

- Inclinometer COS-13-002 indicated insignificant movement (less than 2 mm or 0.08 in), between August 16, 2023 and May 8, 2024.
- Inclinometer COS-13-004 showed a drift in the displacement plots with approximately 2 mm (0.08 in) of movement, in the upslope direction, between August 16, 2024 and May 8, 2024.

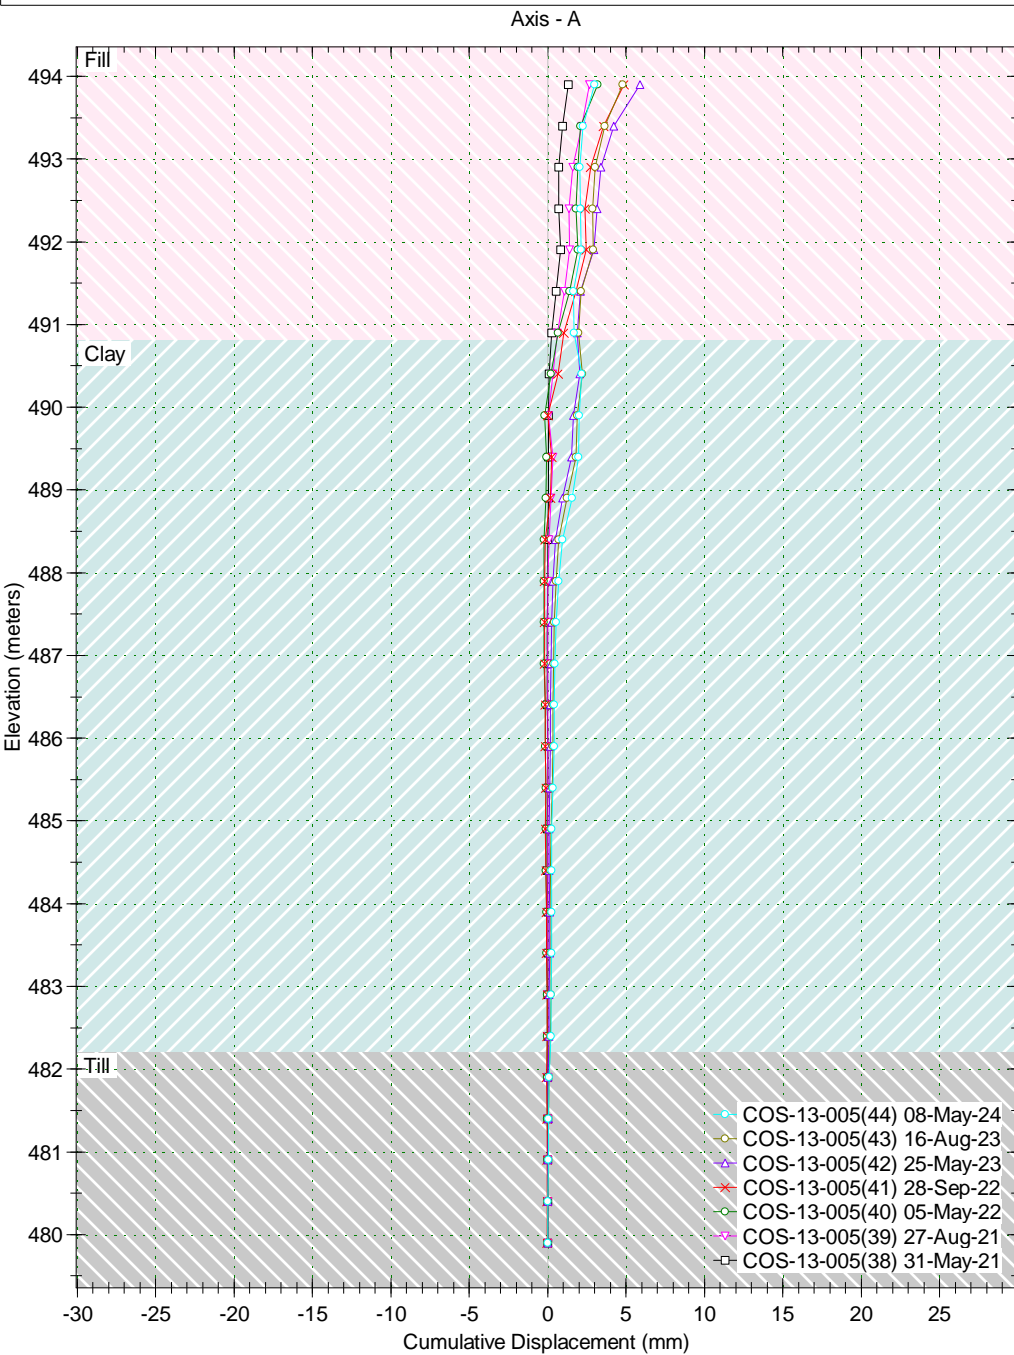
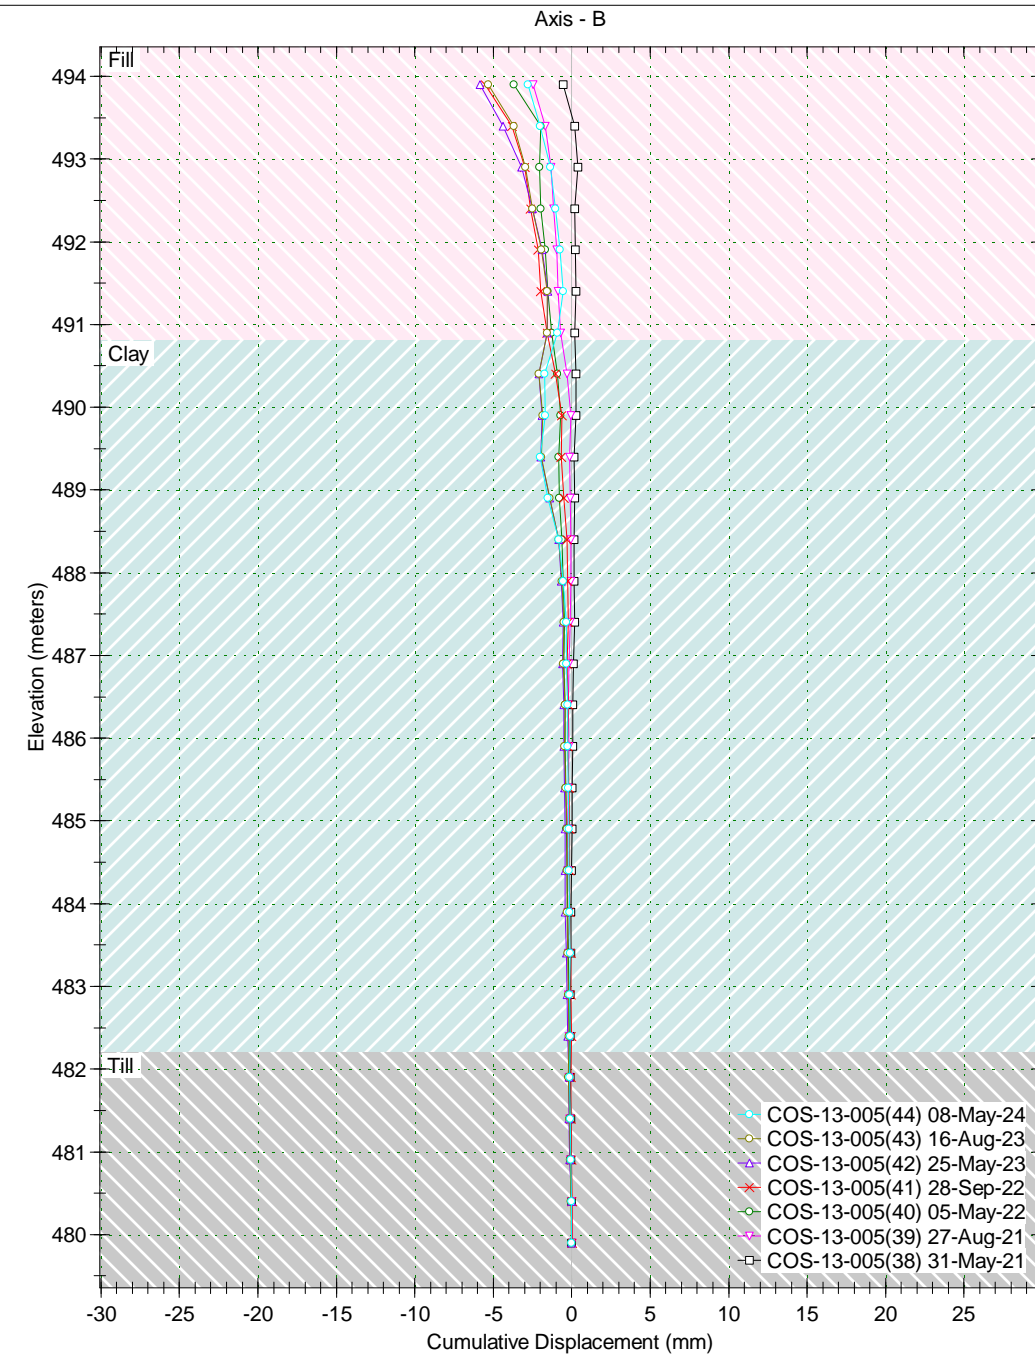
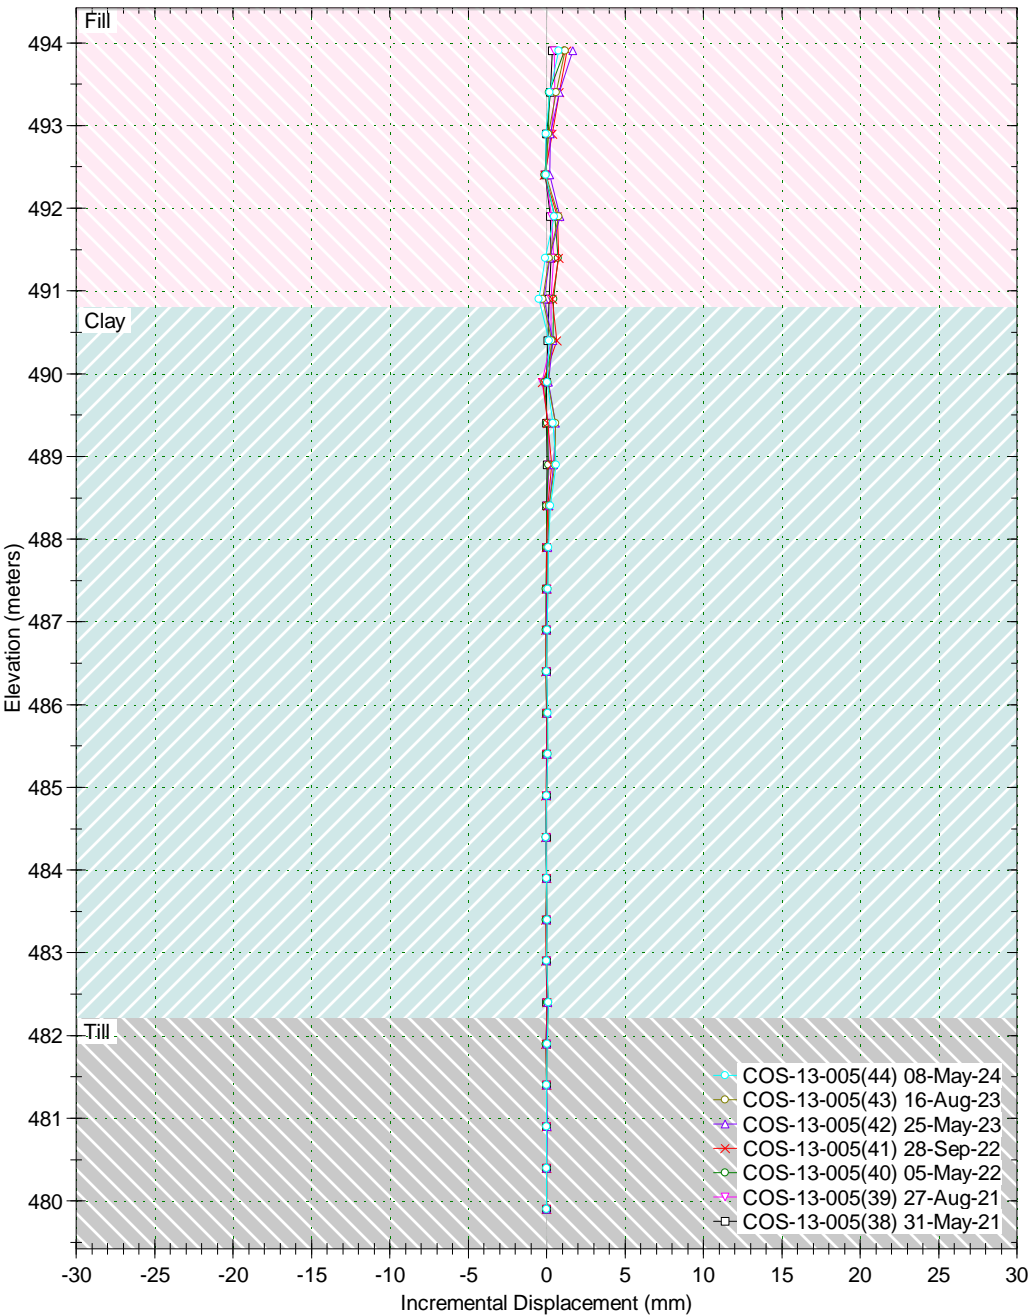
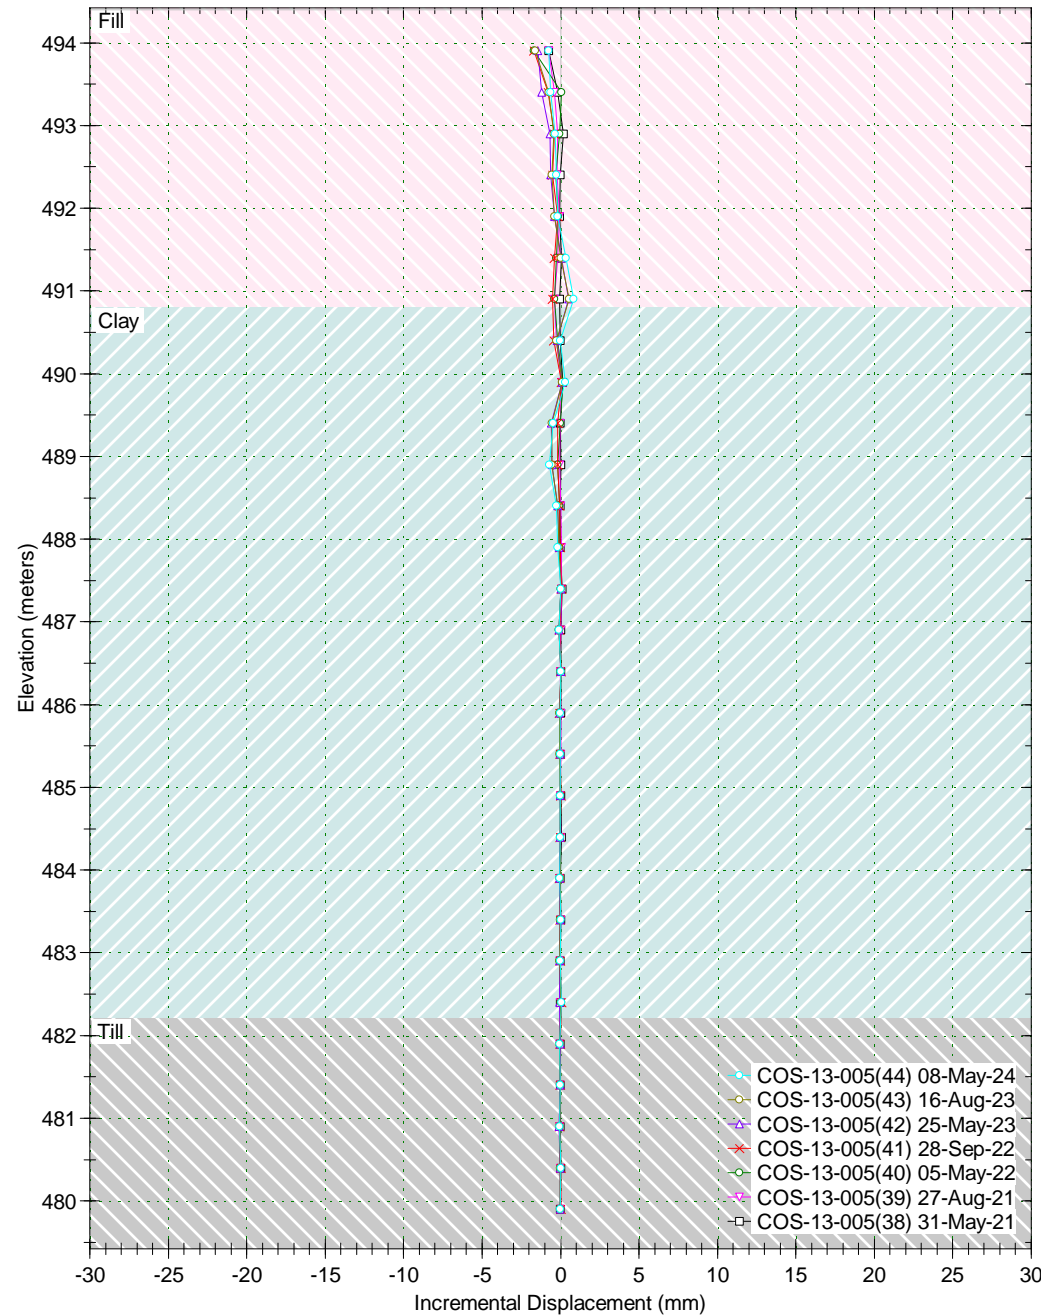
Borehole : COS-13-005 (Aug 13 2020 Baseline)
 Project : Nutana Slope
 Location : 316 Sask. Cres. E.
 Northing : 5775631.299
 Easting : 386078.8467
 Collar : -0.1

- Inclinometer COS-13-005 indicated approximately 2 mm (0.08 in) of movement, in the upslope direction, between August 16, 2024 and May 8, 2024. This inclinometer plot showed apparent movement in the direction parallel with Cherry Lane.
- Inclinometer 20-109 indicated approximately 2.5 mm (0.10 in) of downslope movement between August 16, 2023 and May 8, 2024. This inclinometer plot showed a drift in the direction parallel with Cherry Lane, similar to what was observed in 2022 and 2023.
- Inclinometer 20-111 indicated insignificant movement (less than 2 mm or 0.08 in), between August 16, 2023 and May 8, 2024.

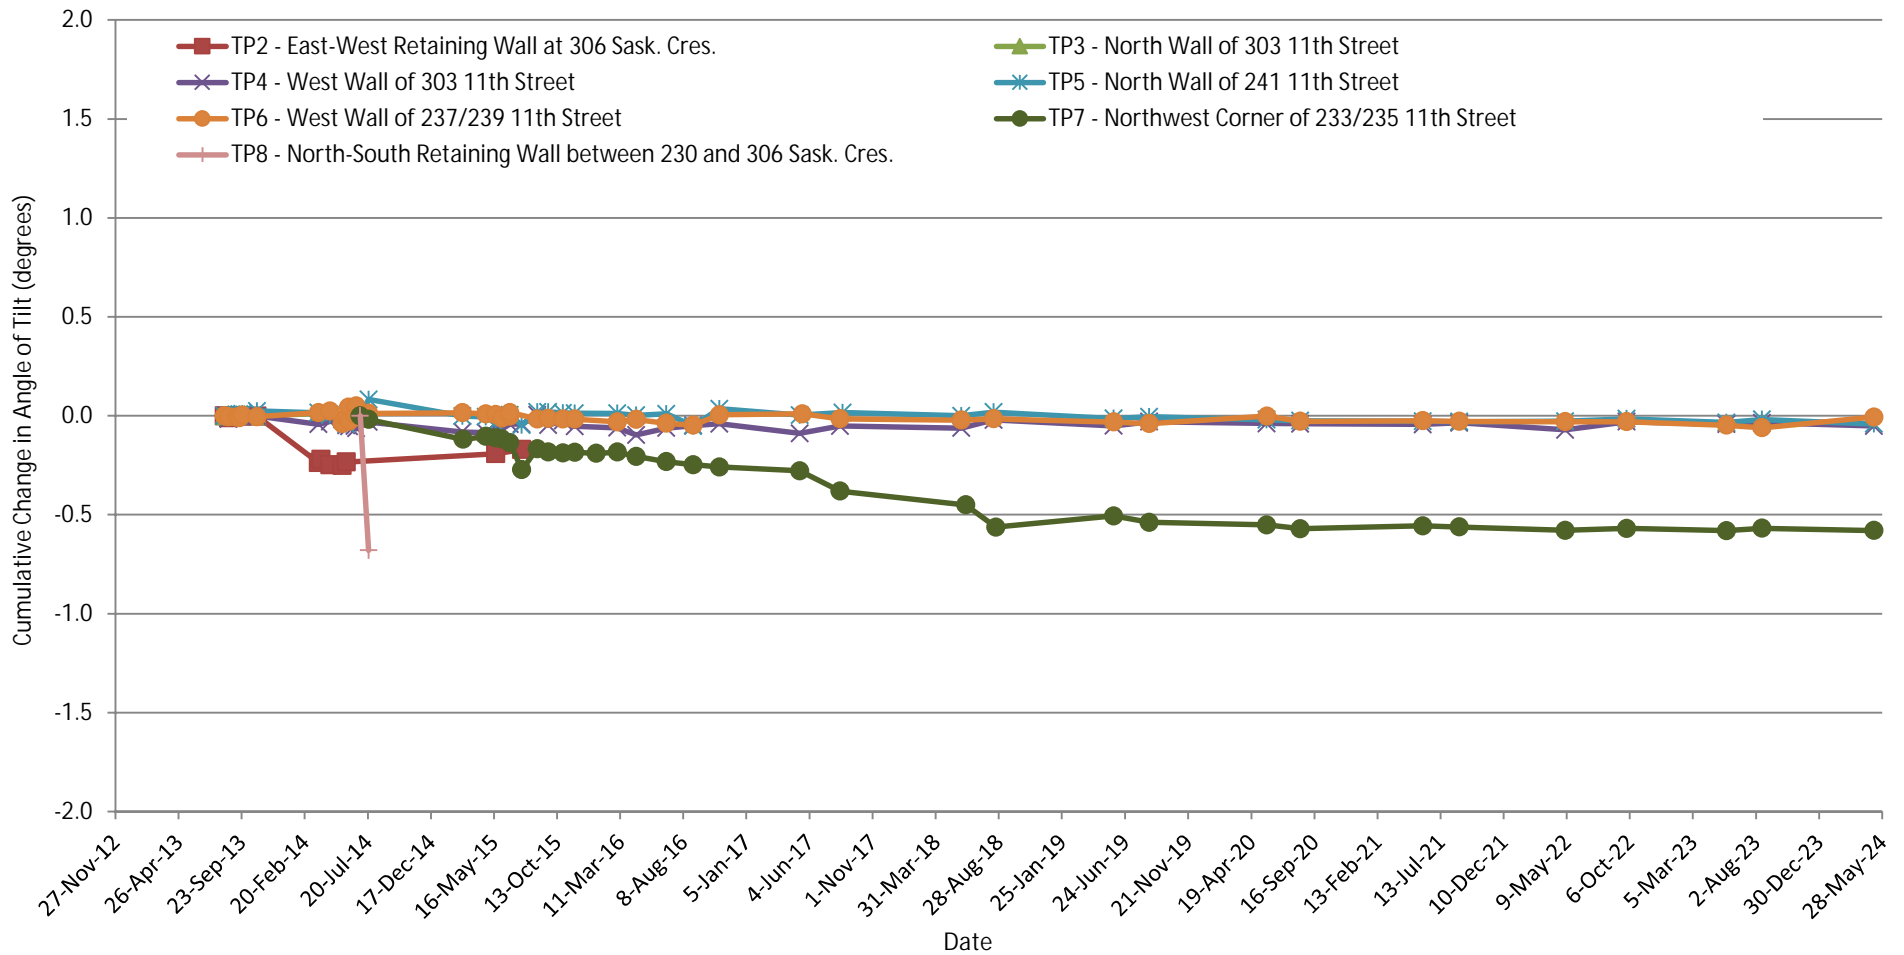
PROJECT	City of Saskatoon	NUTANA SLOPE INSTABILITY
TITLE	RESULTS OF TILT MONITORING <i>May 2024 Monitoring</i>	
	PROJECT	CA0029692.9234
	DESIGN	
	CADD	
	CHECK	
REVIEW		
FILE No.		SCALE N/A REV.
FIGURE: B1

- Tilt plates TP4, TP5, and TP7 indicate insignificant changes in angle of tilt (less than 0.05 degrees) between August 16, 2023 and May 8, 2024.
- Tilt Plate TP6 indicated a change in angle of tile of approximately 0.05 degrees, towards the building, between August 16, 2023 and May 8, 2024.

- 1) Positive changes in tilt indicate tilting toward the monitoring structure.
- 2) TP1, located on the retaining wall between 230 and 306 Sask. Cres., is not monitored for health and safety reasons; monitoring results for this tilt plate show a change in angle of tilt of approximately 9 degrees between August 2013 and June 2014.
- 3) TP3 and TP8 are destroyed, and TP2 is buried.

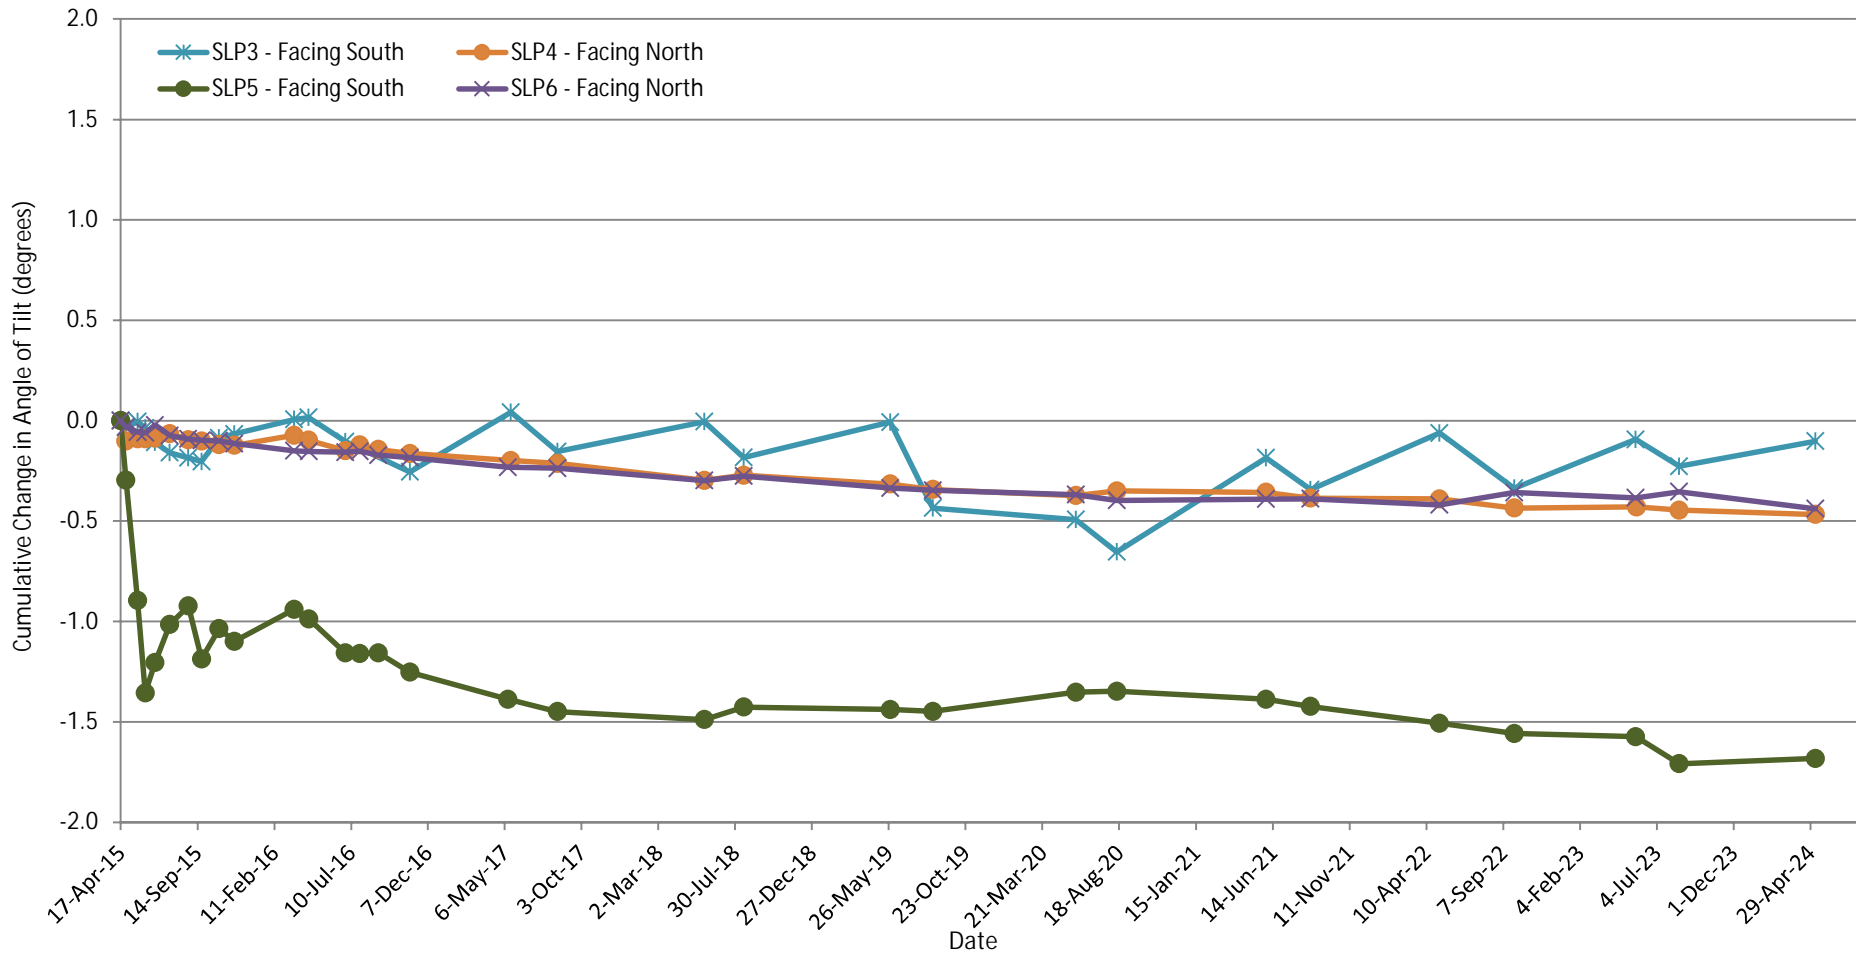
NUTANA SLOPE INSTABILITY	
RESULTS OF TILT MONITORING May 2024 Monitoring			
	PROJECT	CA0029692.9234	FILE No.
	DESIGN		SCALE N/A REV.
	CADD		
	CHECK		
	REVIEW		
			FIGURE: B2

- Tilt Plate SLP3 indicated a change in angle of tilt of approximately 0.13 degrees, towards the north, between August 16, 2023 and May 8, 2024. However, past readings for SLP3 have been erratic and appear to be affected by seasonal changes.

- Tilt plates SLP4 and SLP5 indicated an insignificant change in angle of tilt (less than 0.05 degrees) between August 16, 2023 and May 8, 2024. However, the tilt monitoring plots indicate a trend of steady tilt of approximately 0.05 degrees/year.

- Tilt plate SLP6 indicated a change in angle of tilt of approximately 0.09 degrees, towards the north, between August 16, 2023 and May 8, 2024.
