TECHNICAL MEMORANDUM

Reference No. CA0029692.9234-TM-02-Rev1

NUTANA SLOPE STABILITY UPDATE – AUGUST 2024

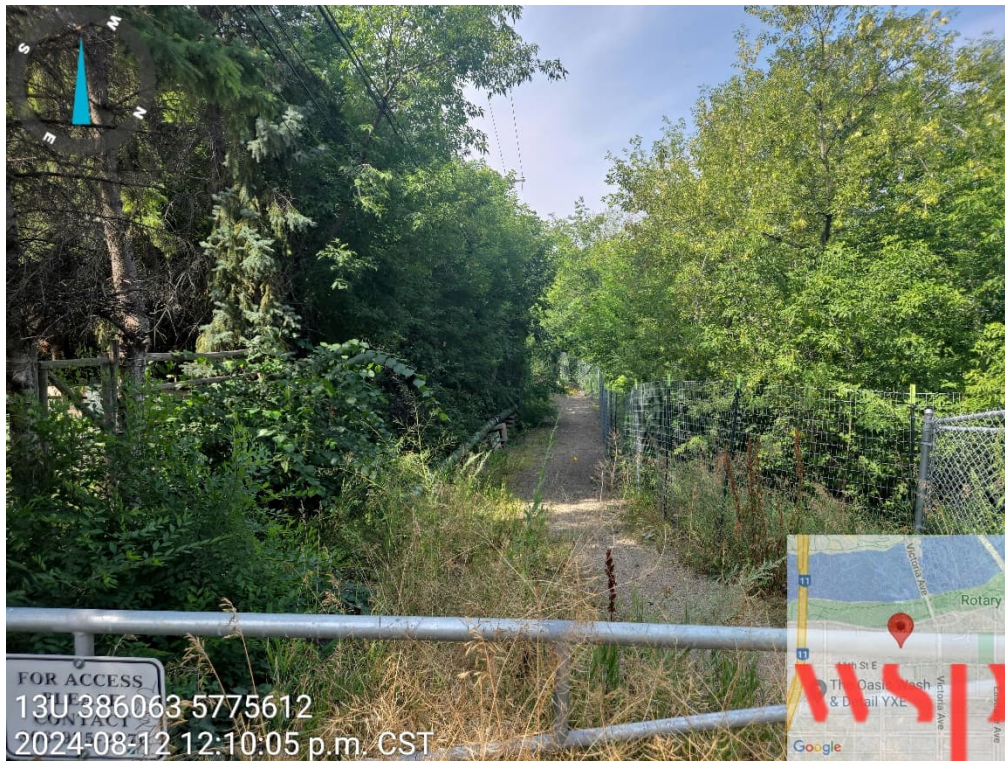
Photograph 1: Looking west down the back alley at the East Failure (August 12, 2024)

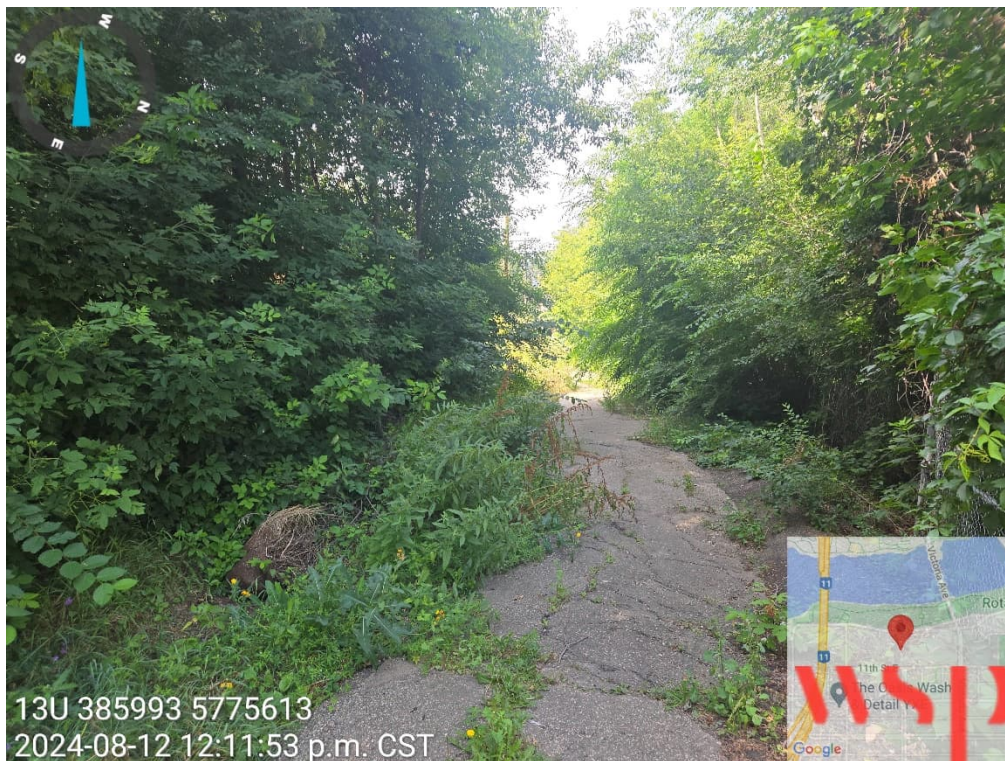
Photograph 2: Looking west down the back alley at the West Failure (August 12, 2024)

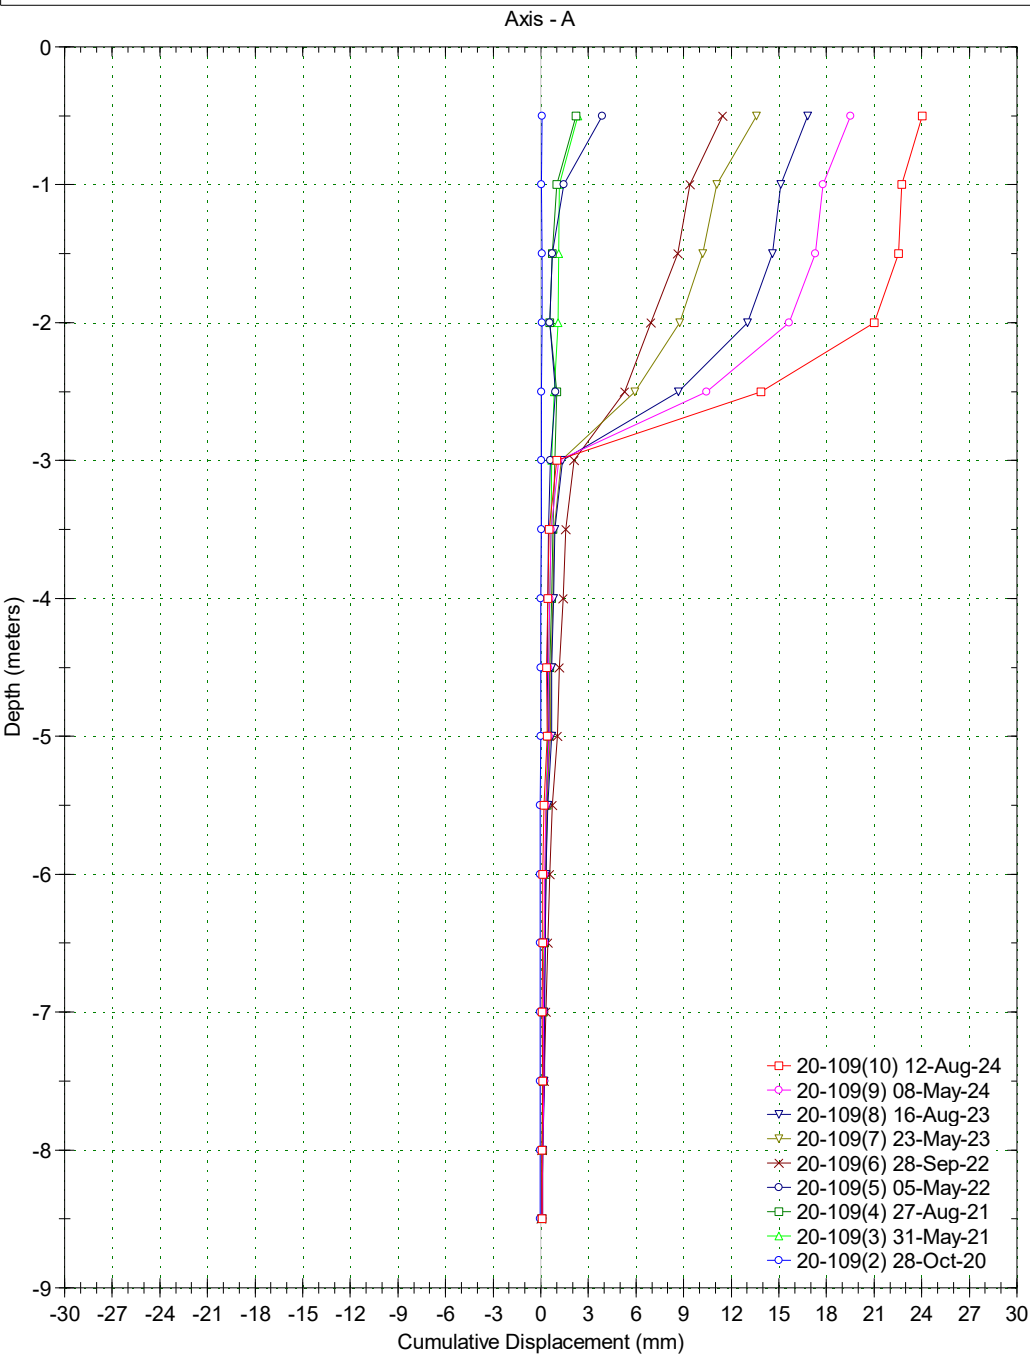
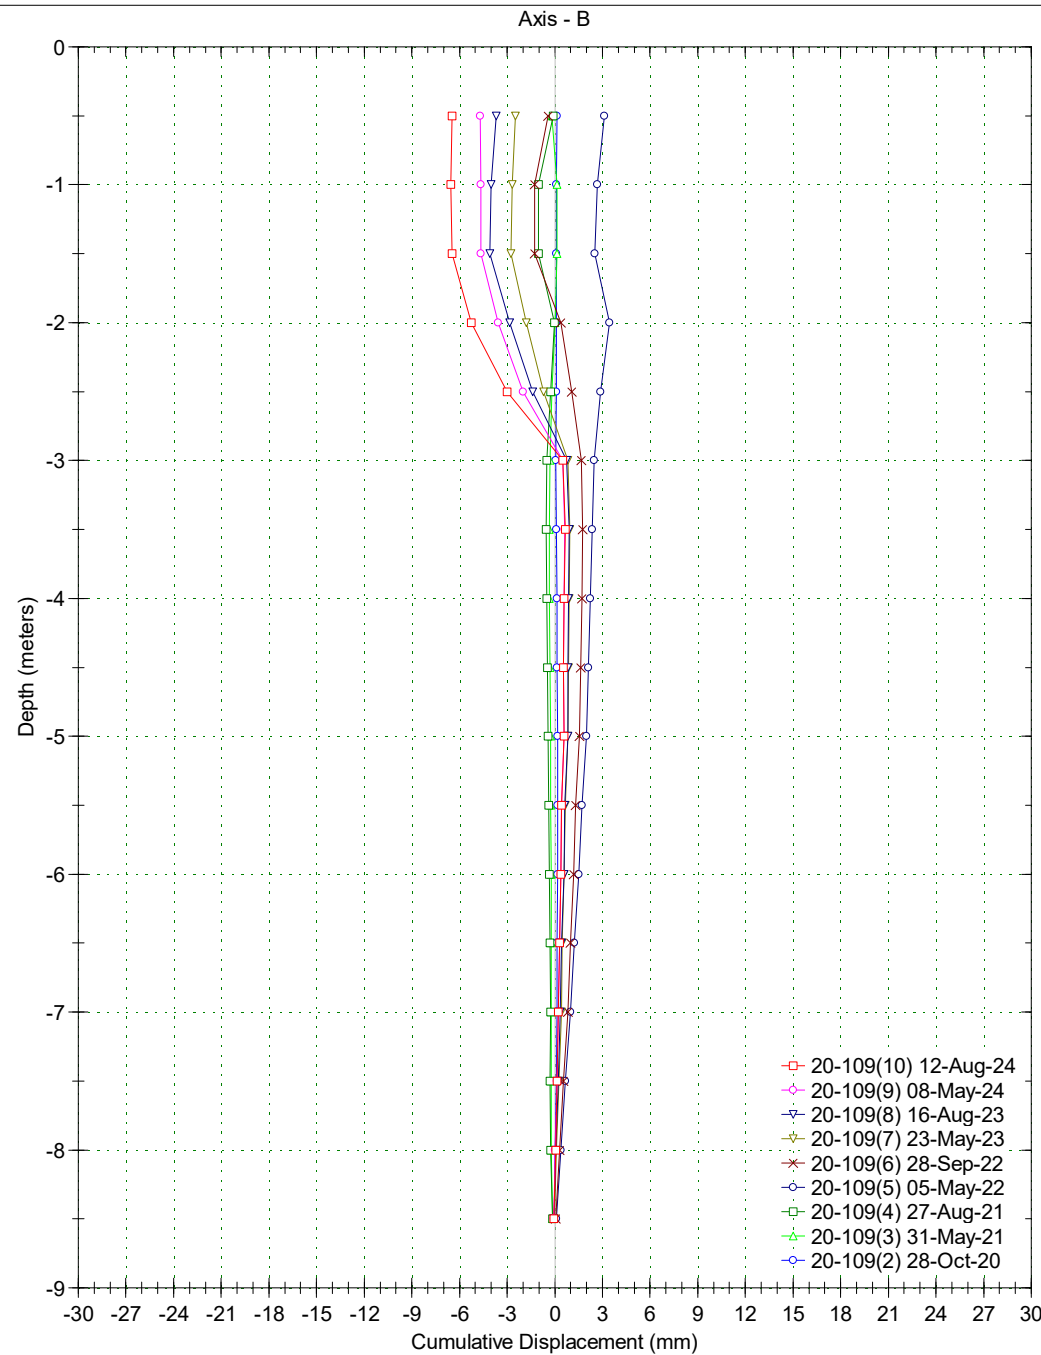
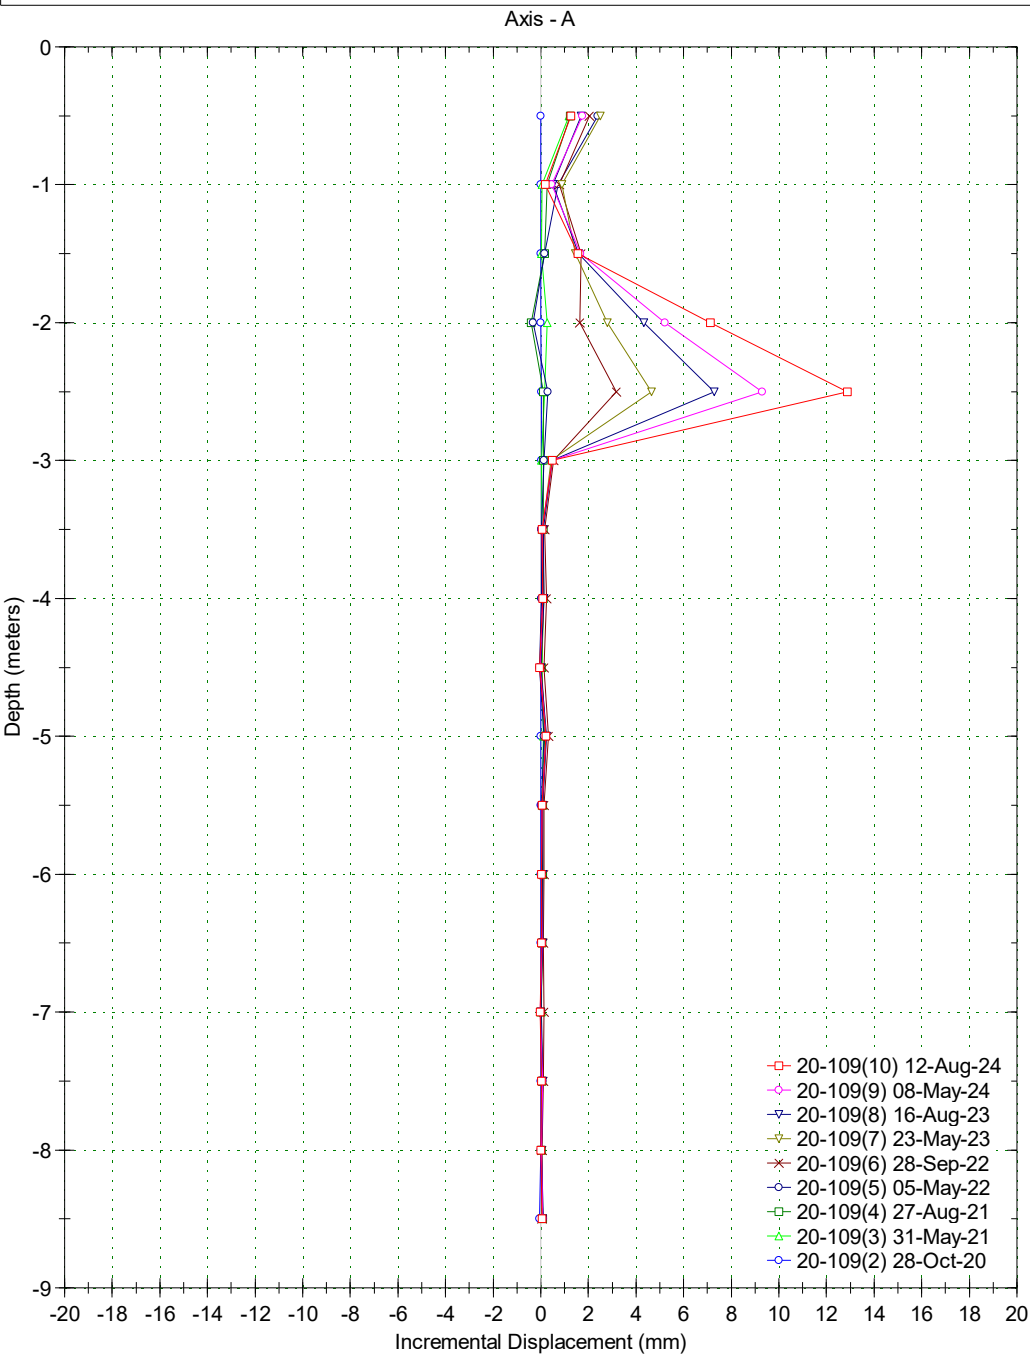
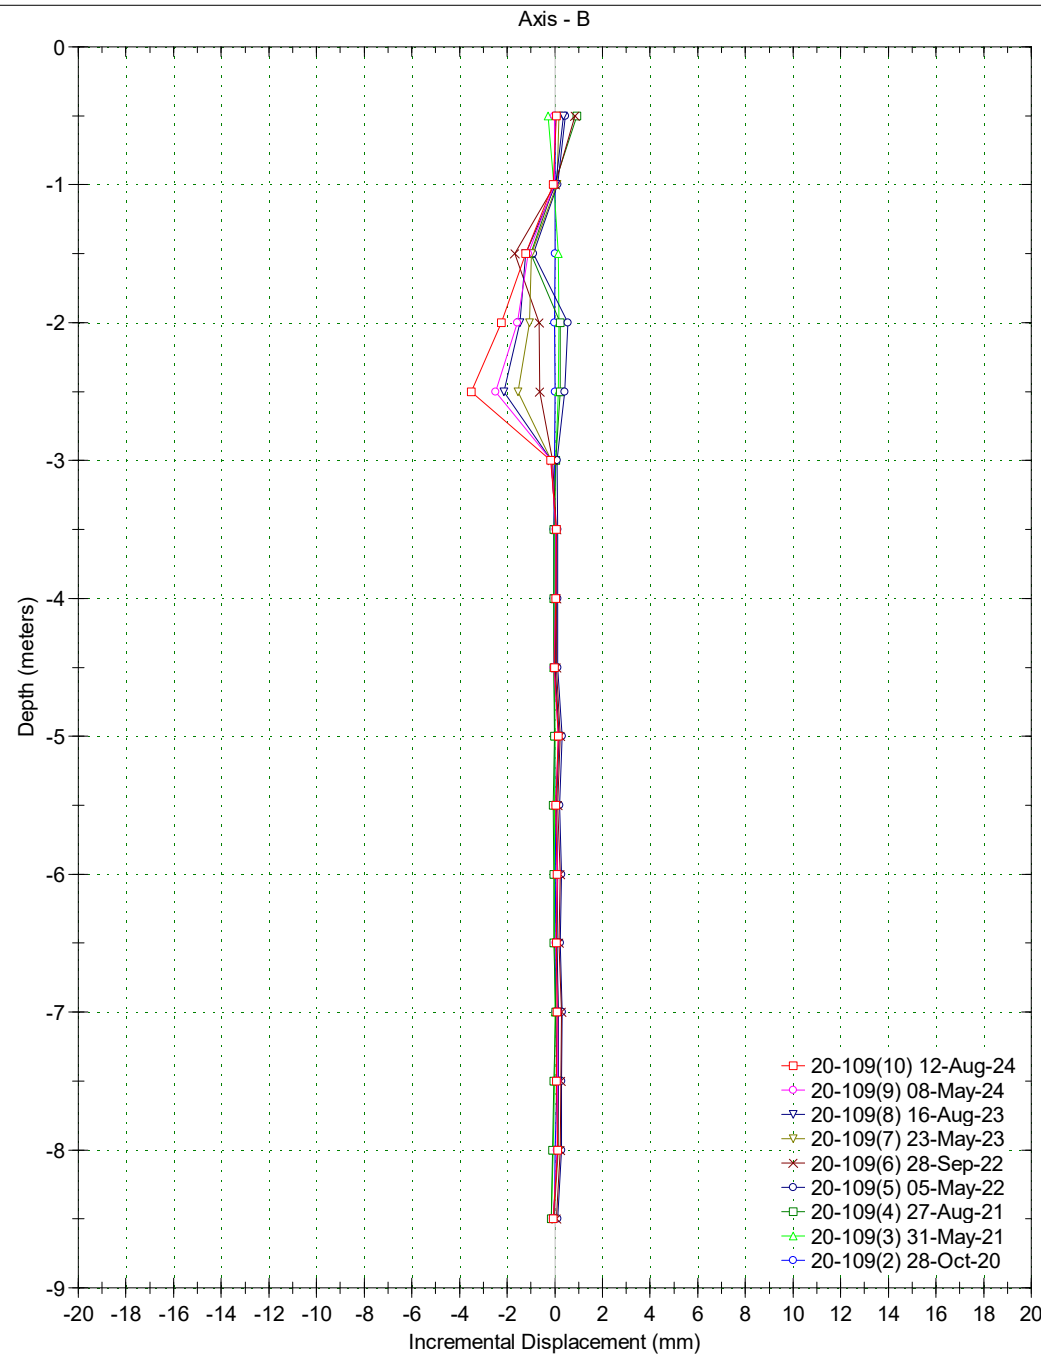
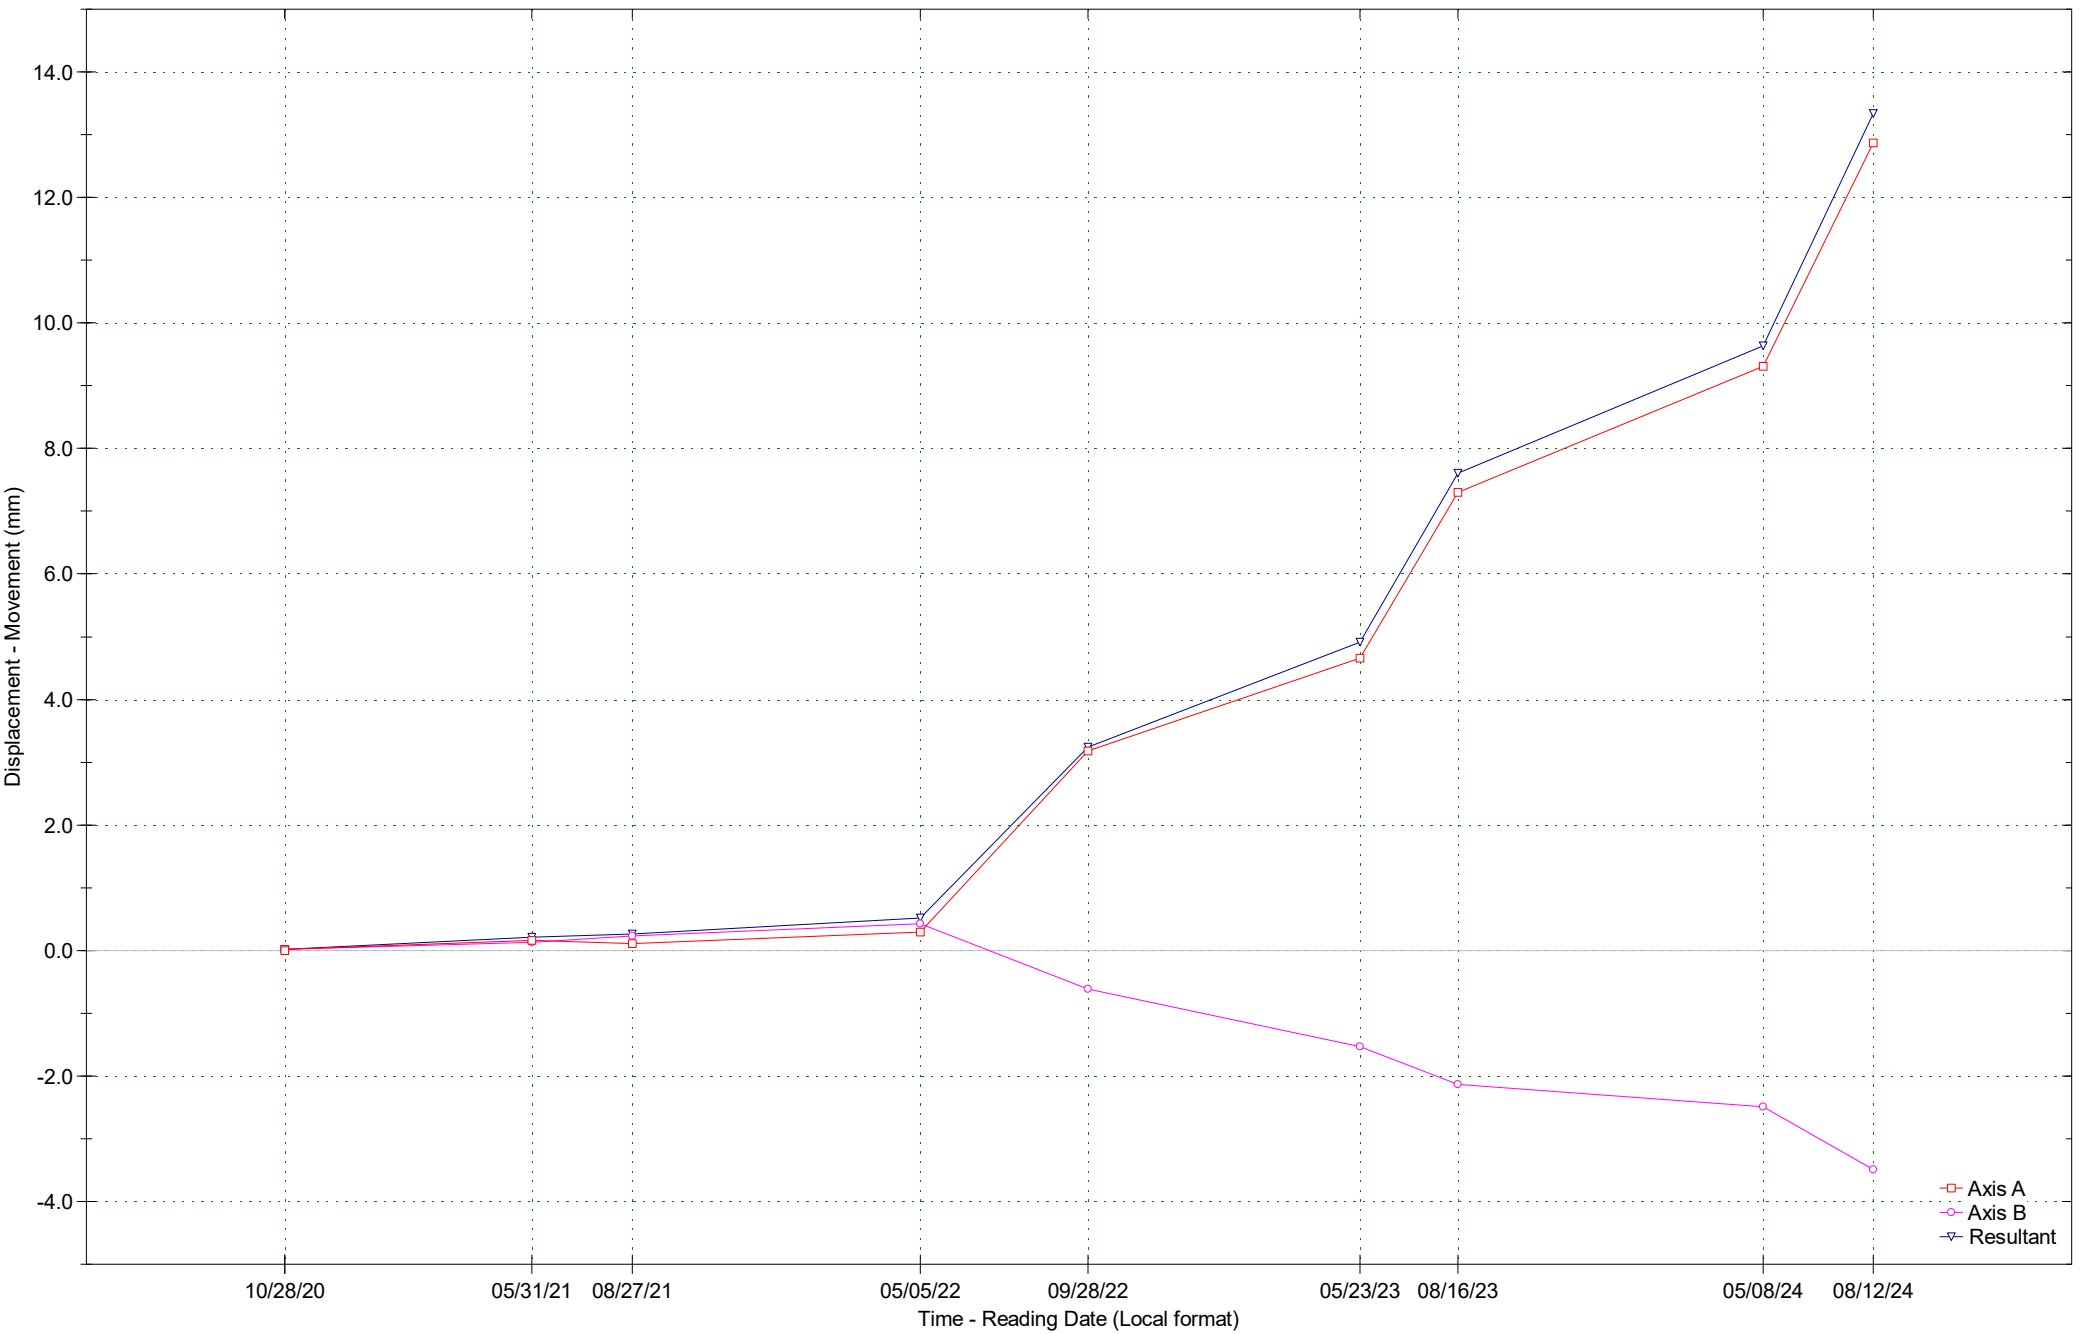
Borehole : 20-109
Project : Nutana Slope
Location :
Northing : 5775622
Easting : 385977
Collar :

- Inclinometer 20-109 indicated approximately 25 mm of cumulative downslope movement between October 28, 2020 and August 12, 2024, including 4.5 mm (0.18 in) of movement between May 8 and August 12, 2024. The zone of movement is approximately 2.5 m below the top of casing. The rate of slope movement increases from approximately 1 mm/yr between October 28, 2020 and May 5, 2022 to 6 mm/yr between May 5, 2022 and August 12, 2024.
- Inclinometer 20-111 indicated approximately 2.5 mm (0.10 in) of movement in the upslope direction, between May 8, 2024 and August 12, 2024.

Slope inclinometer 20-109 indicates a zone of movement a depth of approximately 2.5 m below the top of casing with a rate of movement approximately 6 mm/yr between May 5, 2022 and August 12, 2024, an increase from 1 mm/yr for the period between October 28, 2020 and May 5, 2022. WSP recommends that COS consider increasing the frequency of monitoring for the two inclinometers located in the west slide (20-109 and 20-111). WSP could assist with additional instrumentation monitoring if COS requests.

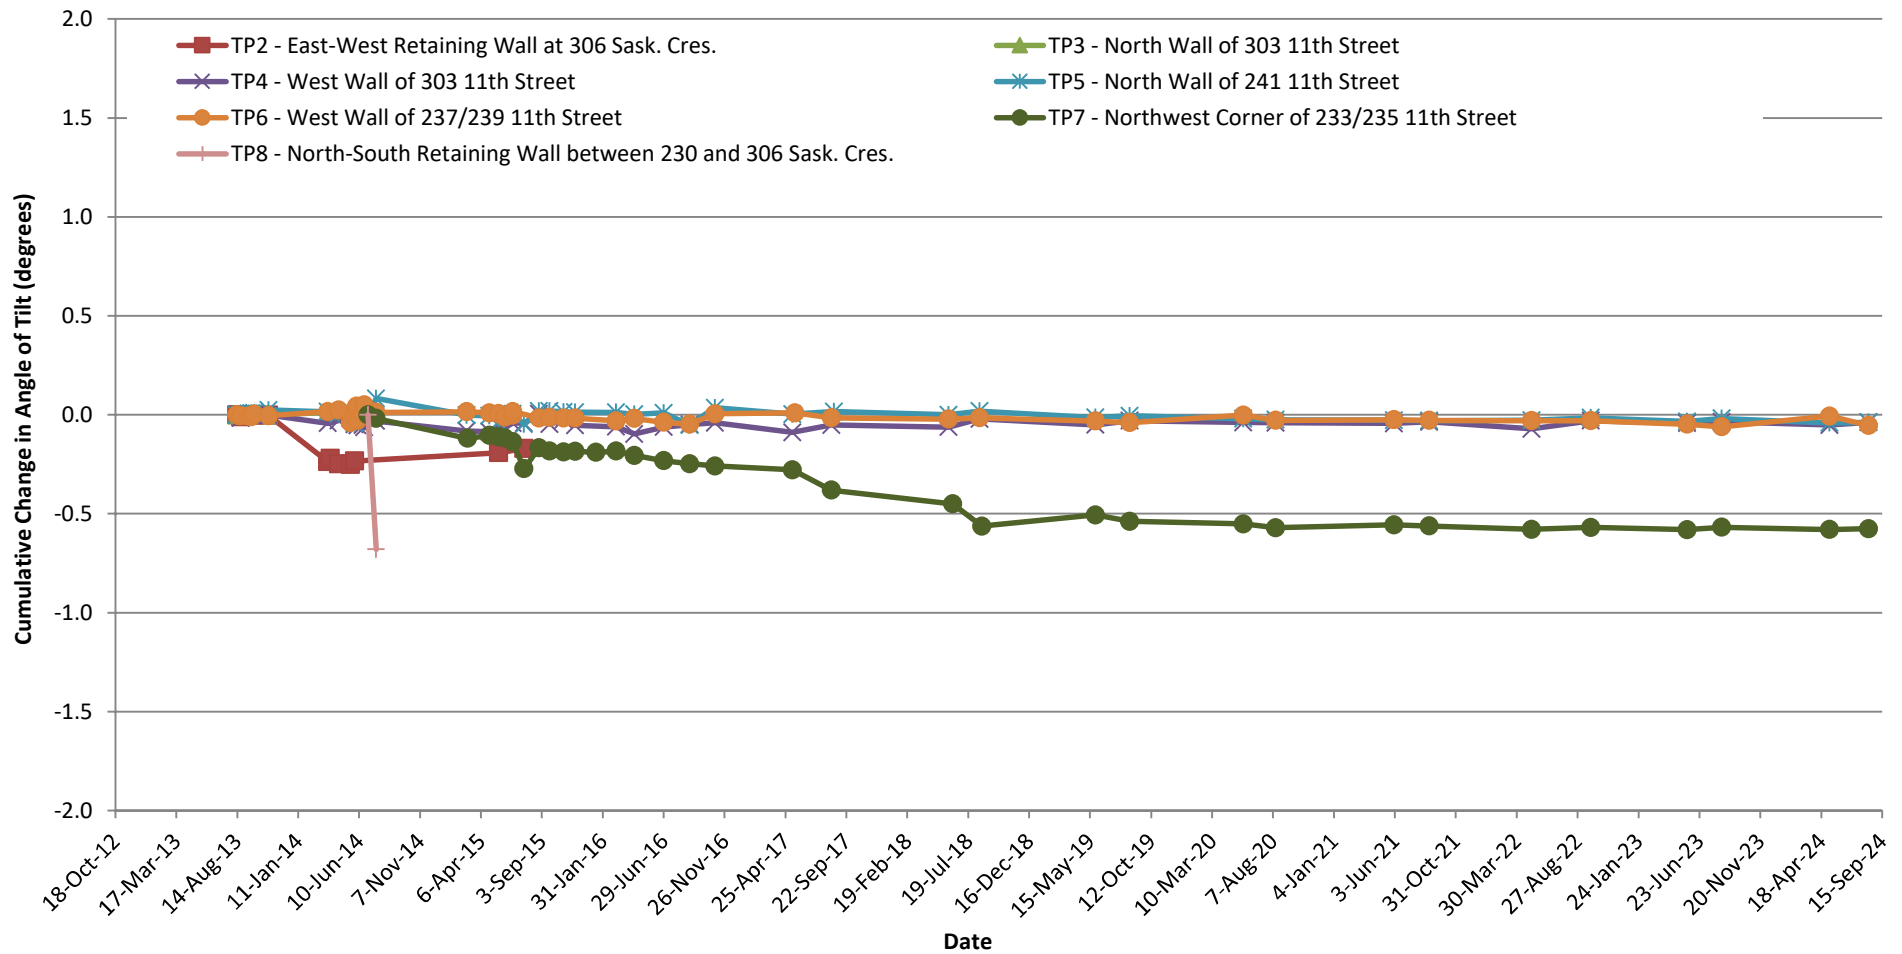
NUTANA SLOPE INSTABILITY	
RESULTS OF TILT MONITORING <i>August 2024 Monitoring</i>			
	PROJECT	CA0029692.9234	FILE No.
	DESIGN		SCALE N/A REV.
	CADD		
	CHECK		
	REVIEW		
			FIGURE: B1

- Tilt plates TP4, TP5, TP6 and TP7 indicate insignificant changes in angle of tilt (less than 0.05 degrees) between August 2019 and August 2024.
- Tilt Plate SLP3 indicated a change in angle of tilt of approximately 0.10 degrees, towards the south, between May 8 and August 12, 2024. However, past readings for SLP3 have been erratic and appear to be affected by seasonal changes.

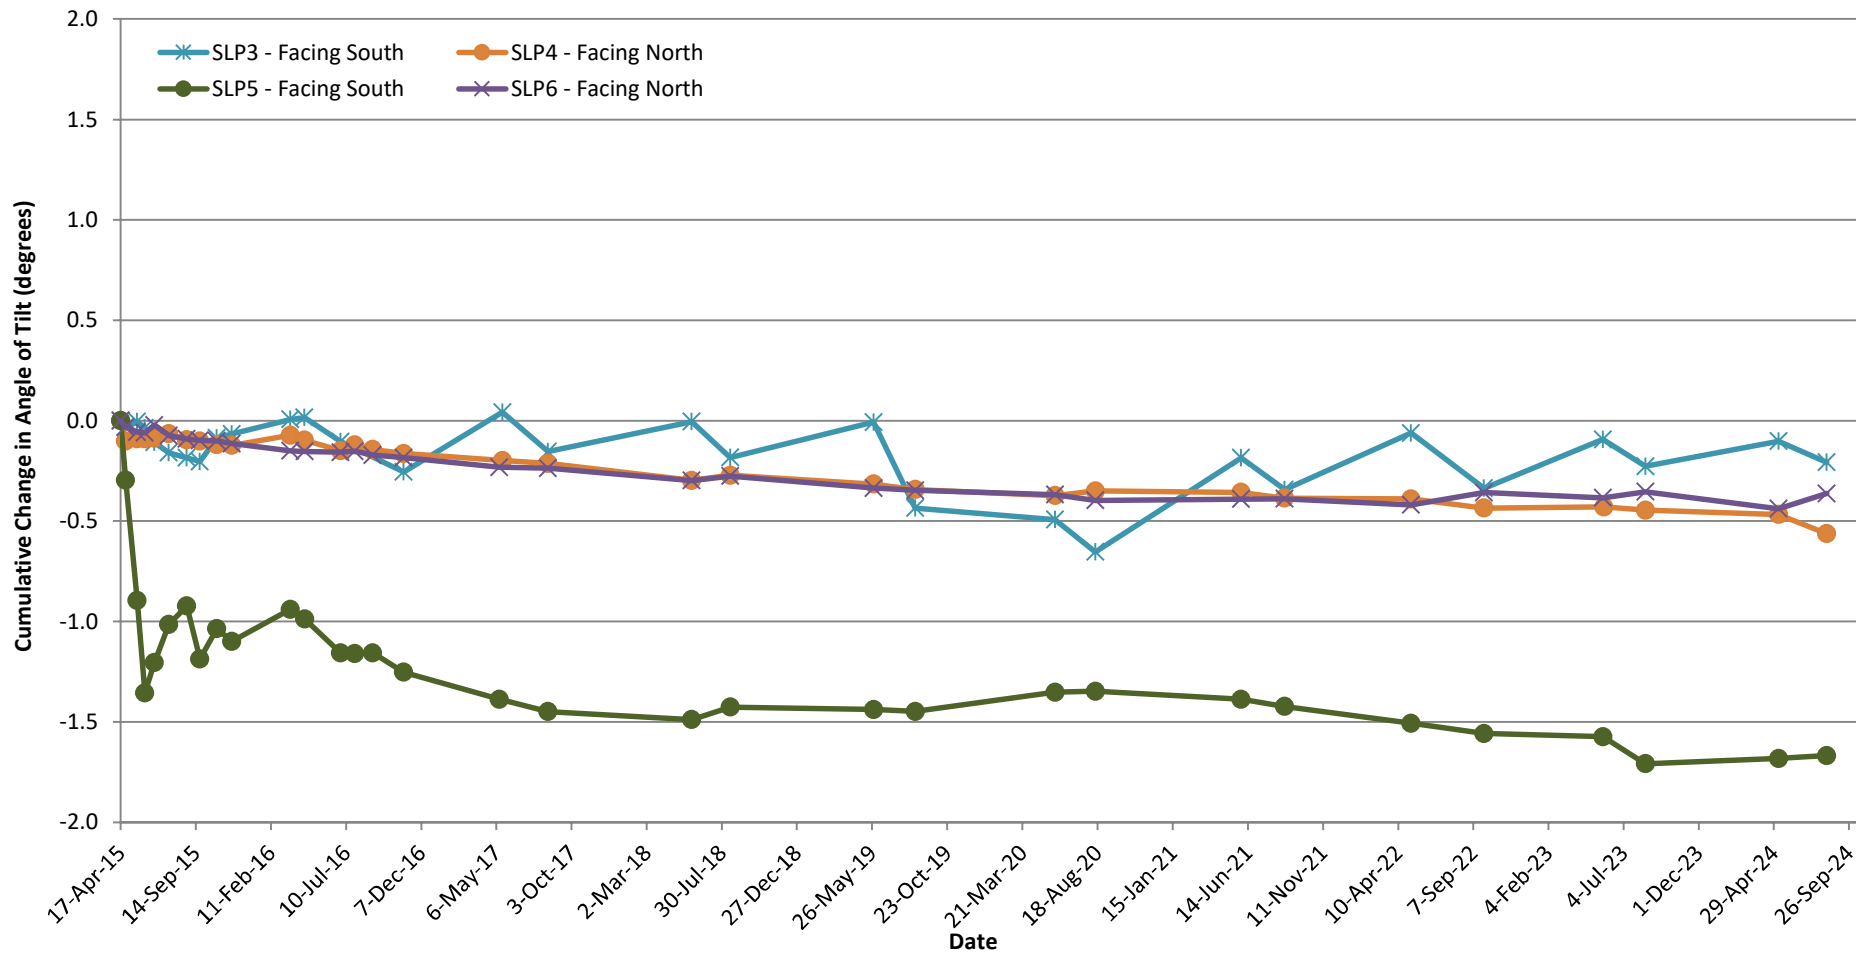
PROJECT	CA0029692.9234	FILE No.
	DESIGN		SCALE N/A REV.
	CADD		
	CHECK		
	REVIEW		
			FIGURE: B2

- Tilt Plate SLP4 indicated an increased change in angle of tilt in this monitoring period, with a change in angle of tilt of approximately 0.10 degrees, towards the north, between May 8 and August 12, 2024. This change trend will be confirmed in the next monitoring period.

- Tilt plate SLP5 indicated an insignificant change in angle of tilt (less than 0.05 degrees) between August 16, 2023 and August 12, 2024.
- Tilt plate SLP6 indicated a change in angle of tilt of approximately 0.08 degrees, towards the south, between May 8 and August 12, 2024.
