## Civic Square East

Saskatoon, SK

## **EXECUTIVE SUMMARY**

Bersch Consulting Ltd. was retained by the City of Saskatoon to conduct an asbestos assessment of the main floor at Civic Square East located at 202 4<sup>th</sup> Avenue North, Saskatoon, Saskatchewan. The assessment was performed by Bersch Consulting Ltd. which began on July 4, 2023.

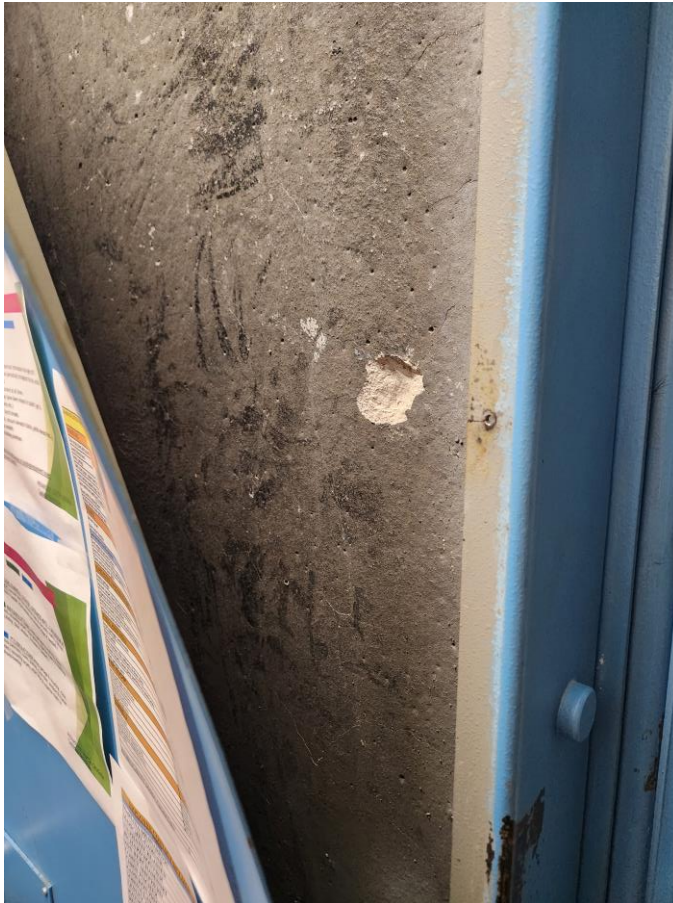
B67AAG04M – 11a/b

**Asbestos Containing Material**

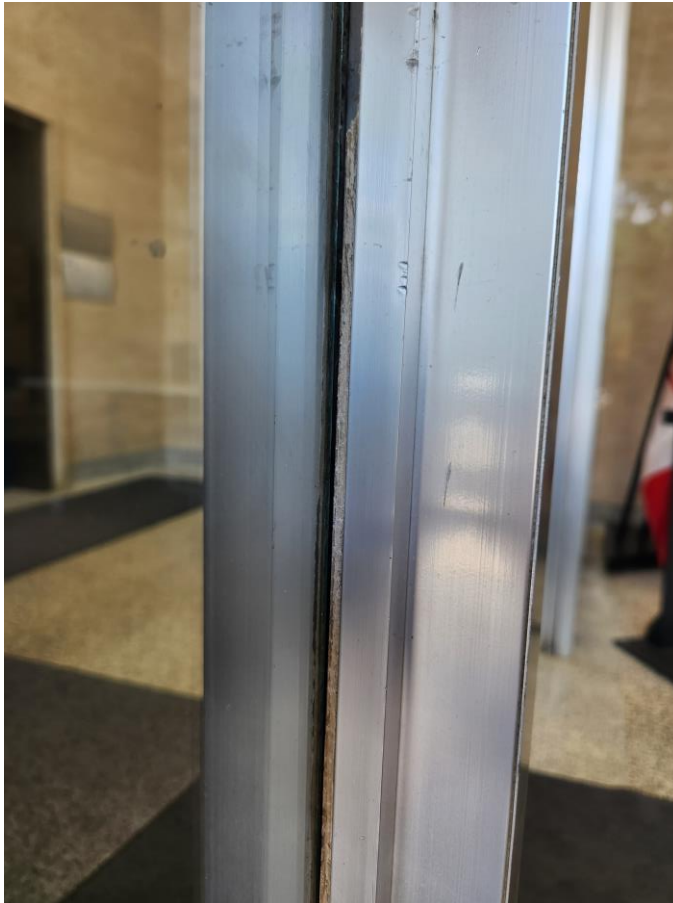
<p><b>Sample Number</b> B67AAG04M – 21a/b</p> <hr/> <p><b>Description</b> Grout 103 SREDA West Wall to North and South of Door #6 In Between Wall Slabs</p> <p><b>Asbestos Containing Material</b></p> <hr/>

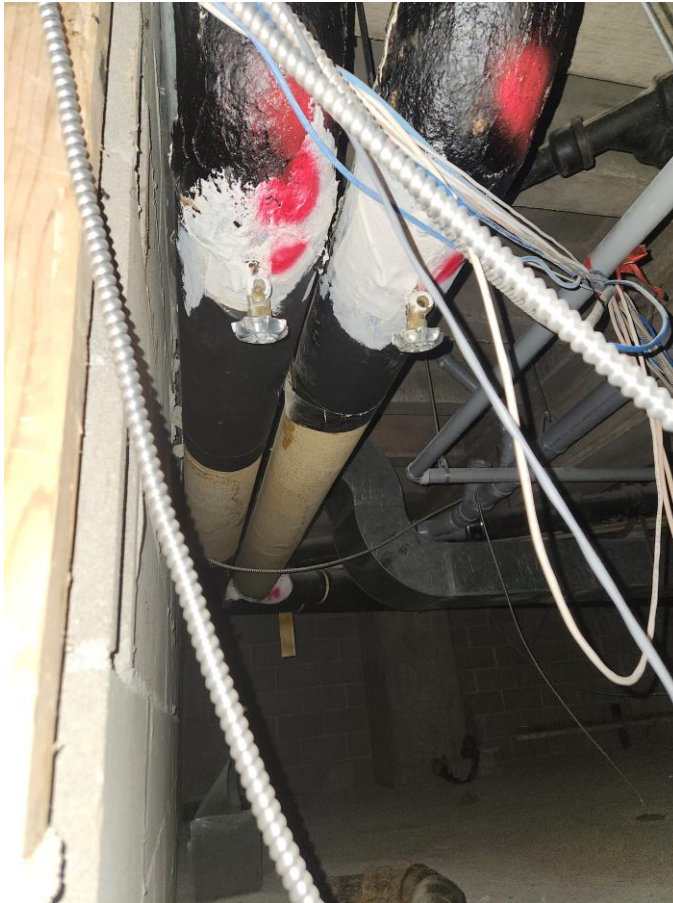
Asbestos Containing Pipe Fitting  
Located Within the Ceiling Space  
Above the Vault

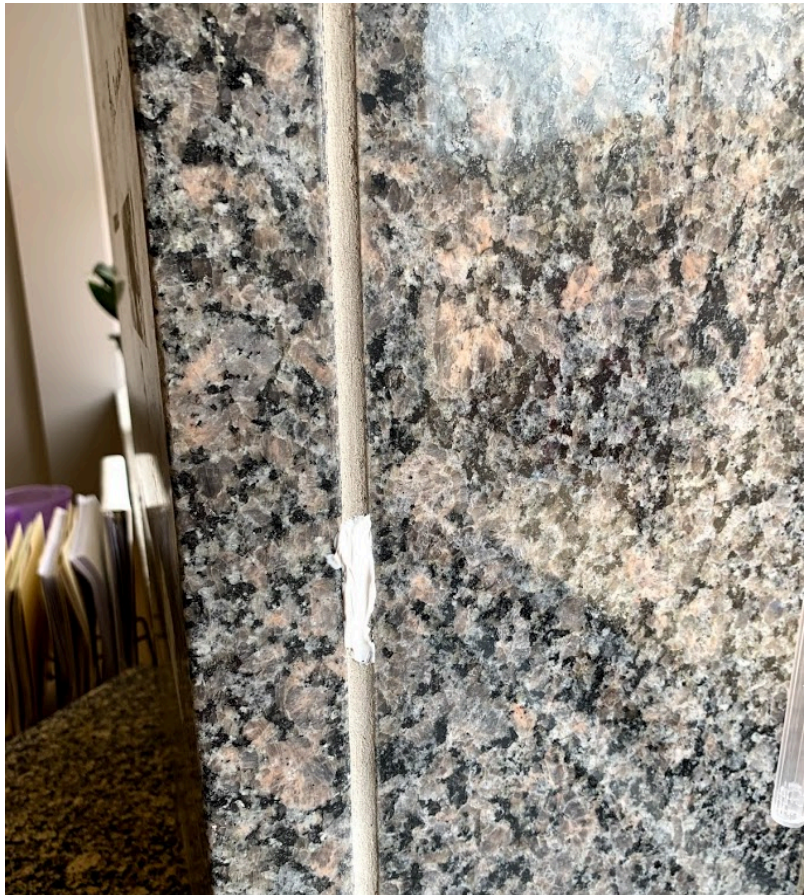
B67PRC24K – 002

Between Interior Window Frame  
and Marble.

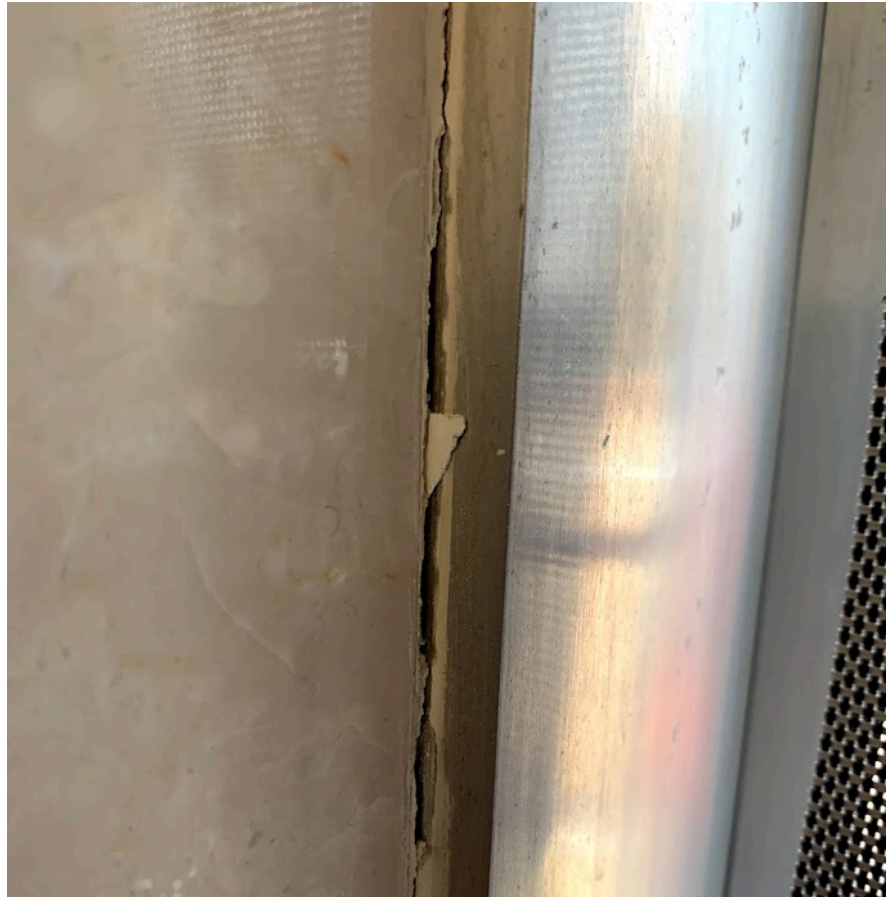
B67PRC24K - 003

On Marble

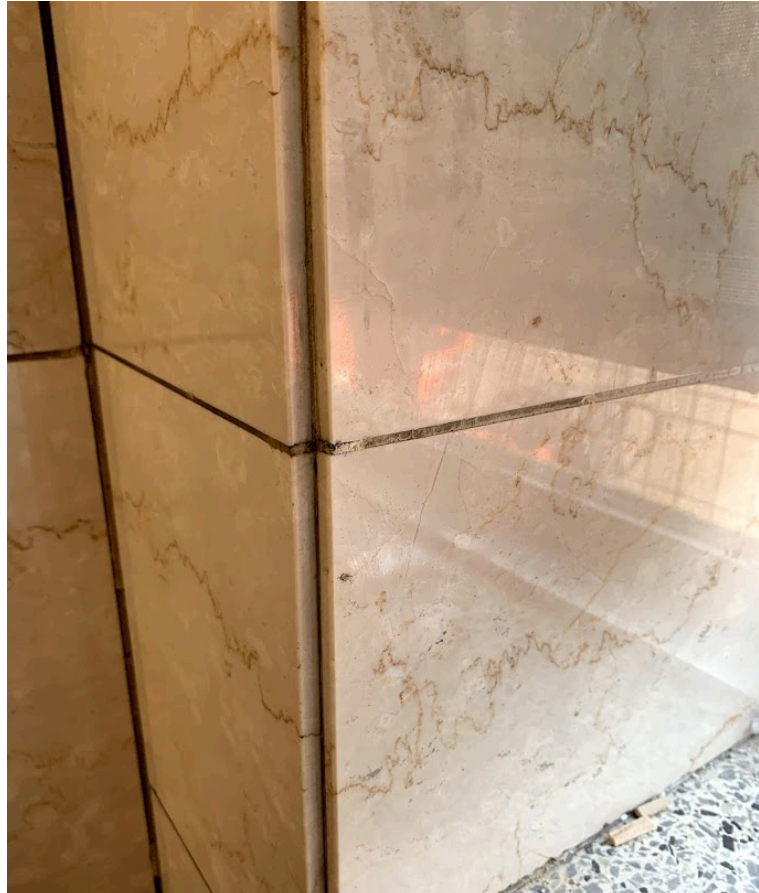
B67PRC24K - 004

Main Level SREDA Office on  
Marble Attached to Window  
Frame

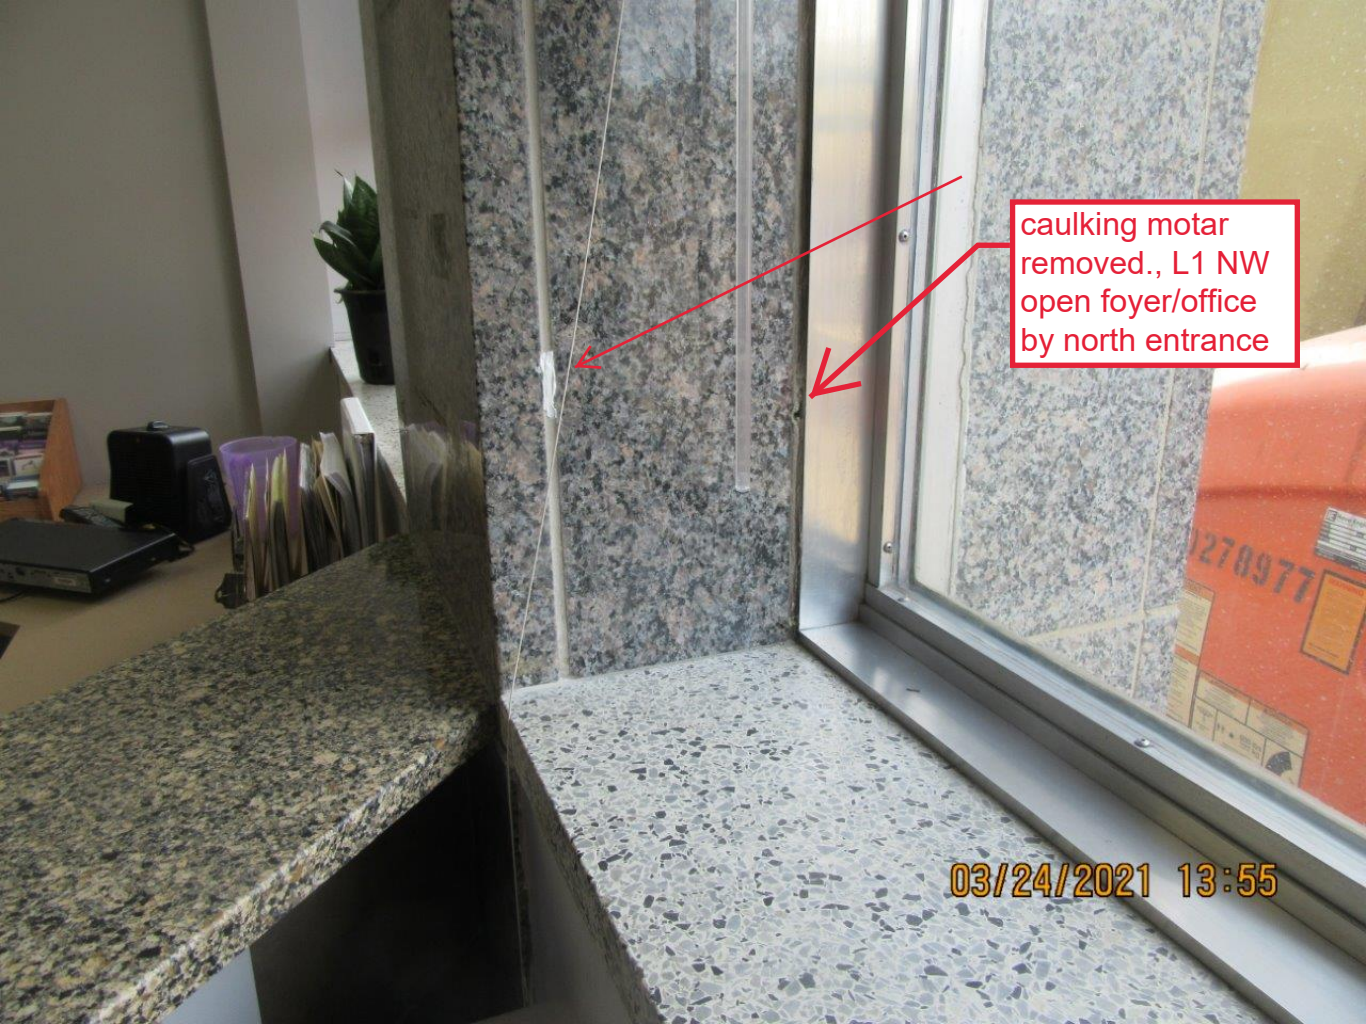
caulking motar removed., L1 NW open foyer/office by north entrance

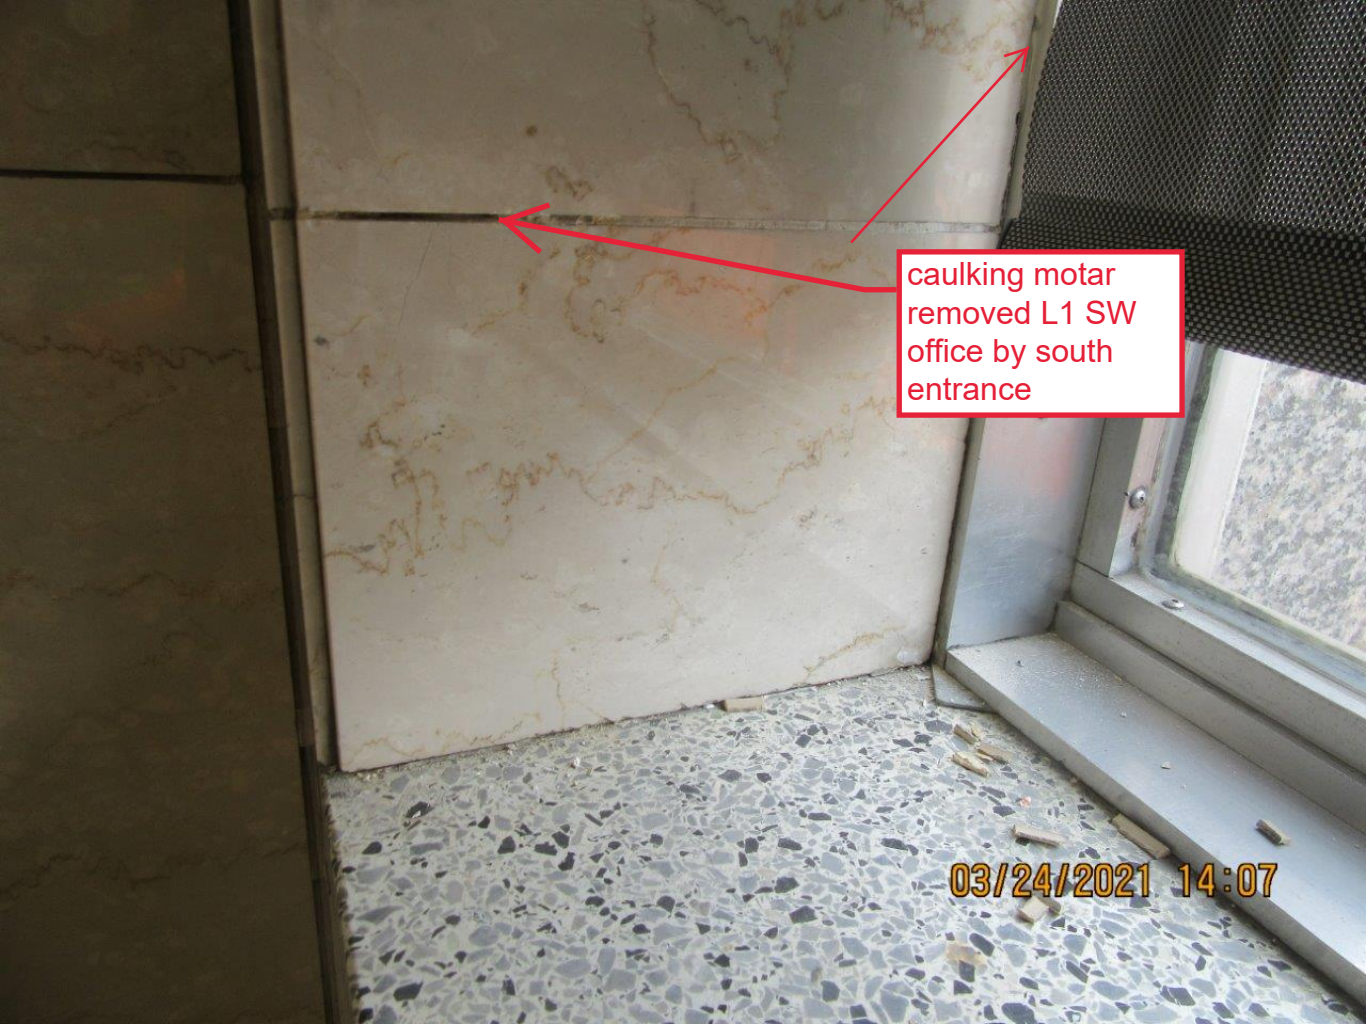
caulking motar  
removed L1 SW  
office by south  
entrance

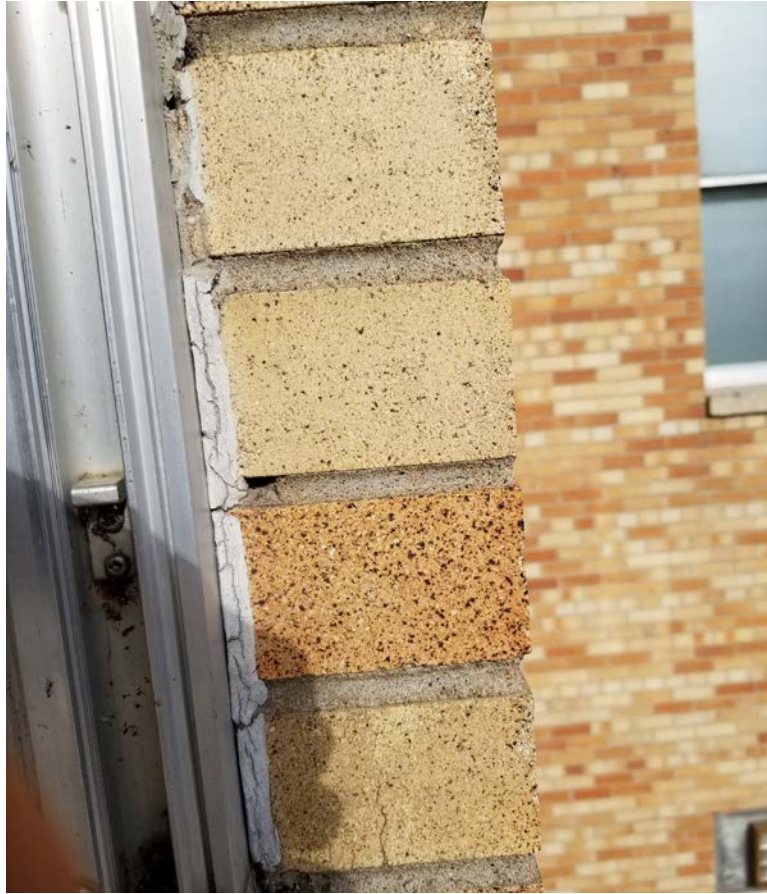
- a) **345 Staff Lounge** - The caulking between the window frame and the brick is deemed as containing asbestos. Refer to **Sample 1** of the Bulk Analysis in Appendix I.
- b) **316 Office Area** - The caulking between the window frame and the stone is deemed as containing asbestos. Refer to **Sample 3** of the Bulk Analysis in Appendix I.
- c) **Window Mullions** – The area behind a window mullion was observed and determined to be fiberglass insulation. This area does not contain asbestos material. Refer to **Photo 4** in **Appendix II Site Photos**.

345 Staff Lounge Exterior  
Caulking Between Window  
Frame and Brick.

As a result of the site investigation there are asbestos concerns regarding the replacement of the exterior windows. The removal of the caulking is considered a low risk asbestos process.

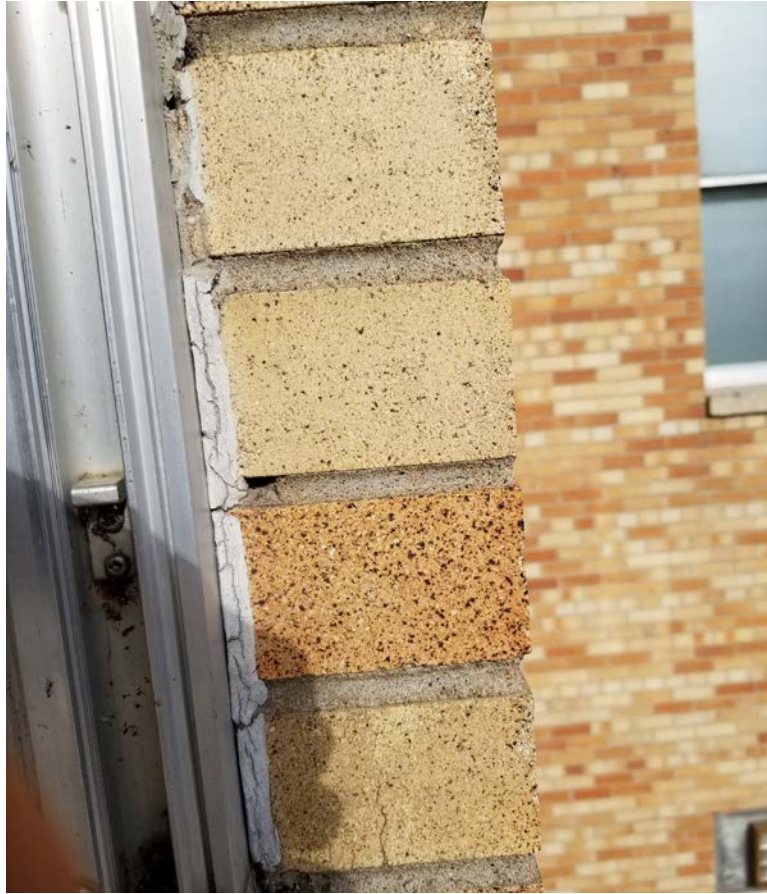
345 Staff Lounge Exterior  
Caulking Between Window  
Frame and Brick.

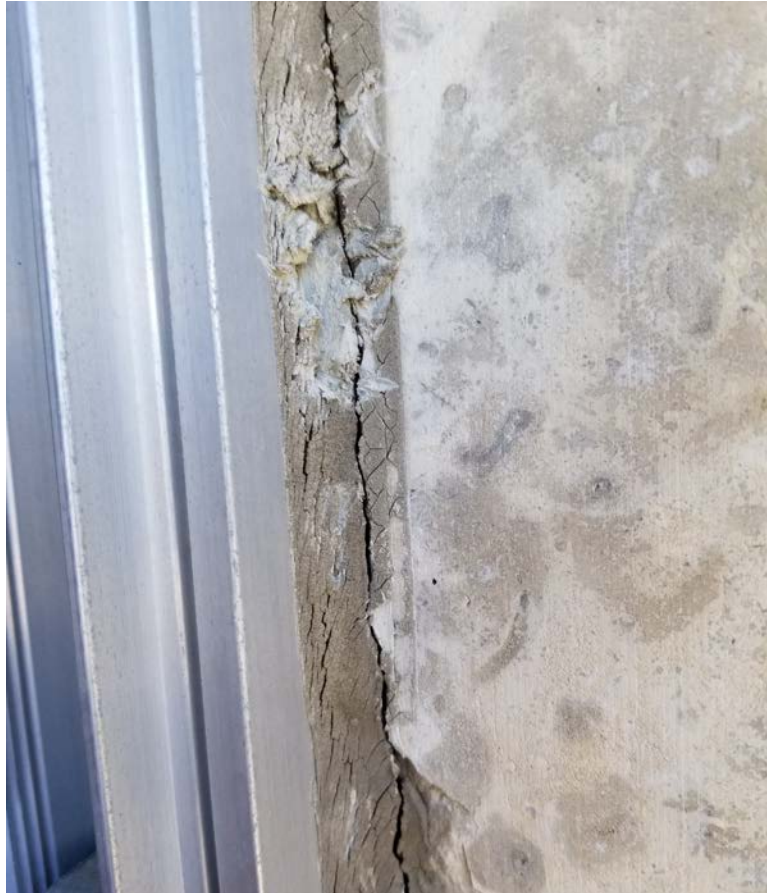
316 Office Area Exterior  
Caulking Between Window  
Frame and Stone.
