**SUBJECT: Fire Hall #6 - Asbestos Registry Report**

**BULK SAMPLE ANALYSIS REPORT**

**FINAL**  
**Limited Asbestos  
Building Materials  
Assessment**

Fire Hall #6 Cable Drop Project  
3309 Taylor Street East,  
Saskatoon, Saskatchewan

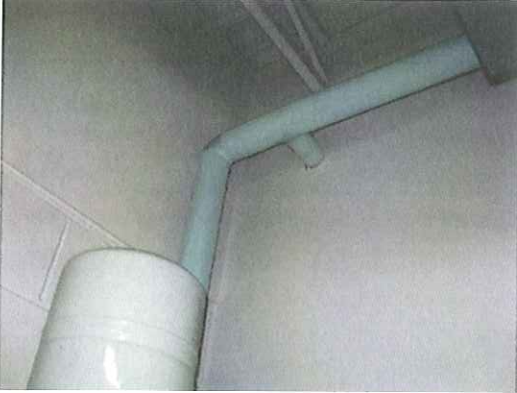
#1) Pipeline Fitting

NO.	DATE	SAMPLE INFORMATION	ASBESTOS	%	ANALYST
B1	6-May-13	114 - Pipeline fitting on small green line	None detected		WB
B2	6-May-13	121 - Pipeline fitting on small white line, overhead adjacent unit heater in the northeast corner	None detected		WB
B3	6-May-13	103 - Pipeline fitting above ceiling tile adjacent women's dorm entry	None detected		WB
B4	6-May-13	124 - Duct expansion gasket on ducting in upper deck	None detected		WB
B5	6-May-13	102 - Sheet flooring- tan, beige and blue stone pattern	None detected		WB
B6	6-May-13	112 - Sheet flooring- grey, white and black stone pattern	None detected		WB

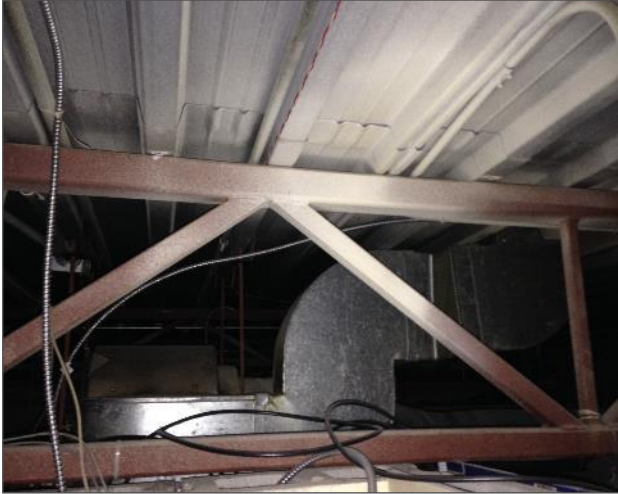
Ducts are not insulated.

Photo 1: Un-insulated metal duct, structural steel, and metal roof decking above acoustic ceiling tiles in Men's Washroom (Location 105)

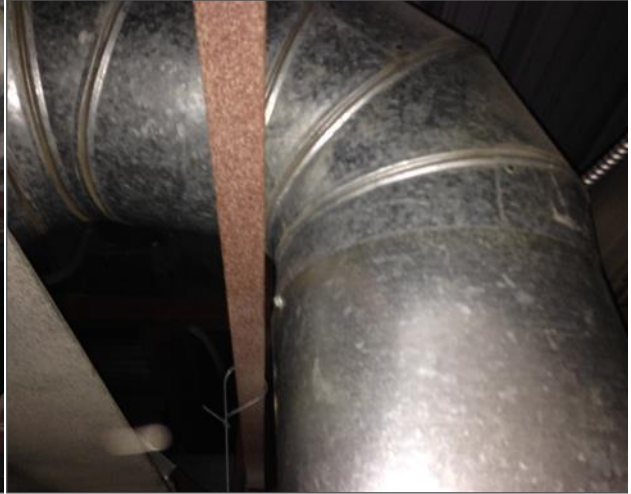
Photo 2: Un-insulated metal duct with no mastic above acoustic ceiling tiles in Men's Washroom (Location 105).

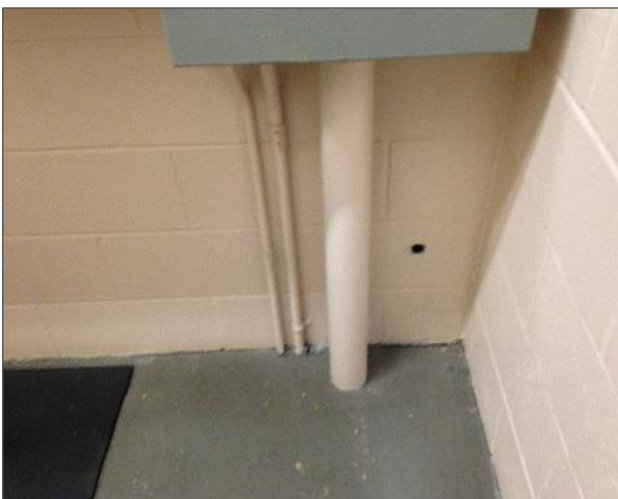
Destructive testing was conducted of masonry block walls. The masonry block wall, between the Study (Location 119) and the Compressor Room (Location 118), was penetrated in one location, loose fill vermiculite is not present. The location of destructive testing are indicated on the drawings in Appendix I.

Photo 3: Intrusive hole in concrete block wall that separates the Compressor Room (Location 118) and the Study Room (Location 119). No insulation was found.

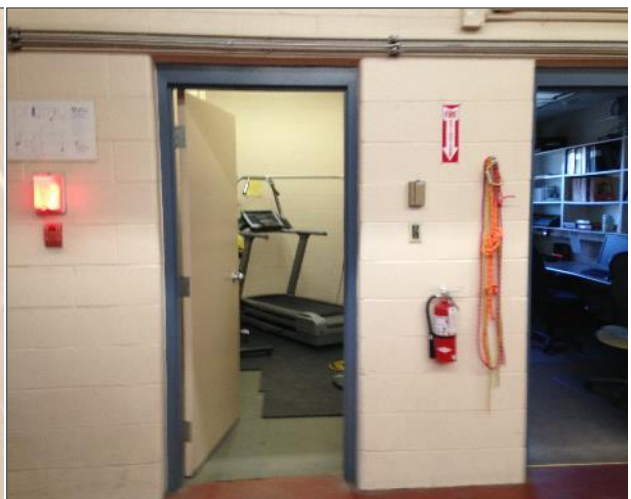
Photo 4: Compressor Room (Location 118) on left and the Study Room (Location 119) on the right.

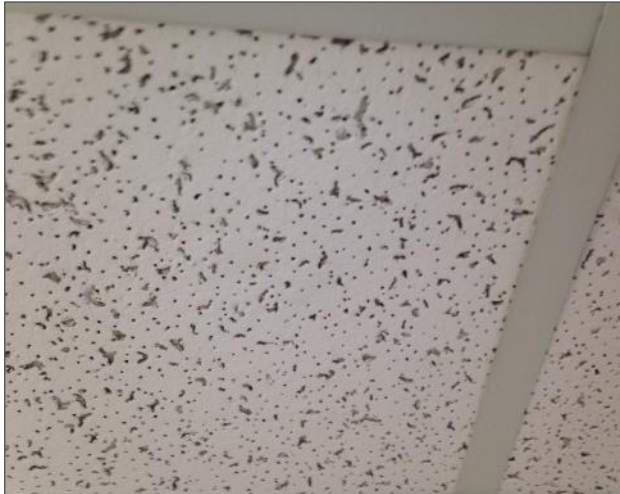
All ceiling tiles are presumed to be non-asbestos based on the date of manufacture determined from the date stamp applied to the top of the tiles or the age of the materials determined from the age of the building or the renovation. The tiles were manufactured after asbestos stopped being used in acoustic ceiling tiles.

Photo 5: Acoustic Ceiling Tiles, 24"x48" Pinhole and Fissure (Non-asbestos containing Date Stamp 02/08/16), Men's Washroom (Location 105)

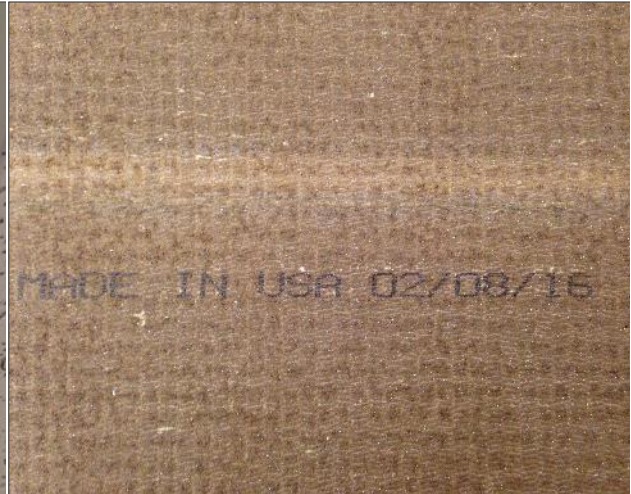
Photo 6: Acoustic Ceiling Tiles, 24"x48" Pinhole and Fissure (Non-asbestos containing Date Stamp 02/08/16), Men's Washroom (Location 105)

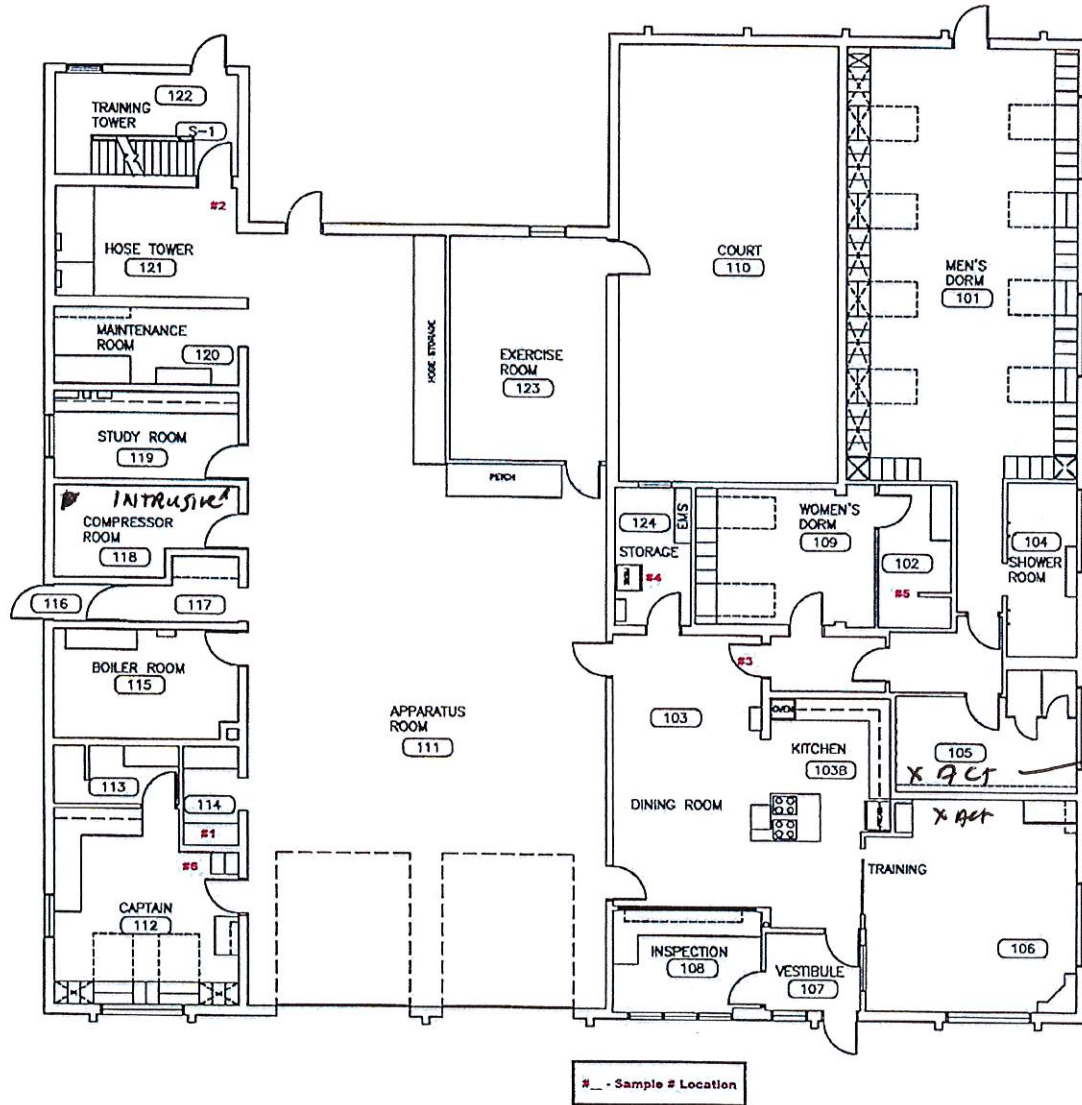
INTRUSIVE  
HOLE IN  
CONCRETE  
BLOCK  
WALL.  
- NO  
VERMICULITE

Acoustic  
ceiling  
tile.  
02/08/16.

NO DUCT ON  
PIPE  
INSULATION.
