**CITY OF SASKATOON – SURVEYOR’S BUILDING  
ASBESTOS SURVEY REPORT**

**MAY 2013**

**Prepared For: City of Saskatoon – Infrastructure Services Department**  
1101 Avenue P North, Saskatoon SK, Canada S7L 7K6  
Attn: Brent Anderson

**Prepared By: Bersch & Associates Ltd.**  
**Project No. : B67SRE01S**

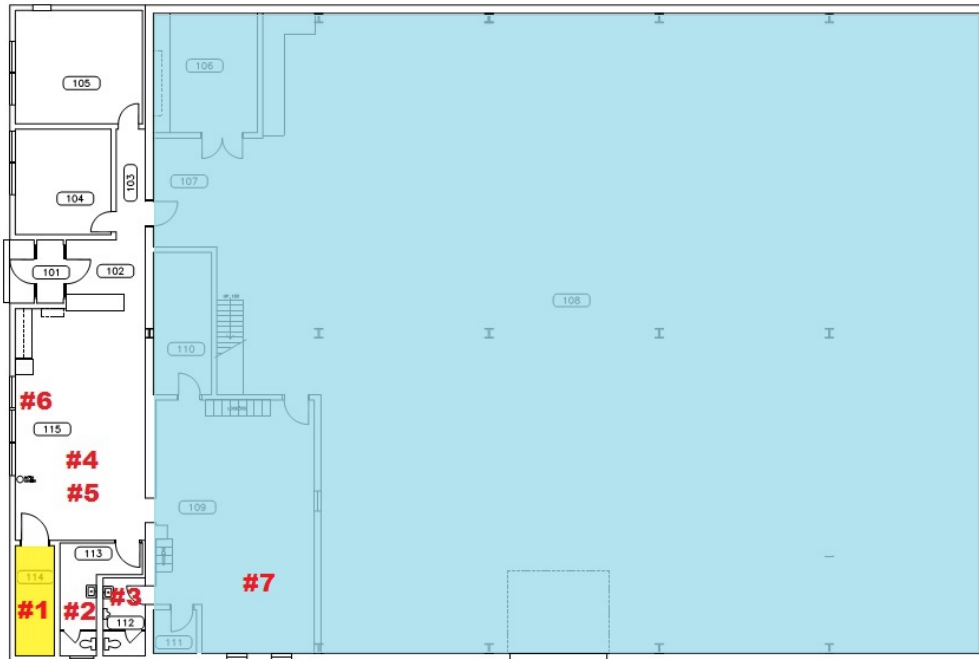
**FLOOR PLANS**

**Transite Liner Panel**  
 **Asbestos Floor Tile**

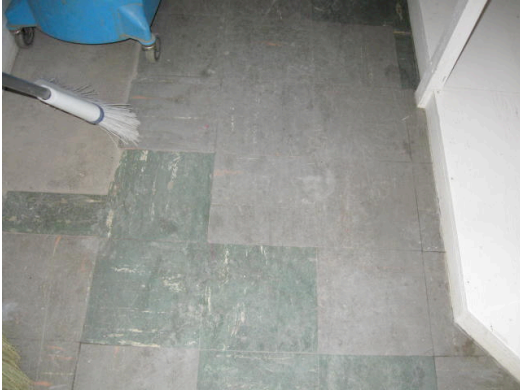
#1) 9" X 9" Floor Tile

**9-inch by 9-inch floor tile** was identified as containing asbestos. This material was observed to be in good condition with a low potential for disturbance. The material may be managed.

<b>PRIORITY:</b>	<b>THREE</b>
<b>CONDITION:</b>	<b>GOOD</b>
<b>POTENTIAL FOR DISTURBANCE:</b>	<b>LOW</b>
<b>ACTION:</b>	<b>MANAGE</b>

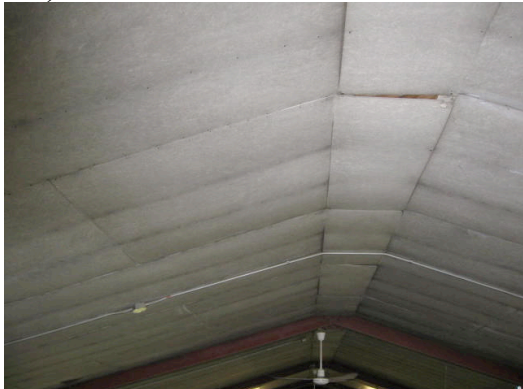
#7) Transite board

**Transite liner panel** was identified throughout the shop ceiling as containing asbestos. This material was observed to be in good condition with a low potential for disturbance except for three slightly damaged areas. One damaged area in the northwest corner of the shop consists of a fragment hanging from the ceiling that should be removed and the edges of the remaining fracture encapsulated with silicone or encapsulant. Two small damaged areas adjacent the top of the mezzanine stairs should also be encapsulated. Management of the material is recommended.

<b>PRIORITY:</b>	<b>ONE</b>
<b>CONDITION:</b>	<b>MODERATE</b>
<b>POTENTIAL FOR DISTURBANCE:</b>	<b>LOW</b>
<b>ACTION:</b>	<b>REPAIR / MANAGE</b>
