Building: Mendel Art Gallery

SUBJECT: Bulk Sample Analysis Report Mendel Art Gallery

**City of Saskatoon
Mendel Art Gallery
Asbestos Survey Report**

**Prepared For: City of Saskatoon - Infrastructure Services – Facilities Branch
Mendel Art Gallery
950 Spadina Crescent East, Saskatoon, SK.
Attn: Brent Anderson**

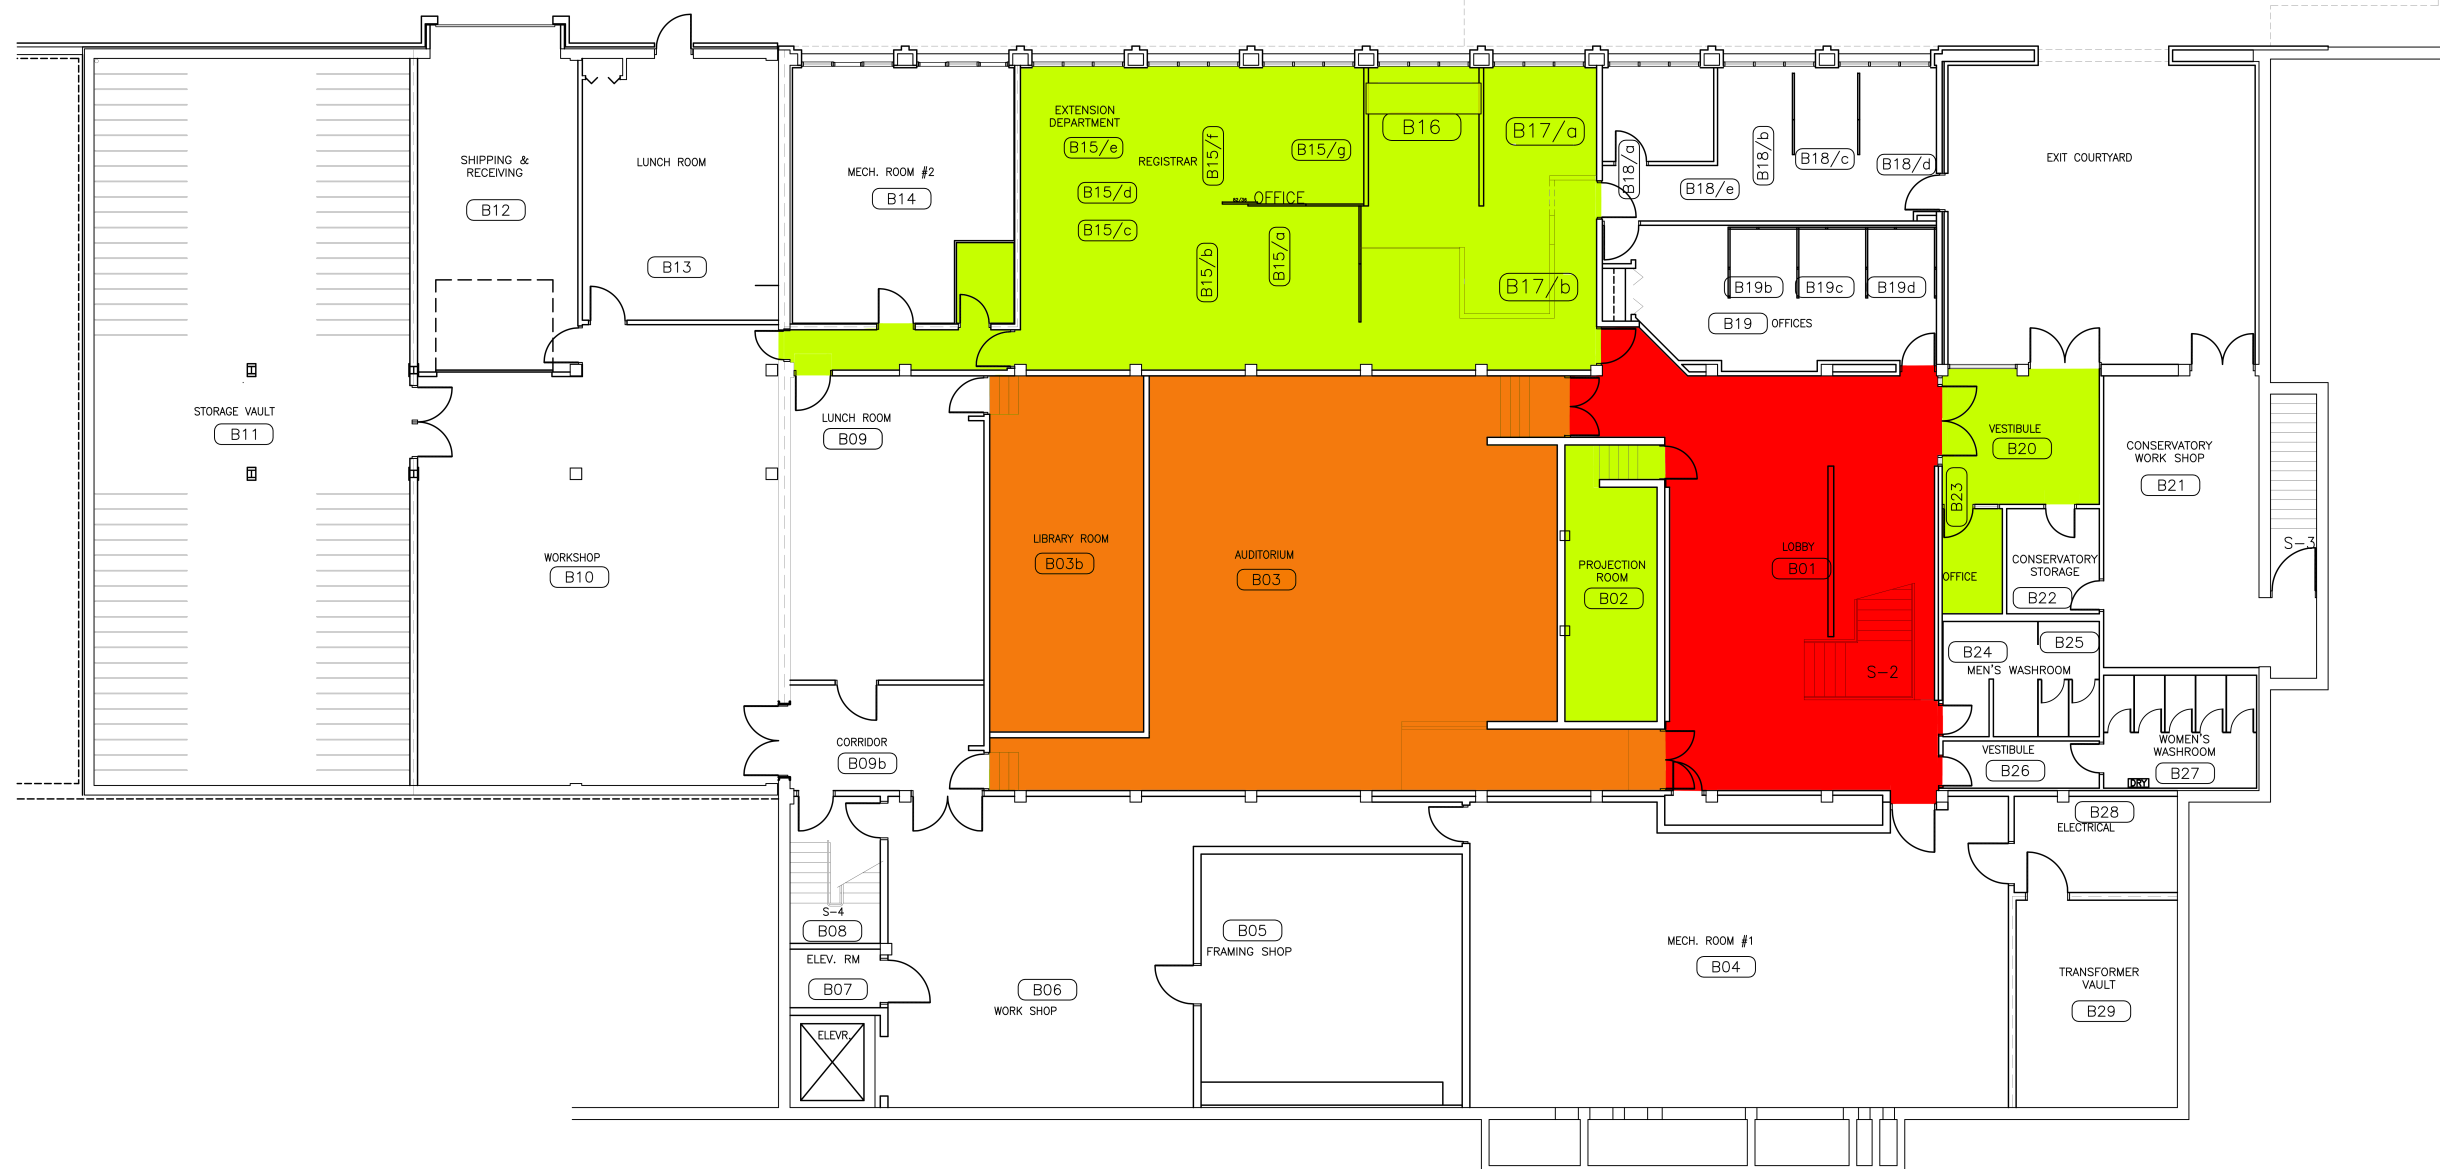
- Asbestos Floor Tile -
- Asbestos Floor Tile
and Textured Ceiling -
- Asbestos Textured Ceiling -

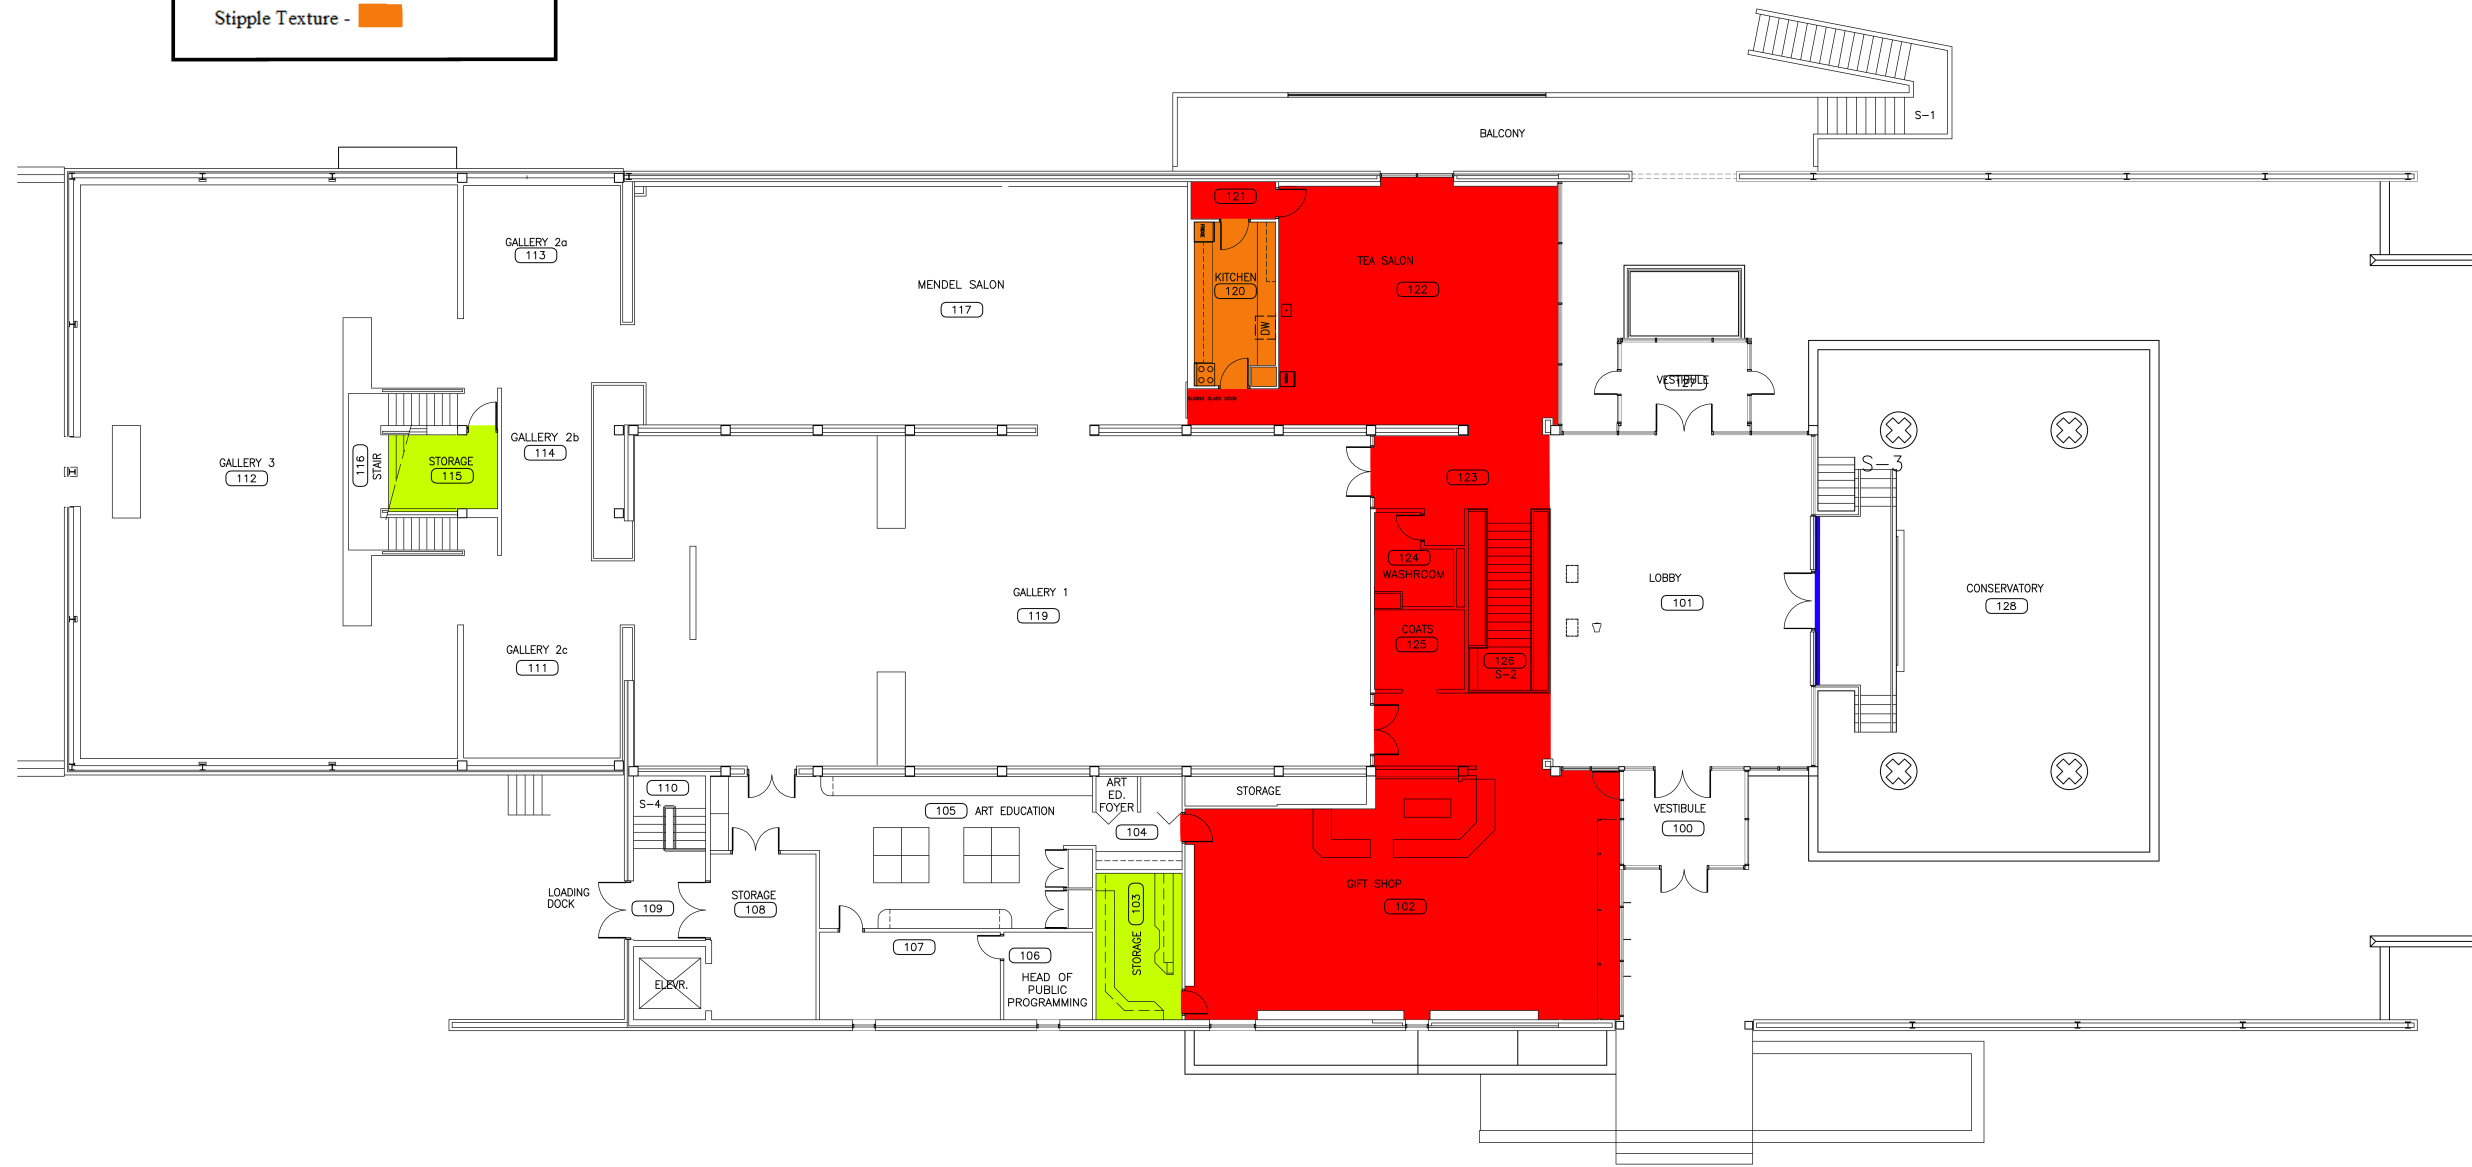
- Asbestos Floor Tile -
- Asbestos Stipple Texture -
- Asbestos Transite Board -
- Asbestos Floor Tile &
Stipple Texture -
