## CITY OF SASKATOON

# Asbestos-Containing Building Materials Assessment Report - Waste Water Treatment Plant Administration Building

**Report Number: 1667963**

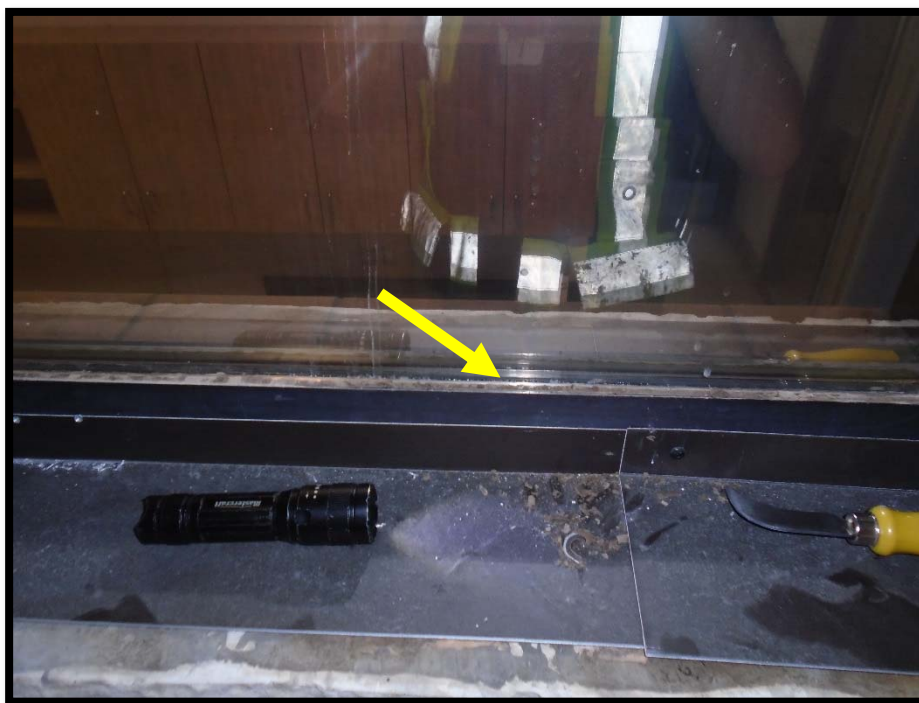
One (1) sample of grey window caulking was collected during the assessment. The sample collected was found to contain 10% Chrysotile asbestos. A layer of black window caulking was found on the sample and found to contain 5.1% Chrysotile asbestos. Asbestos-containing window caulking (see Photograph 1 in Appendix B) was observed in the following locations:

- Room 102.1 (70 linear ft.) on window panes;
- Room 106 (20 linear ft.) on window panes; and
- Room 129.1 (70 linear ft.) on window panes.

**Photograph 1: Asbestos-Containing Grey and Black Window Caulking**

If scheduled for impact, asbestos-containing window caulking should be abated following low-risk abatement work procedures as outlined in the *Saskatchewan Asbestos Abatement Manual (2017)*. Alternatively, as the caulking was observed in good condition, and with a priority rating of 5 (please see the room by room spreadsheet provided in Appendix C for a description of the priority ratings), the glazing can be managed in place if not scheduled for impact.

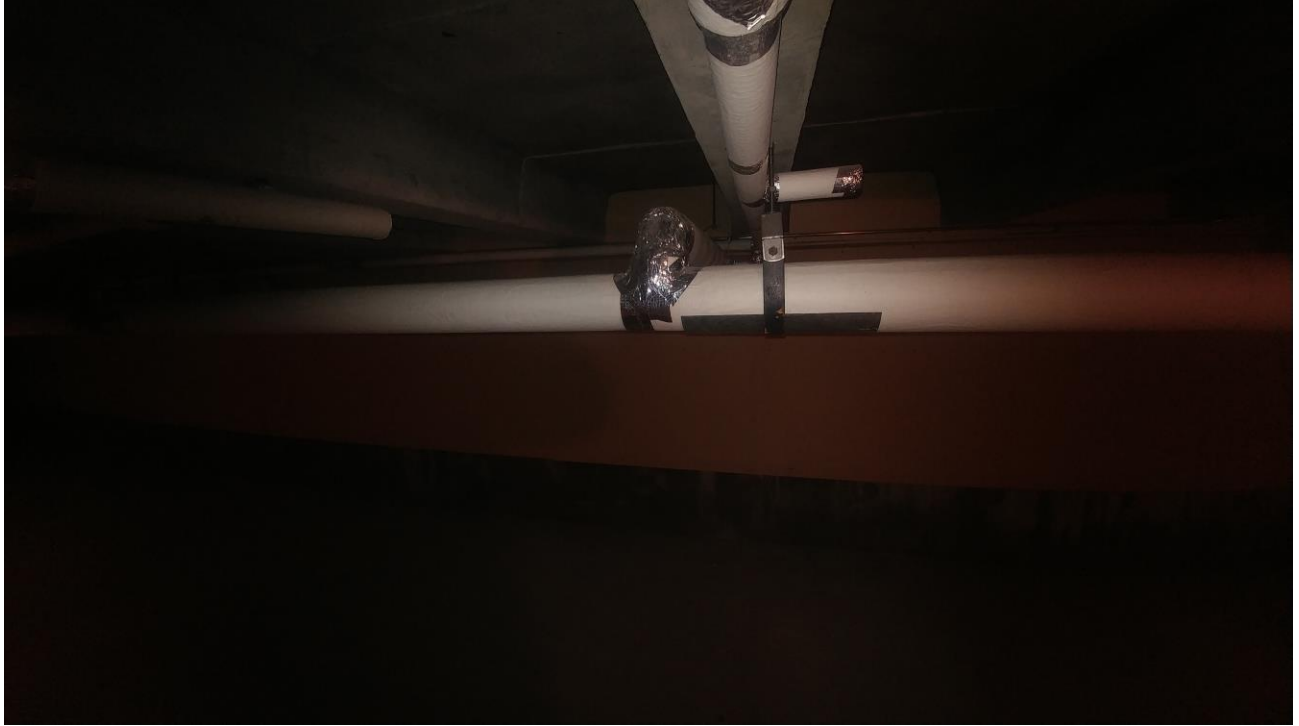
**PHOTO 1 – Fiberglass Lineal Pipe Insulation w Fiberglass Elbow in Foil Wrap**

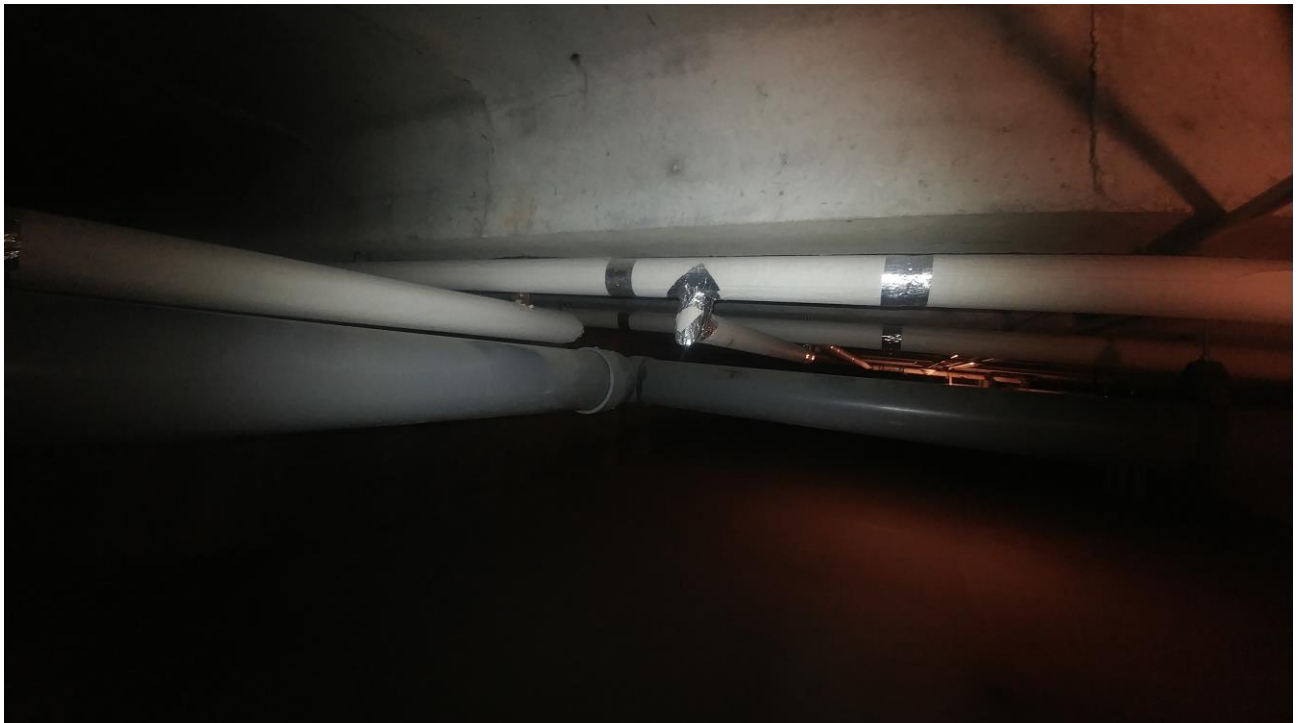
**PHOTO 2 – Fiberglass Lineal Pipe Insulation & PVC Drainpipe**
