**PUBLIC AGENDA
EXECUTIVE COMMITTEE**

Nutana Slope Failure – Options Matrix

This report is intended to present the results of the in-depth geotechnical investigation of the Nutana Slope Failure, including causes, potential remediation options and relative remediation costs. The report also provides an update on the current situation with the riverbank slope failure occurring in Nutana between 11th Street East & Saskatchewan Crescent East.

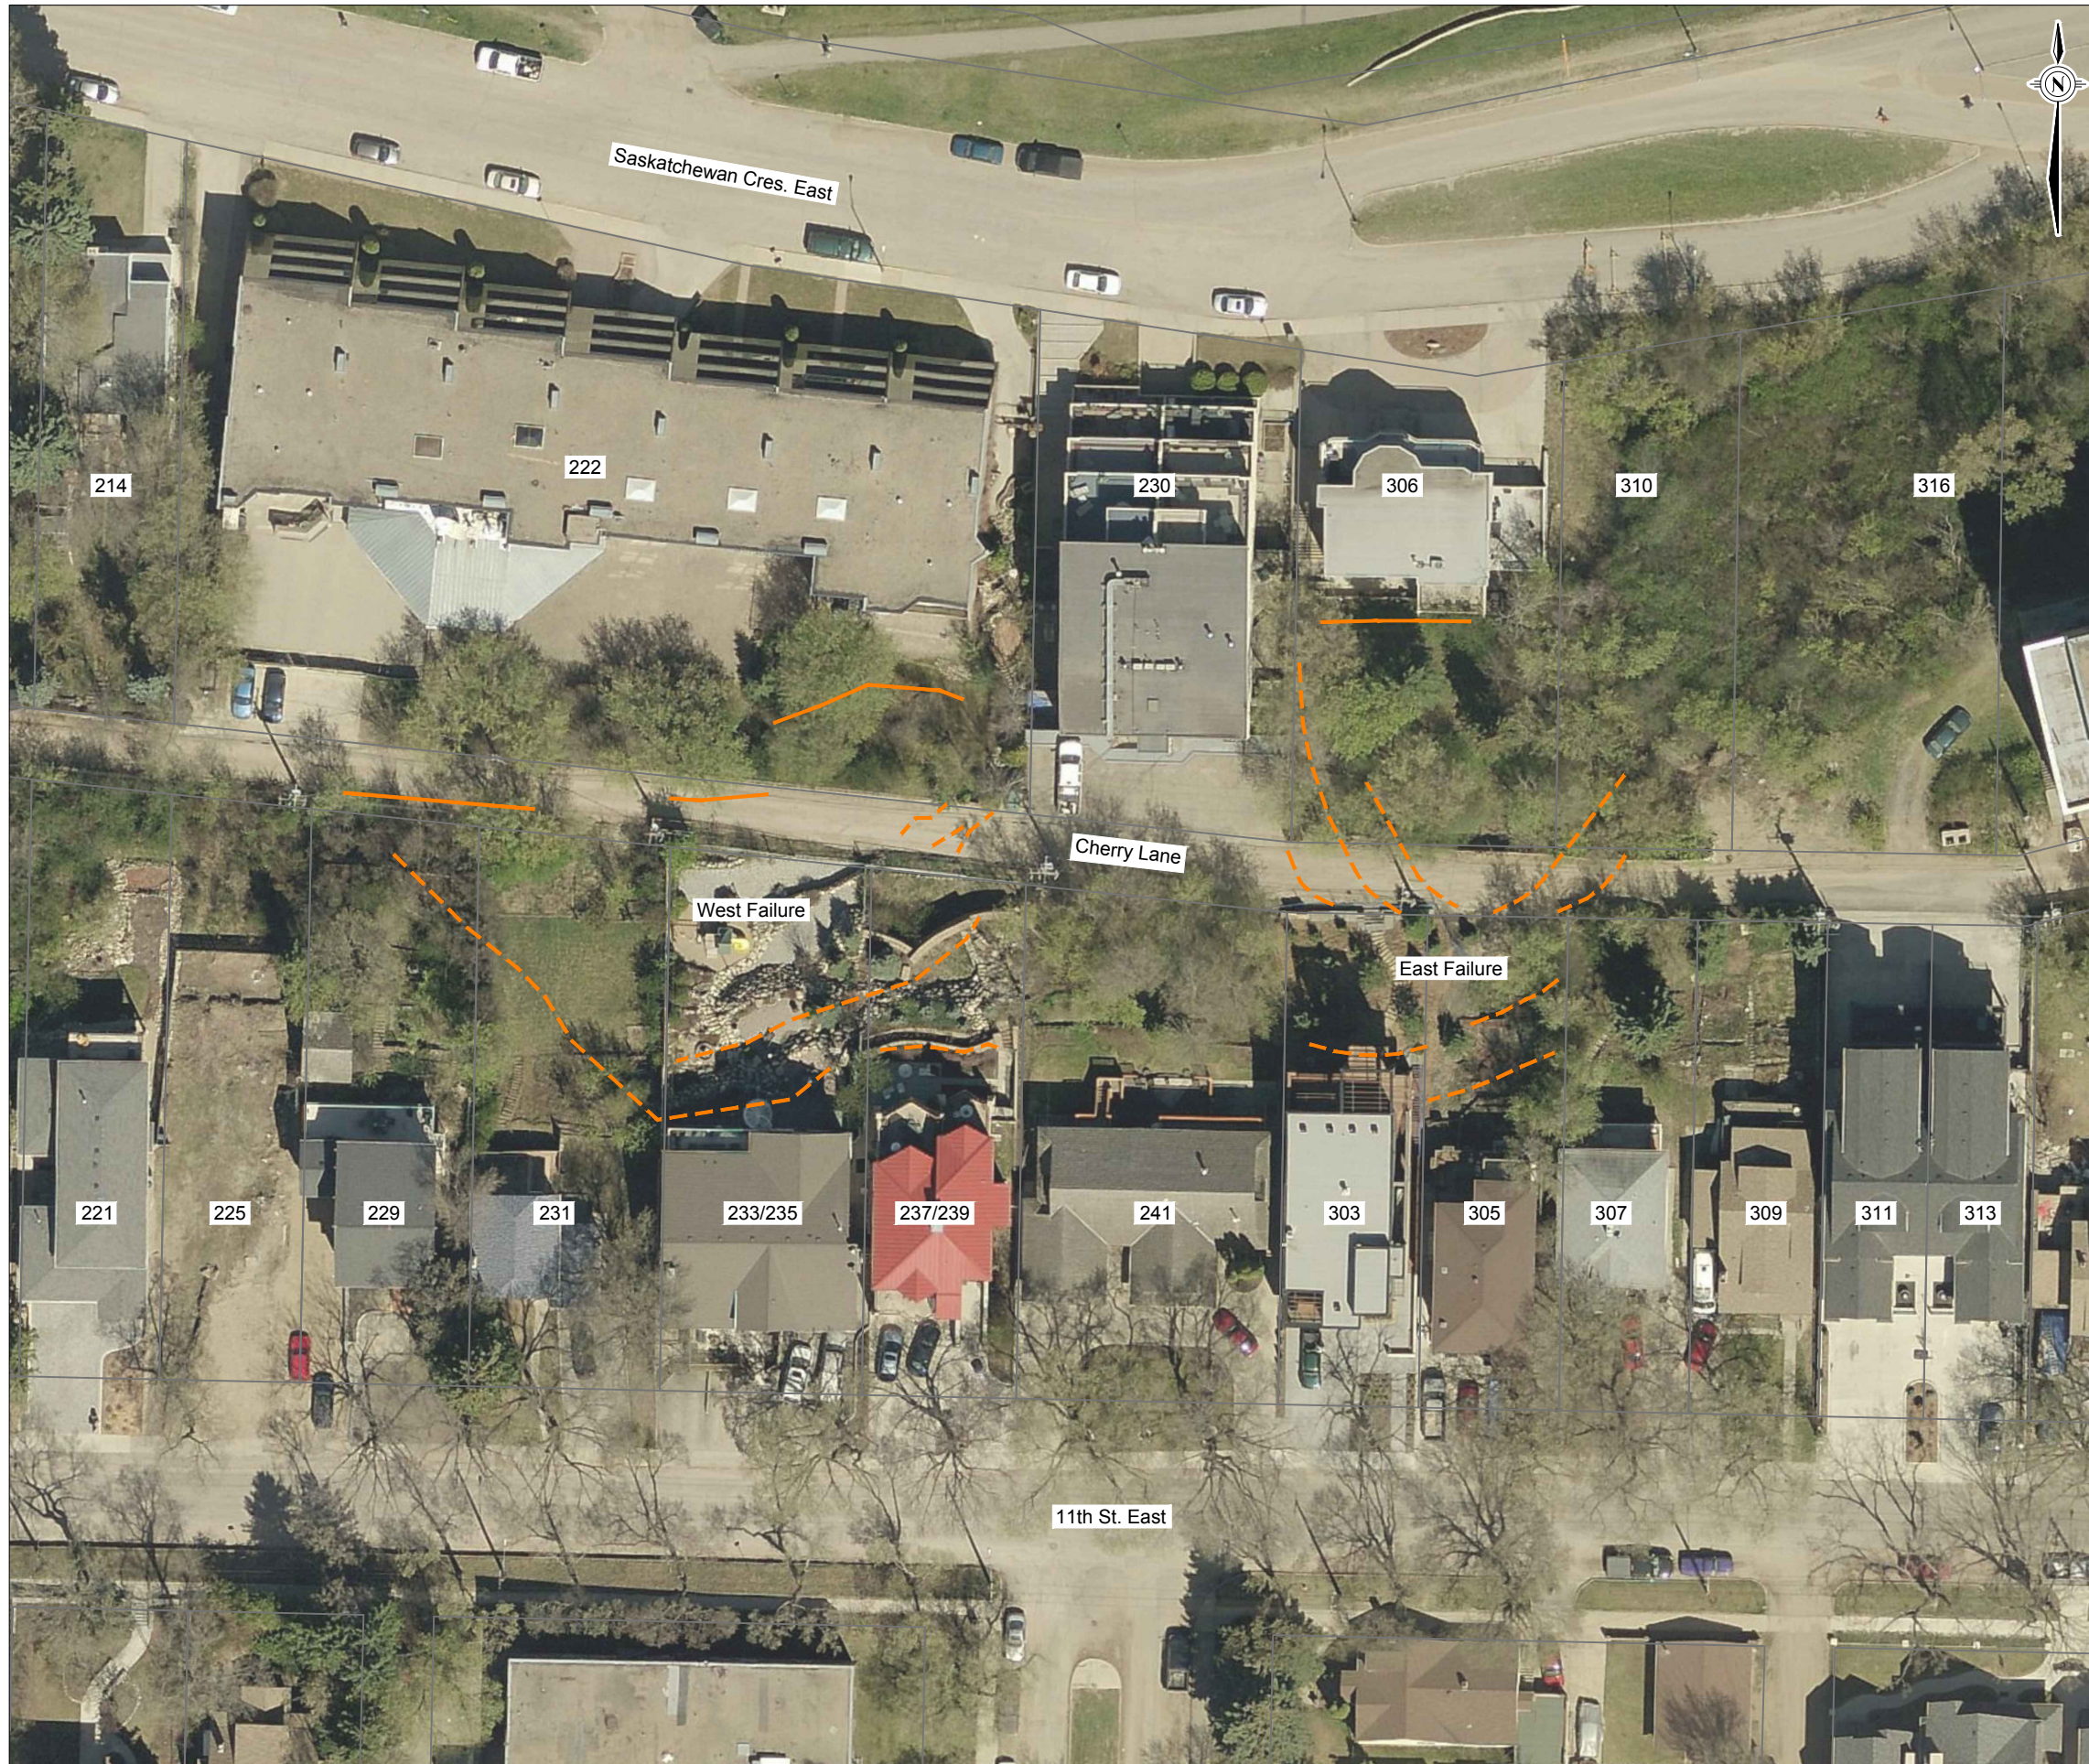
Two slope failures recently occurred in this area, affecting approximately a 120 metre (m) long section of Cherry Lane and the backyards of several houses and buildings. The first failure (referred to as the West Failure) occurred on June 20, 2012. The second failure (referred to as the East Failure) occurred sometime between June 20 and June 24, 2013. Site location, locations of the slope failures and civic addresses of residential properties are shown in Figure 1.

The West Failure impacted a slope area approximately 70 m section of Cherry Lane and 40 m from the head scarp to the toe; it was most pronounced in the backyards of 229, 231, 233/235 and 237/239 11th Street East, through Cherry lane, and into the backyard of 222 Saskatchewan Crescent East. The West Failure resulted in the disruption and interference with the Electrical Utility Services, requiring repairs and adjustment, and disruption of the geometry and stability of the public right-of-way (ROW) land, requiring closure of Cherry Lane. The East Failure affected a slope area approximately 30 m section of Cherry Lane and 45 m from the head scarp to the toe; it was most pronounced in the backyard of 303, 305 and 307 11th Street East, through Cherry Lane, and into the backyard of 306 Saskatchewan Crescent East. The West Failure and East Failure were separated by two residential houses/apartment building, 241 11th Street East and 230 Saskatchewan Crescent East. No obvious cracking or slope movement was observed in this slope section between the two failure areas.

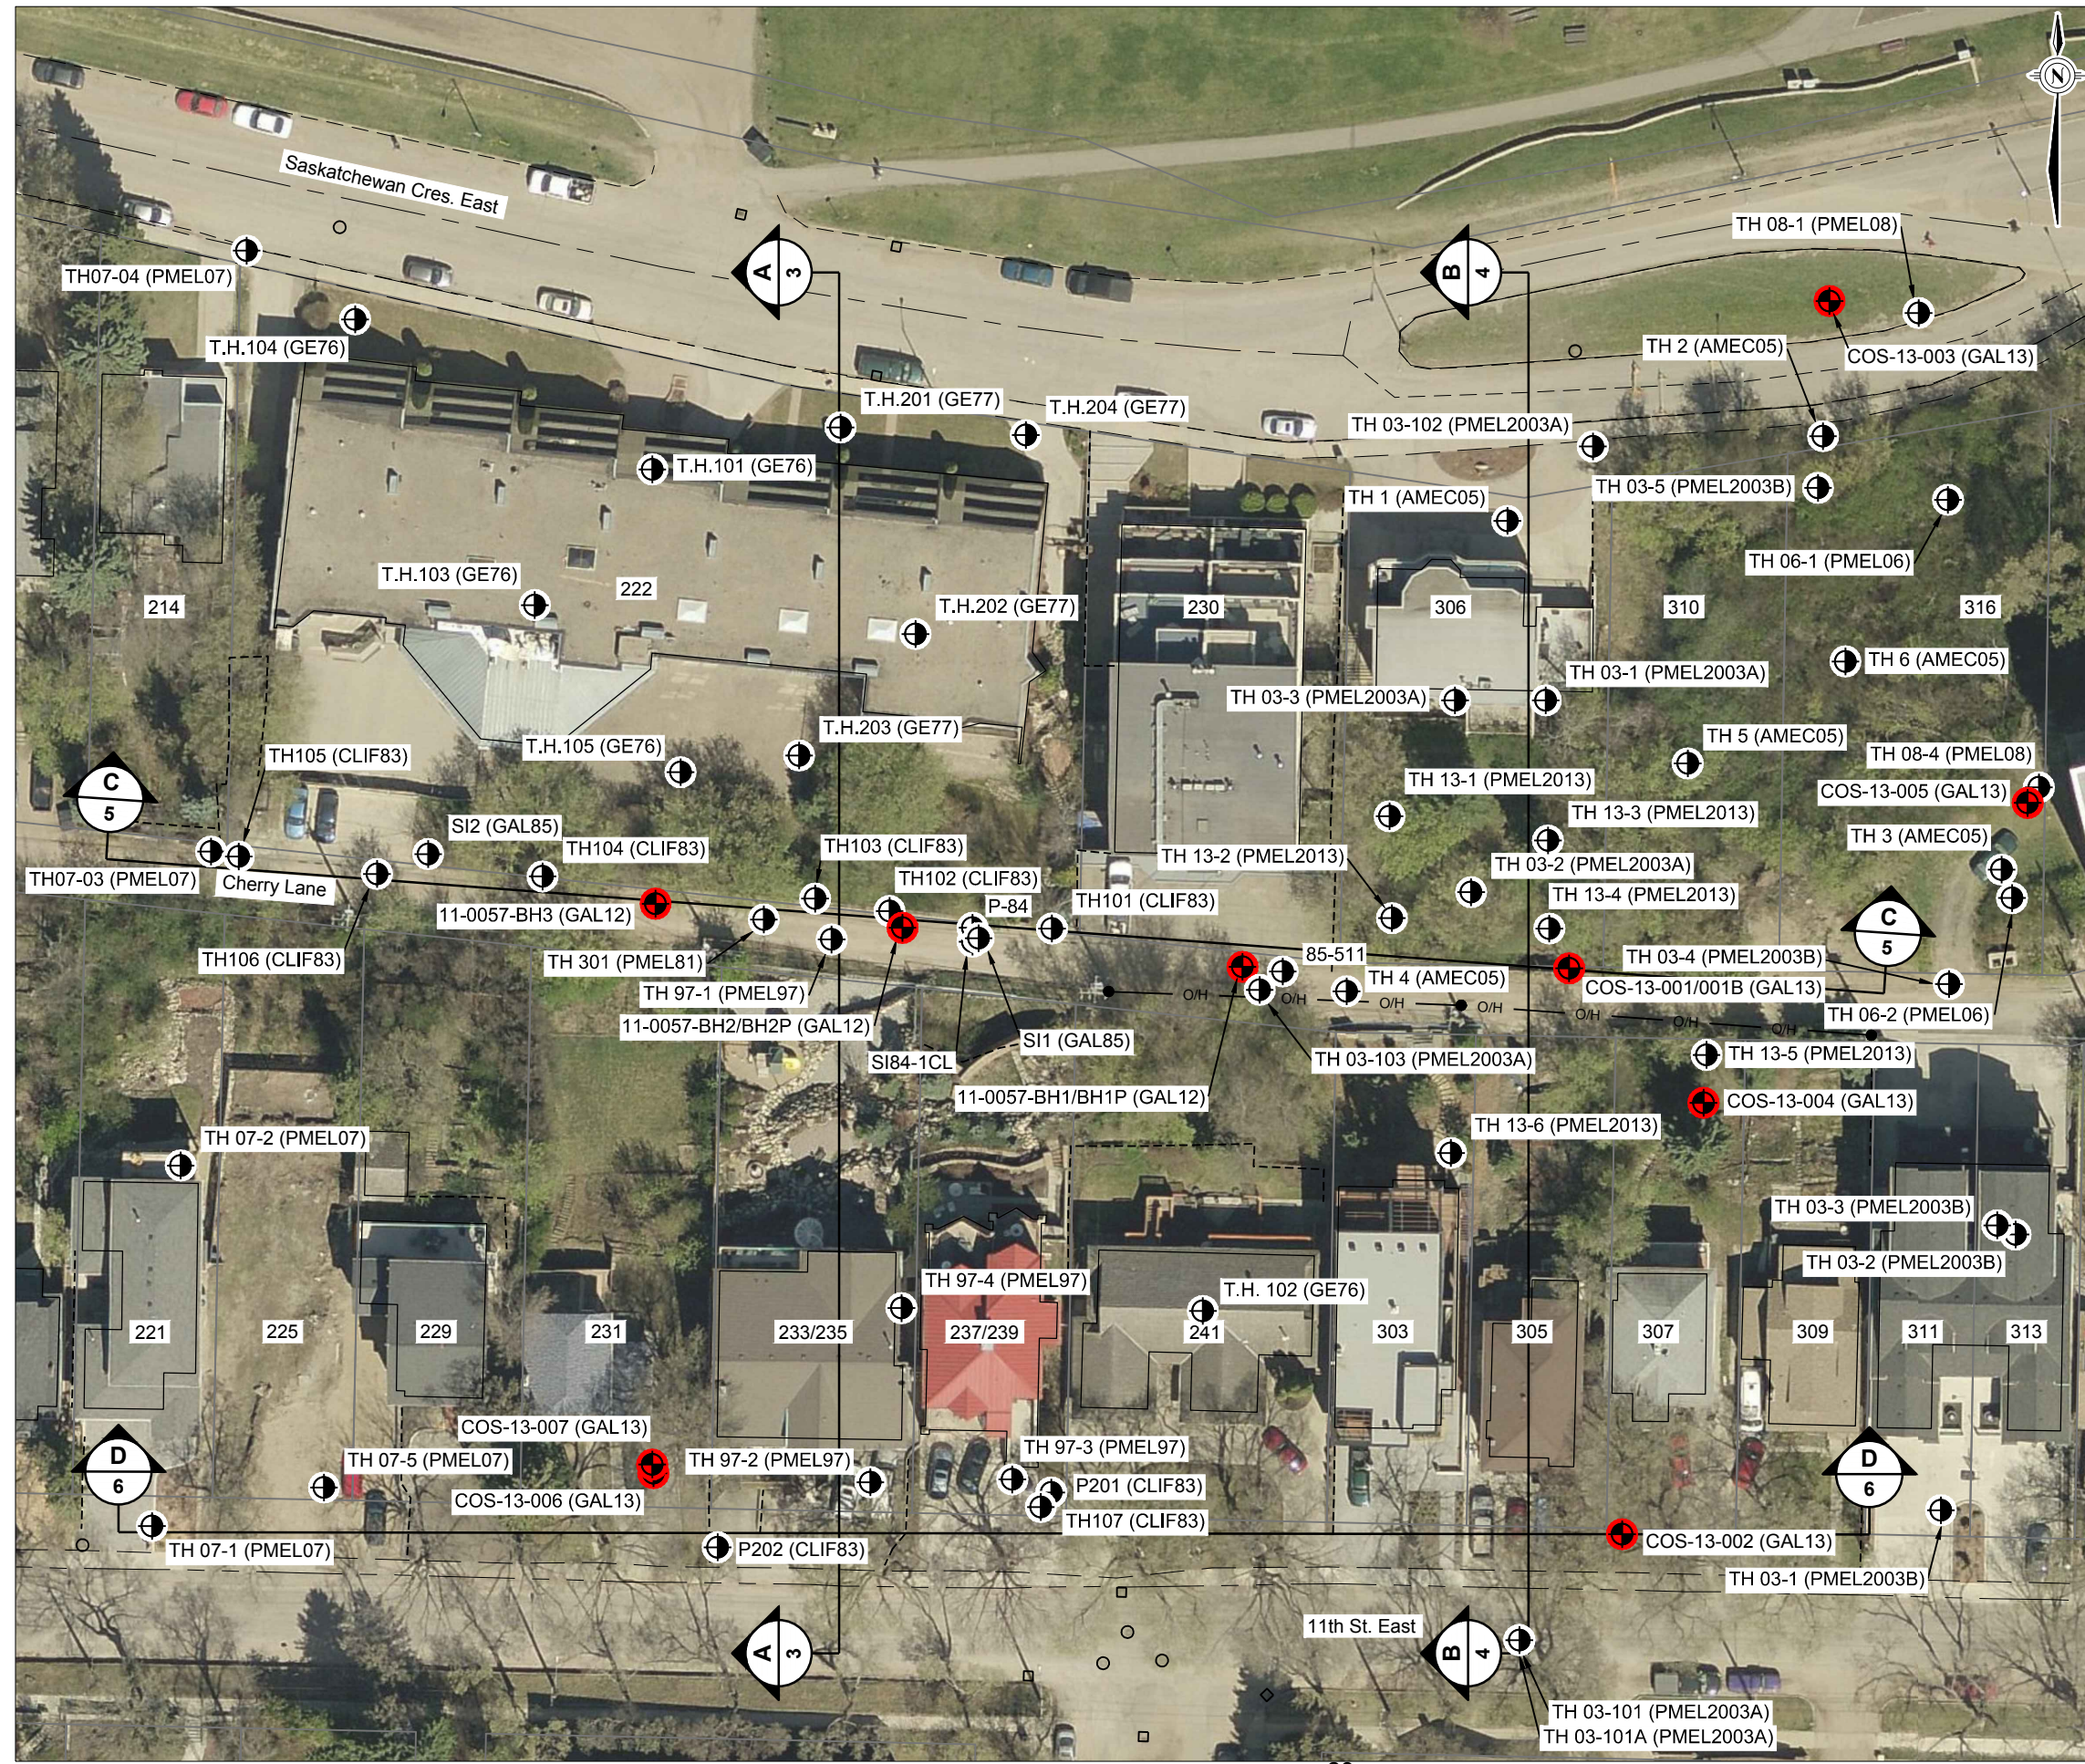
CERRY LANE SLOPE INSTABILITY	
BOREHOLE AND CROSS SECTION LOCATION PLAN			
PROJECT	11-1362-0057	FILE No.	
DESIGN	LM 08/05/14	SCALE	AS SHOWN REV. 0
CADD	JDS 08/05/14		
CHECK	HV 08/05/14		
REVIEW	PGB 08/05/14		
		FIGURE: 2

Two inclinometers, designated as SI84-1CL and 85-511 with locations presented on Figure 2 were installed and monitored in Cherry Lane. However Inclinometer SI84-1CL was blocked in 2004 and inclinometer 85-511 was bent in 2006. Inclinometer SI-84 ICL recorded approximately 20 millimetres (mm) of total movement for the period from November 1992 to October 2001. Inclinometer 85-511 recorded approximately 32 mm of total movement for the period from August 1985 to October 2005.

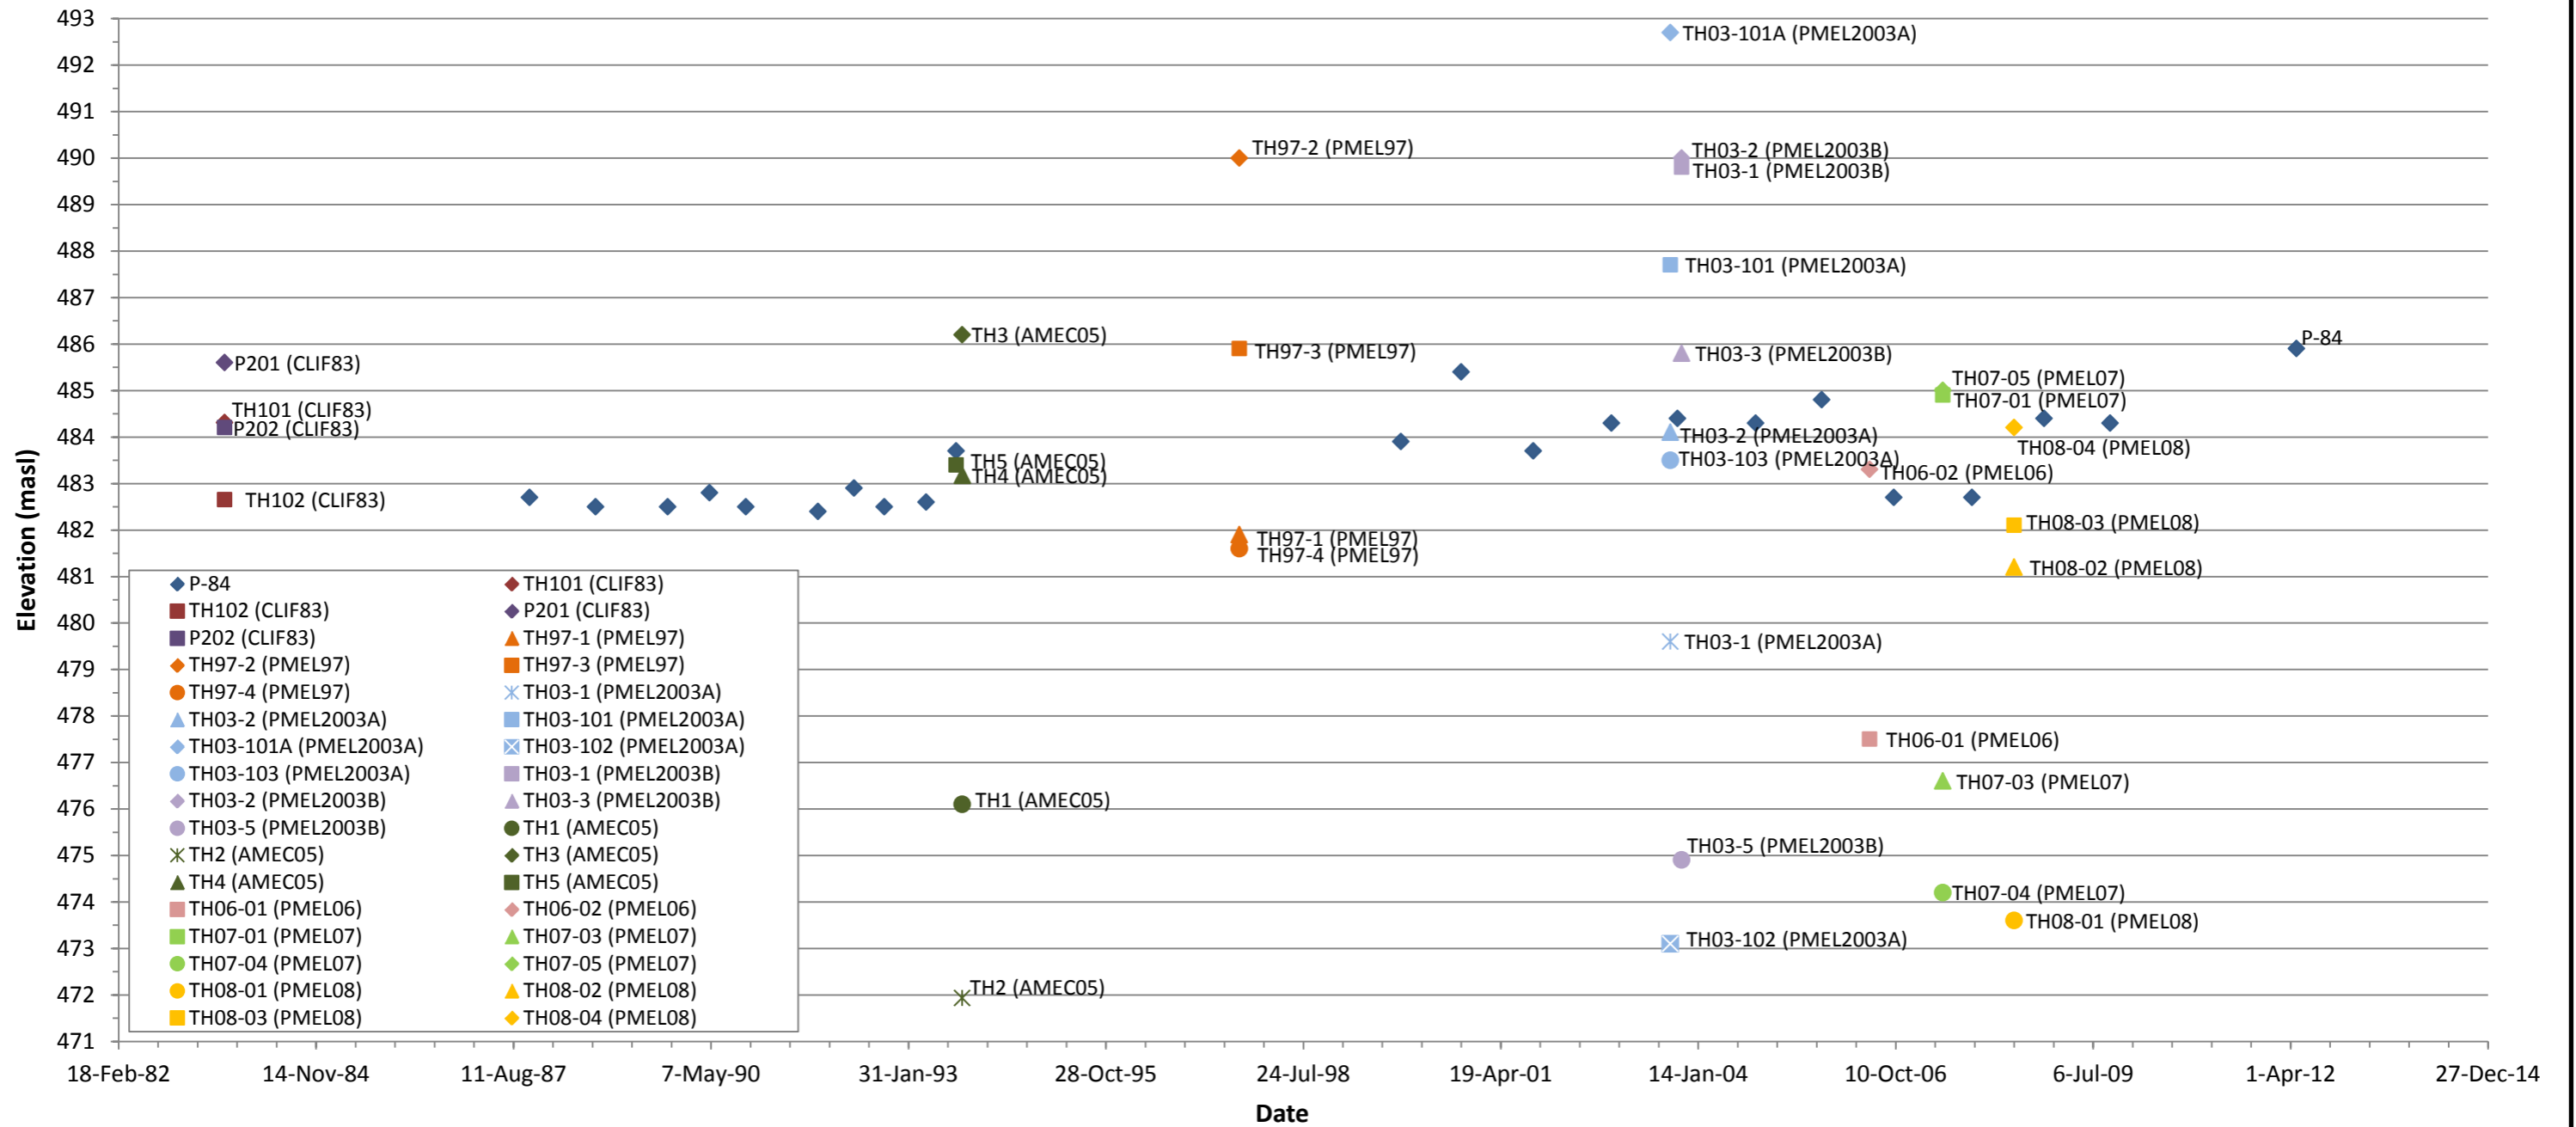
CHERRY LANE SLOPE INSTABILITY	
HISTORICAL GROUNDWATER LEVELS			
	PROJECT 11-1362-0057 DESIGN LNM 08/05/14 CADD CHECK HQV 08/05/14 REVIEW PGB 08/05/14	FILE No. SCALE N/A REV.	FIGURE: 16

Historical groundwater levels (i.e., total head) in the area of Cherry Lane were compiled from data provided in the geotechnical reports reviewed and the East River Bank Monitoring Program reports provided by AMEC (2005b, 2009, 2013), PMEL (1994) and Ireland (2000) and are summarized in Figure 16. The groundwater table slopes downwards across the site from 11th Street to the river. Adjacent to 11th Street, the water table measured in September 1997 in TH07-2 was at about elevation 489.2, approximately 7 m below the ground surface. It should be noted that all groundwater elevations taken from the PMEL (1997) report have been converted from a local elevation presented in the report to be consistent with the surveyed elevations of the slope. It was noted that seepage was encountered during the August 5, 1997 investigation from sand layer at 490.3 masl in TH97-2, located in the front yard of 233/235 11th Street East.

With the exception of the data from piezometer P-84 (Figure 16), which was monitored on an annual basis from 1987 to 2012, there is insufficient data to interpret historical groundwater levels in this area. The highest groundwater elevation measured in P-84 was at 485.9 masl, or approximately 0.3 m below ground surface. It was recorded at this location in May 2012 prior to the occurrence of the West Failure. It should be noted that groundwater levels for this piezometer were generally monitored in fall or winter (October to December), when there is little recharge on ground surface and groundwater levels are expected to be at the lowest. High water table condition can be expected following spring thaw, or after heavy, prolonged precipitation during the summer.

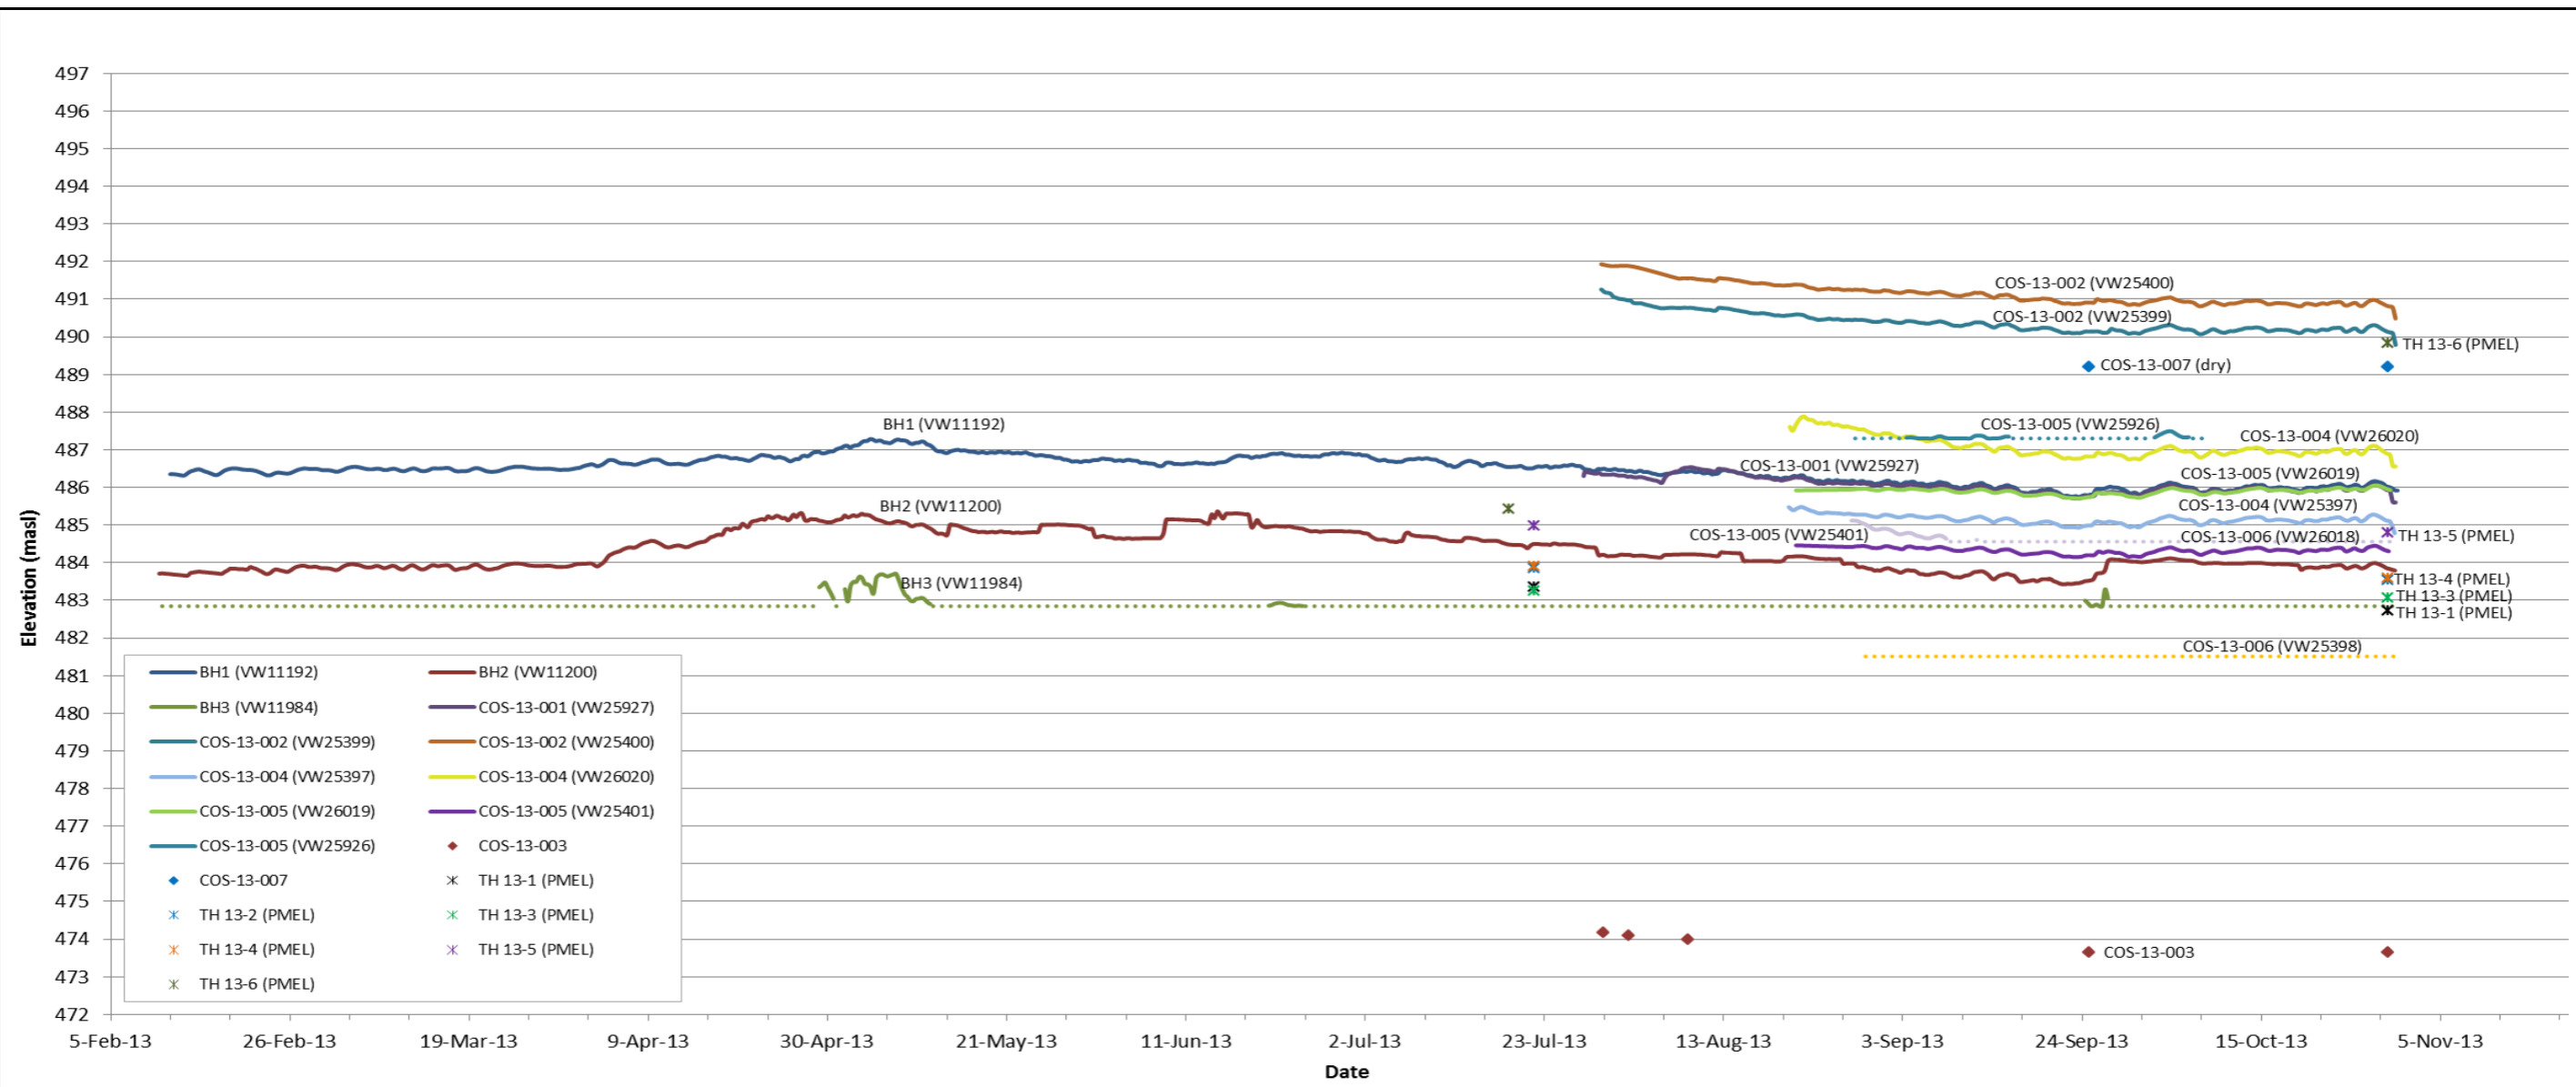
CHERRY LANE SLOPE INSTABILITY	
MONITORED PIEZOMETRIC LEVELS (2012-2013)			
	PROJECT	11-1362-0057	FILE No.
	DESIGN	LNK 08/05/14	SCALE N/A
	CADD		REV.
	CHECK	PGB 08/05/14	FIGURE: 17
REVIEW	HQV 08/05/14

- High groundwater levels recorded at borehole 11-1362-0057 BH2 were 485.3 masl (about 0.6 mbgs) and 485.4 masl (about 0.5 mbgs), recorded on April 27 and June 14, 2013, respectively.

- The highest groundwater level recorded in borehole 11-1362-0057 BH3 was 483.7 masl (about 0.4 mbgs) on May 8, 2013.
- Groundwater levels recorded at 11-0057 BH1 and BH2 started to decrease early in July 2013.

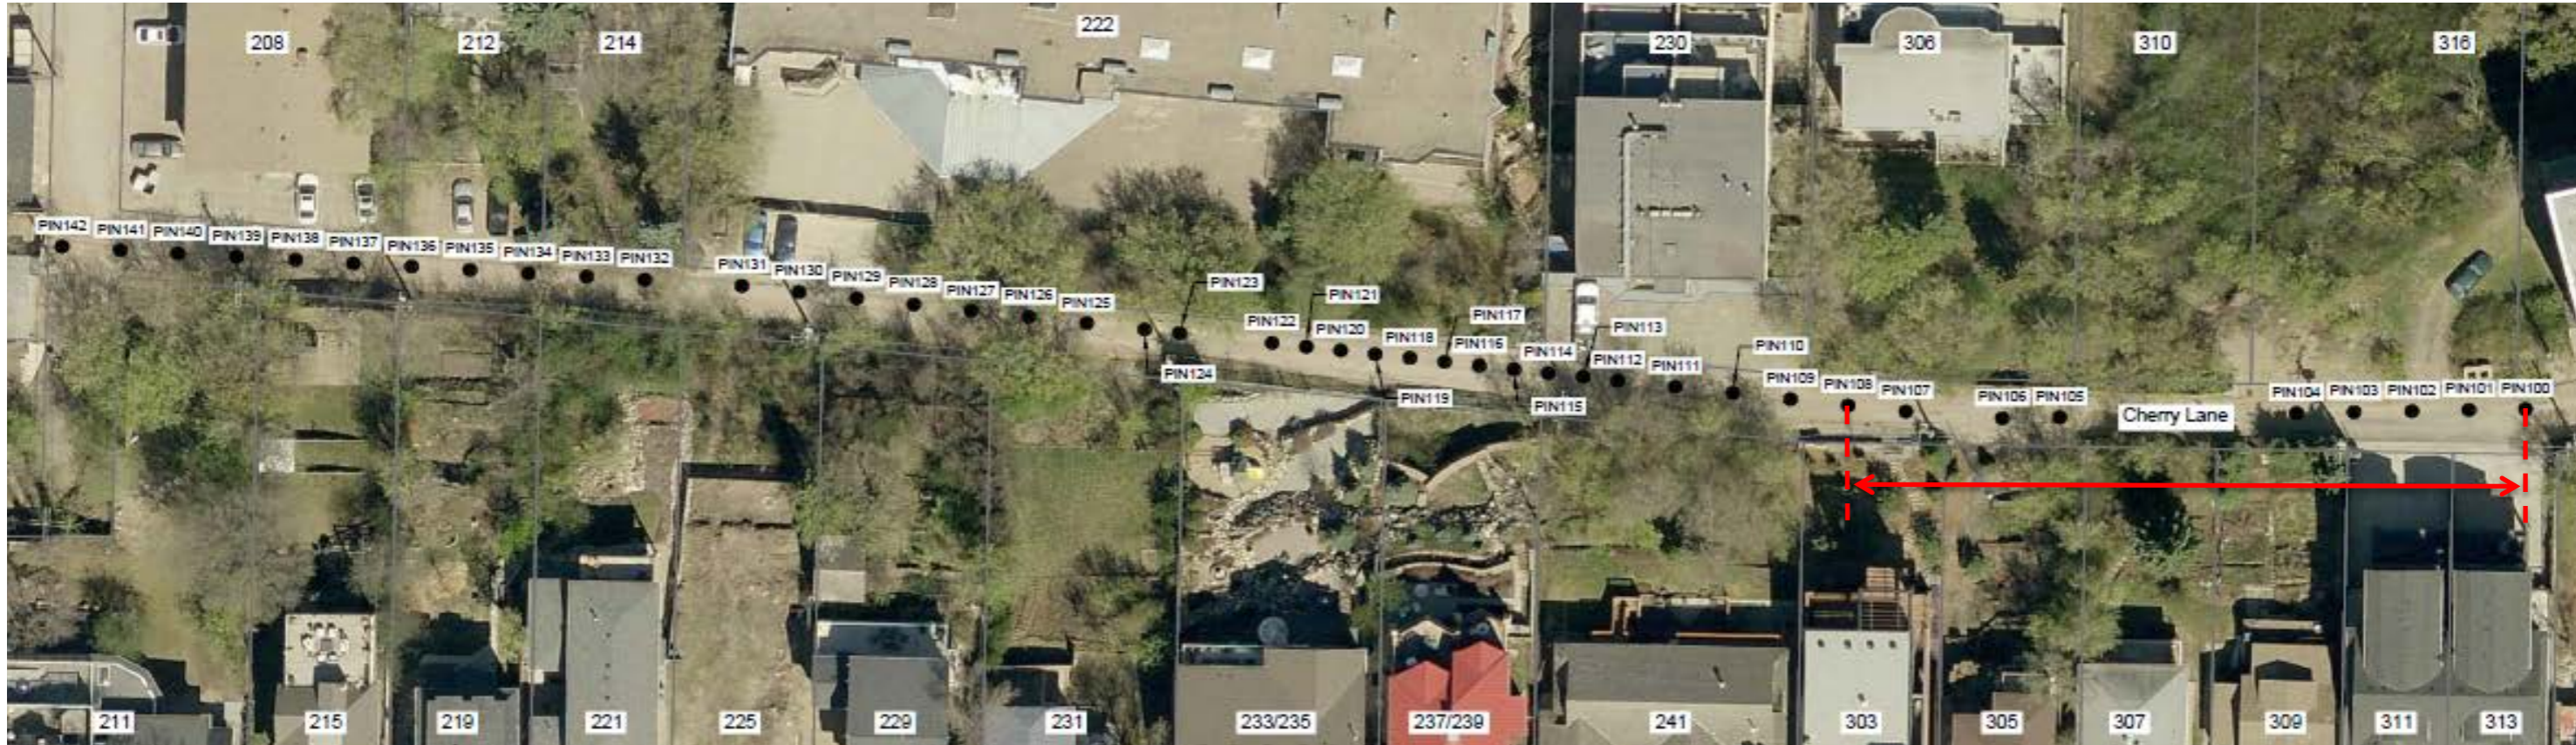
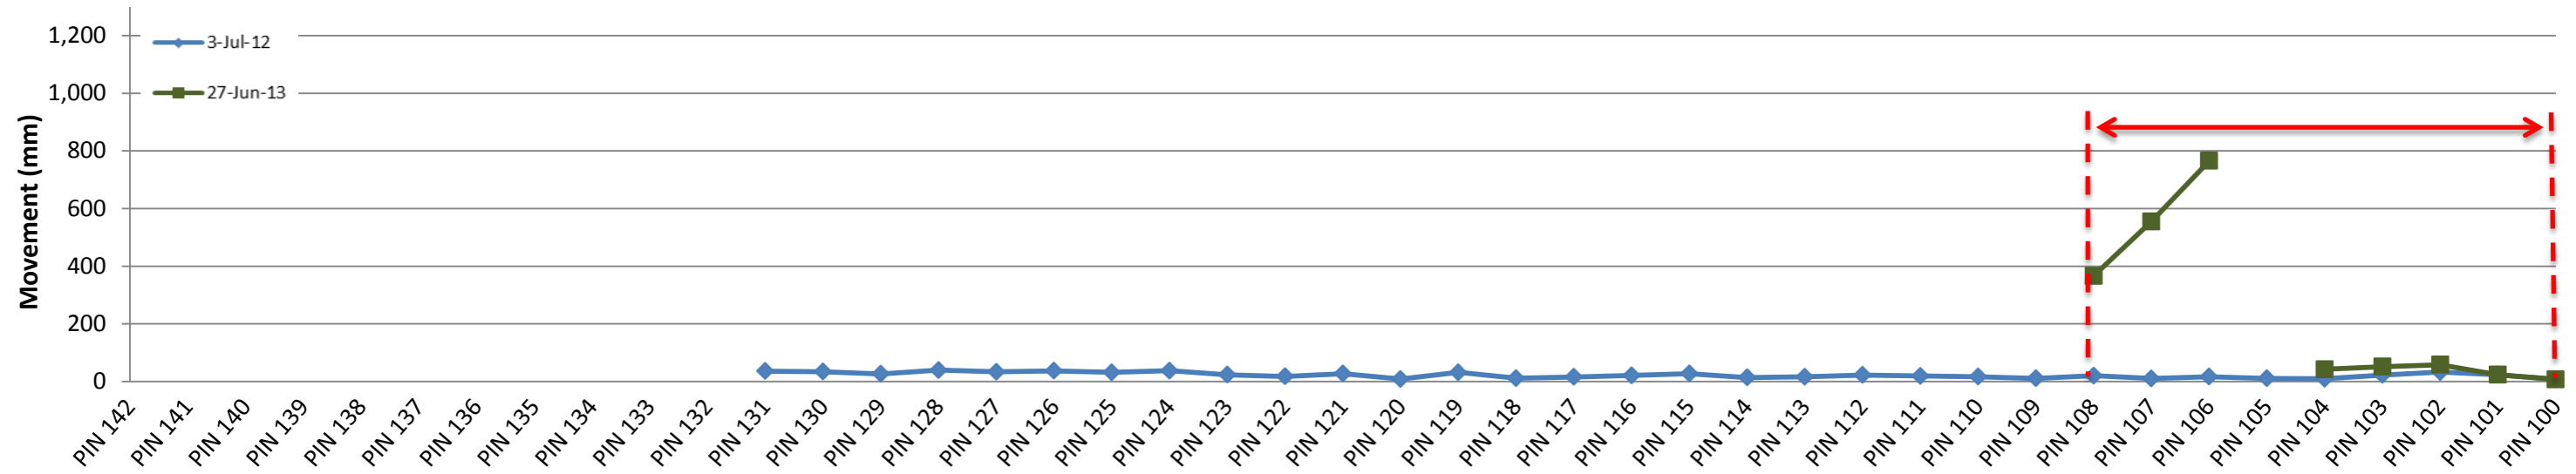
CHERRY LANE SLOPE INSTABILITY	
HORIZONTAL SLOPE MOVEMENT, 100 SERIES PINS (June 28, 2012 to June 27, 2013)			
	PROJECT	11-1362-0057	FILE No.
	DESIGN	LNK 08/05/14	SCALE N/A
	CADD		REV.
	CHECK	HQV 08/05/14	
	REVIEW	PGB 08/05/14	
			FIGURE: 22

Figure 22 presents the results of GPS survey of the 100 series pins between June 28, 2012 and June 27, 2013 for the Cherry Lane at the East Failure. The results show 765 mm of horizontal movement for Pin 106, 555 mm for Pin 107, and 366 mm for Pin 108. Most of these movements occurred in June 2013 because less than 5 mm of movement was measured by line survey for this location up to June 4, 2013 (Figure 20).

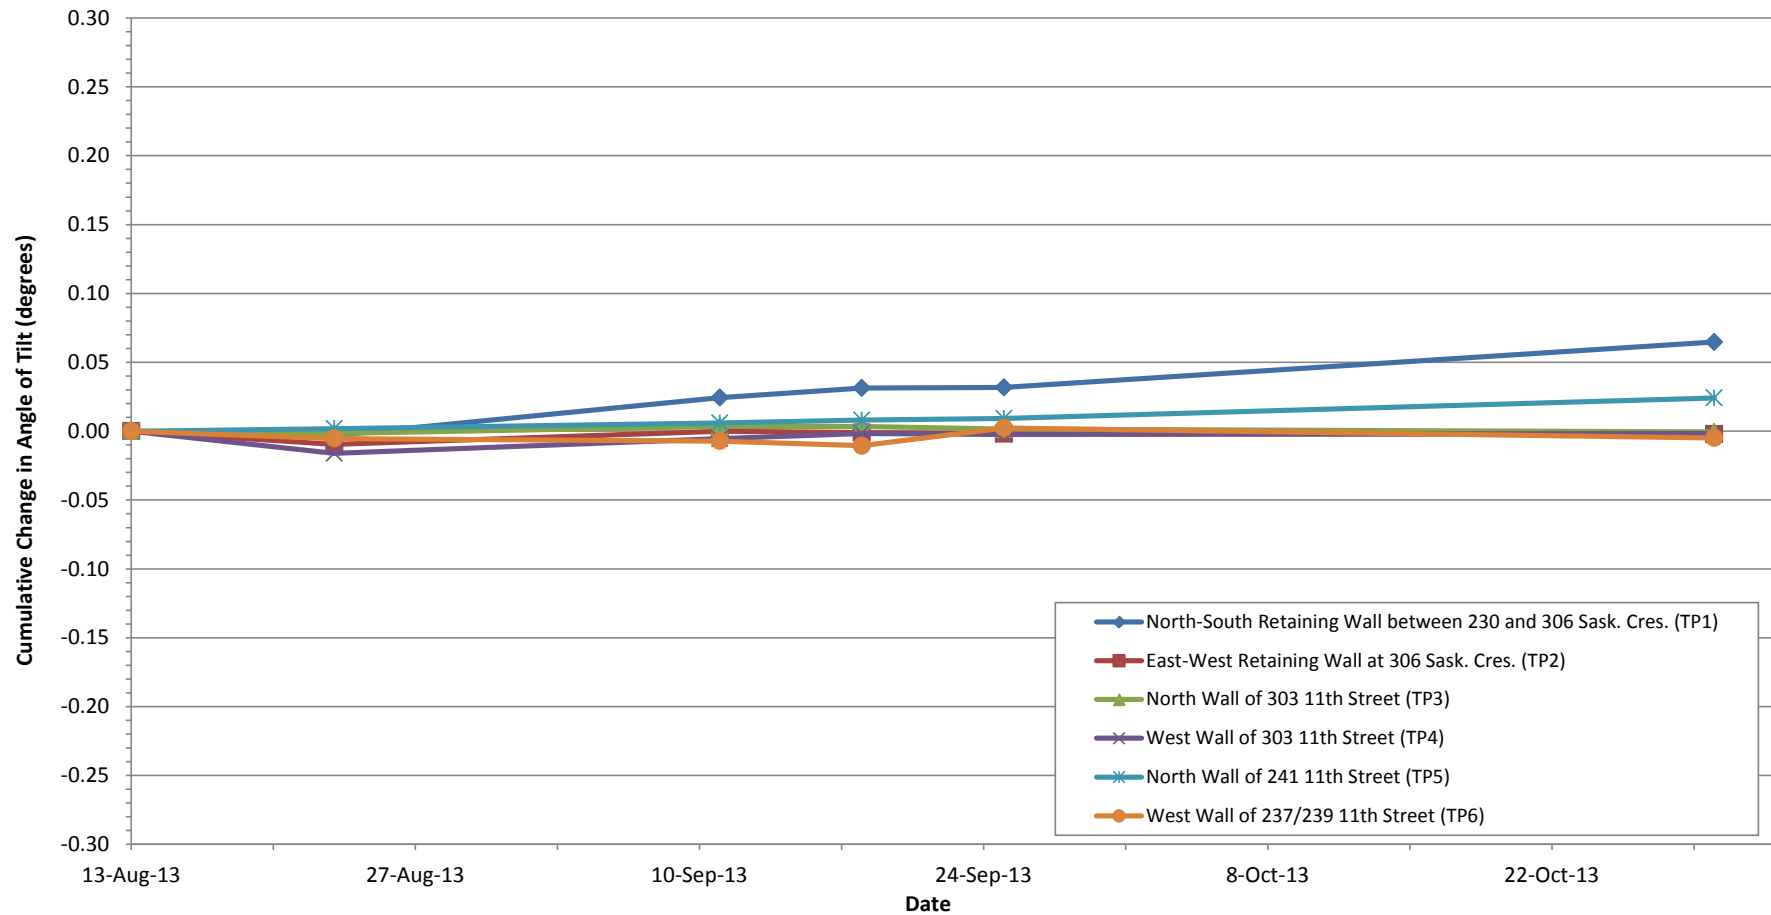
CHERRY LANE SLOPE INSTABILITY			
RESULTS OF TILT MONITORING					
		PROJECT 11-1362-0057 DESIGN LNM 08/05/14 CADD CHECK PGB 08/05/14 REVIEW HQV 08/05/14	FILE No. SCALE N/A REV.01	FIGURE: 25

Tilt plates were monitored approximately every 10 days from August 13 to October 30, 2013. The results of tilt plate measurement are shown in Figure 25. During the monitoring period, a tilt of approximately 0.065 degrees towards the west direction was measured at the tilt plate located on the north-south retaining wall between 230 and 306 Saskatchewan Crescent East. The tilt plate located at 241 – 11th Street has measured a steady increase in tilt angle to 0.024 degrees; however total tilt is near the expected range of measurement accuracy and movement for this structure. Monitoring of the remaining tilt plates have measured variable results which were within the expected range of movement for most structures depending on time of day, weather and other factors.

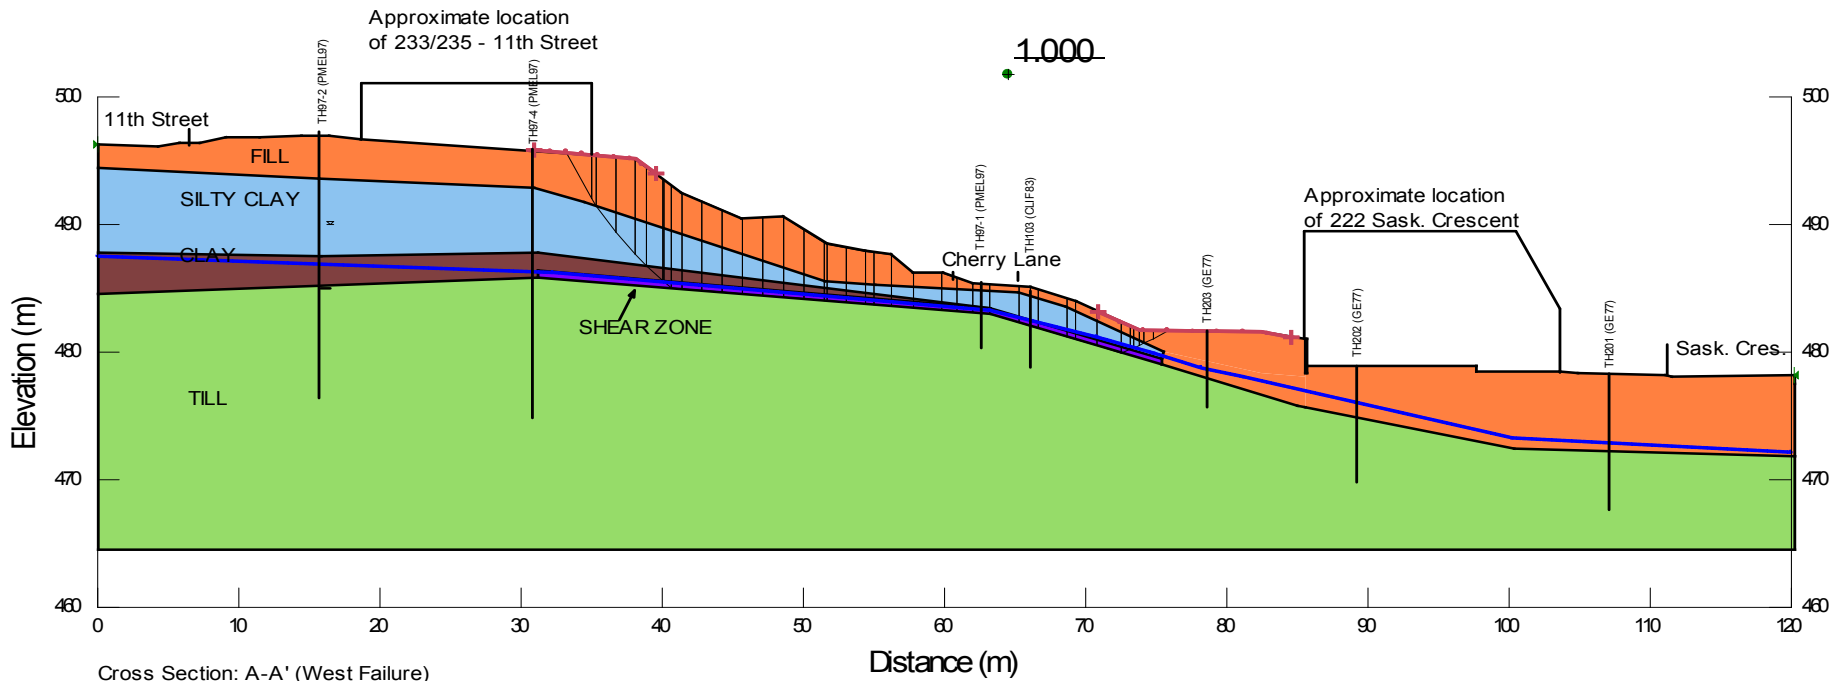
CHERRY LANE SLOPE INSTABILITY	
BACK ANALYSIS - CROSS SECTION A-A' WEST FAILURE			
	PROJECT	11-1362-0057	FILE No.
	DESIGN	LNLM 08/05/14	SCALE N/A REV.
	CADD	HQV 08/05/14	FIGURE: 26
	CHECK	PGB 08/05/14

As the slope has already failed, a stability back-analysis can be conducted. The back-analysis method models the geometry, soil, and groundwater conditions at failure, indicated by a factor of safety (FS) of 1.0. Back-analysis is shown in Figure 26 for the West Failure and Figure 27 for the East Failure.

The slip surface of the sliding soil mass is in surficial stratified deposits at the contact between the clay and the underlying till. Therefore, a composite slope failure along a slip surface at the interface between the clay and till was considered in the analyses.

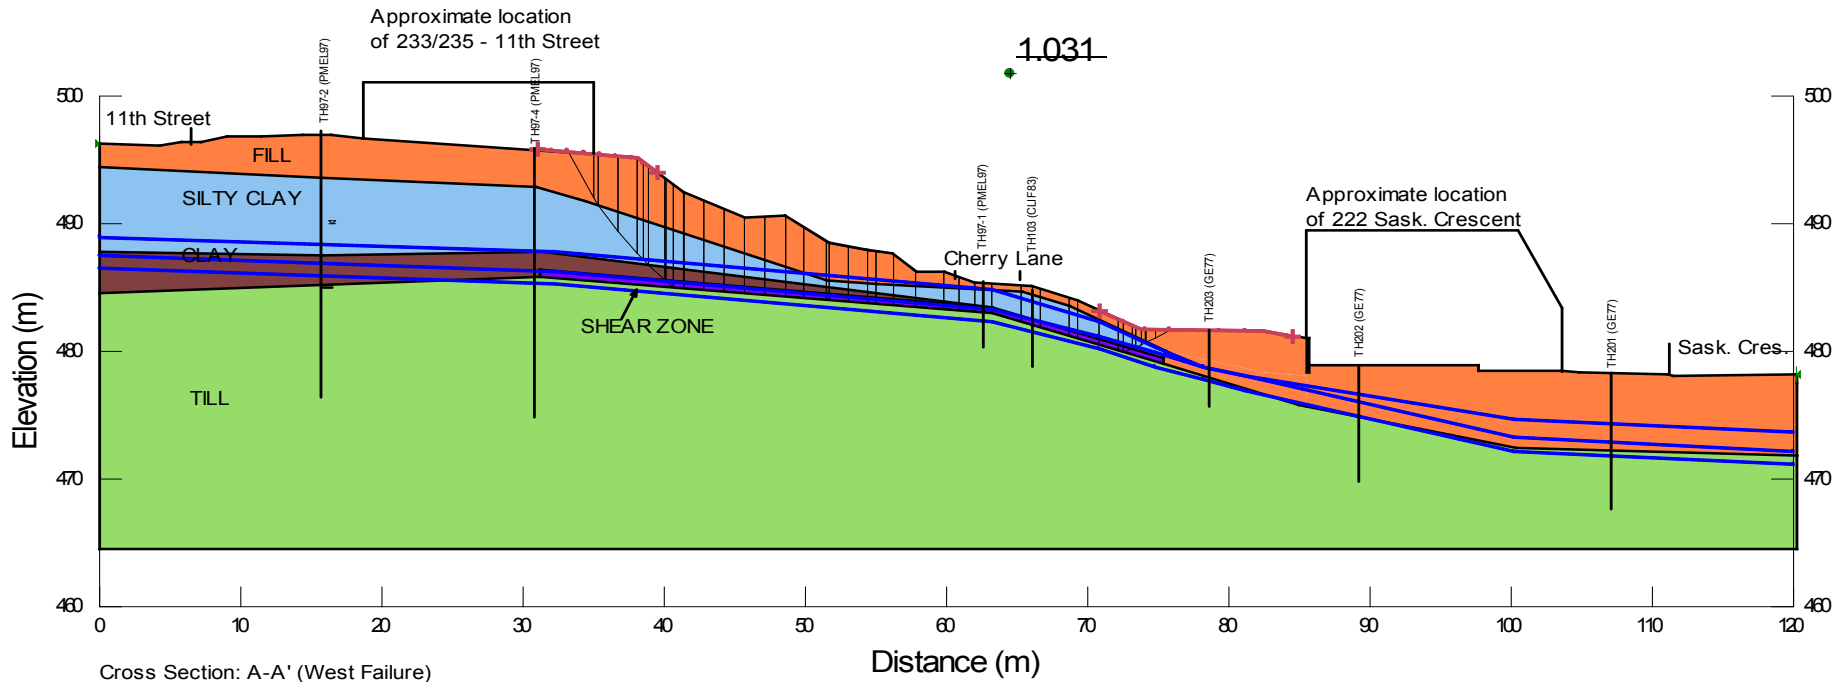
CHERRY LANE SLOPE INSTABILITY	
SLOPE STABILITY ANALYSIS CROSS SECTION A-A' DO NOTHING OPTION WITH LOW WATER TABLE			
	PROJECT	11-1362-0057	FILE No.
	DESIGN	LNLM 08/05/14	SCALE N/A REV.
	CADD		
	CHECK	HQV 08/05/14	
	REVIEW	PGB 08/05/14	FIGURE: 28

Figure 28 and Figure 29 show the stability analyses for the do nothing option, with the piezometric levels approximately 1 m lower than those used on the back-analysis to represent slope instability conditions. The calculated factors of safety are 1.03 and 1.09 for cross-sections A-A' and B-B', respectively, for the case where nothing is done other than lowering the groundwater table.
