**PUBLIC AGENDA
EXECUTIVE COMMITTEE**

Nutana Slope Failure – Options Matrix

This report is intended to present the results of the in-depth geotechnical investigation of the Nutana Slope Failure, including causes, potential remediation options and relative remediation costs. The report also provides an update on the current situation with the riverbank slope failure occurring in Nutana between 11th Street East & Saskatchewan Crescent East.

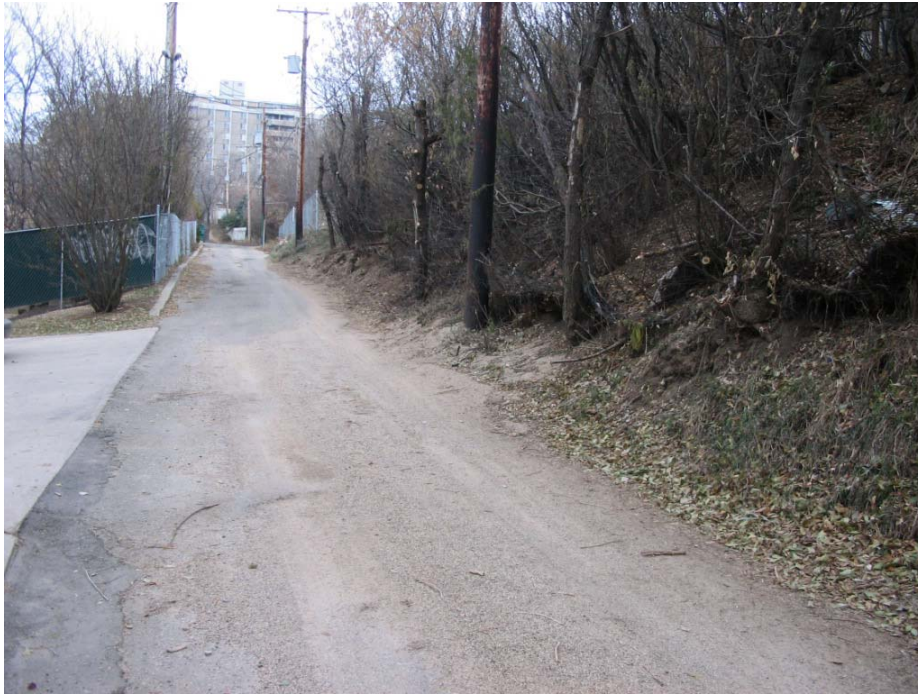
Photo C.1. Looking East at Deflection of Curb and Fence Line along Cherry Lane (Nov 5, 2006)

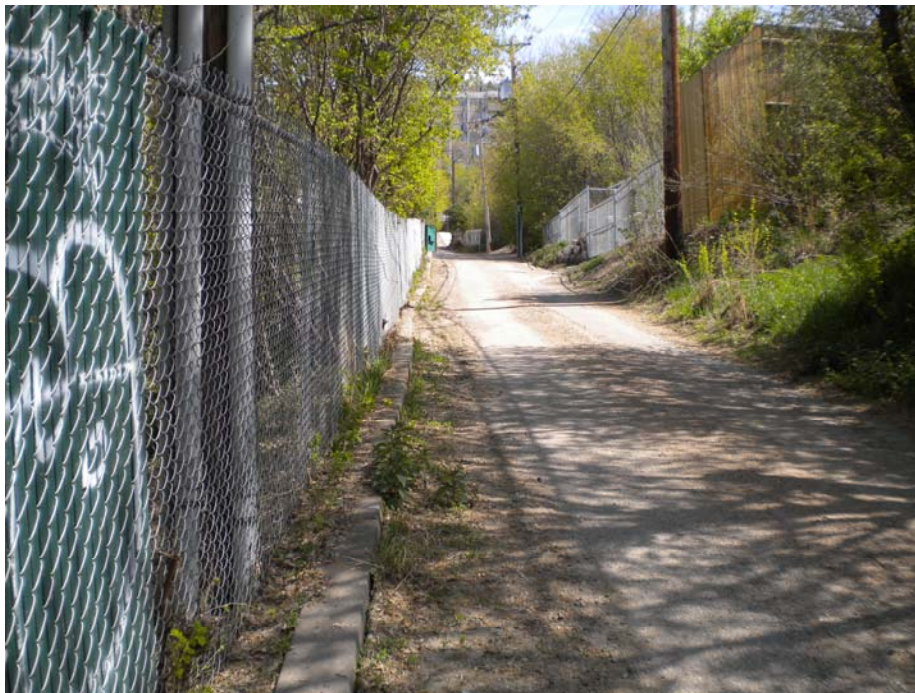
Photo C.2. Looking East at Deflection of Curb and Fence Line along Cherry Lane (May 27, 2010)

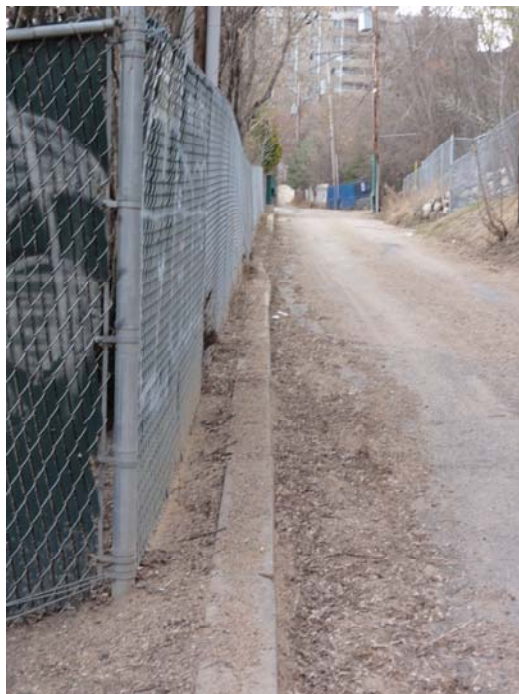
Photo C.3. Looking East at Deflection of Curb and Fence Line along Cherry Lane (April 26, 2012)

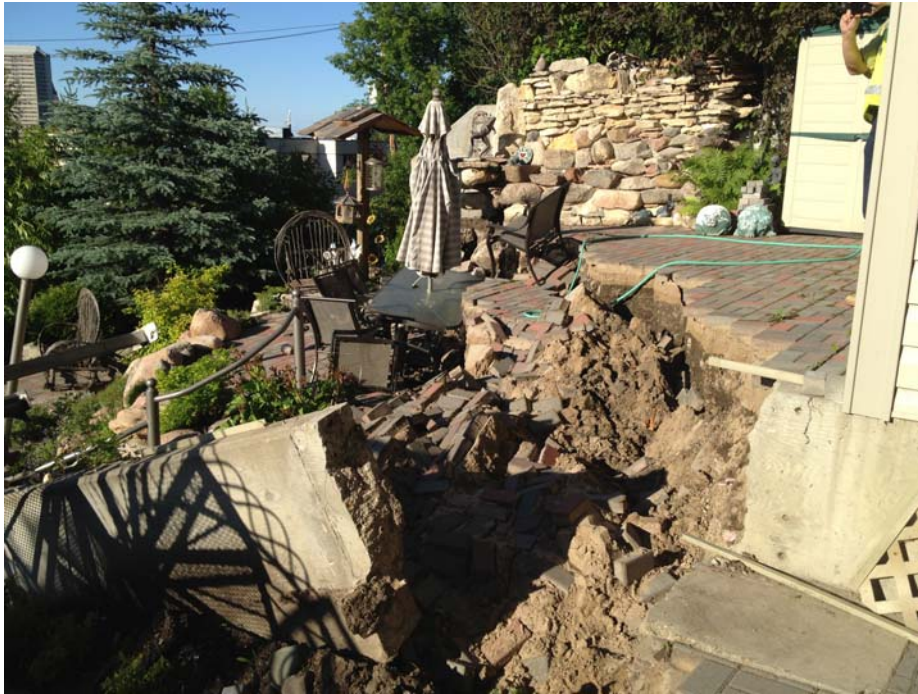
Photo C.5. Headscarp in the Backyard of 233-235 11th St. E. (June 21, 2012)

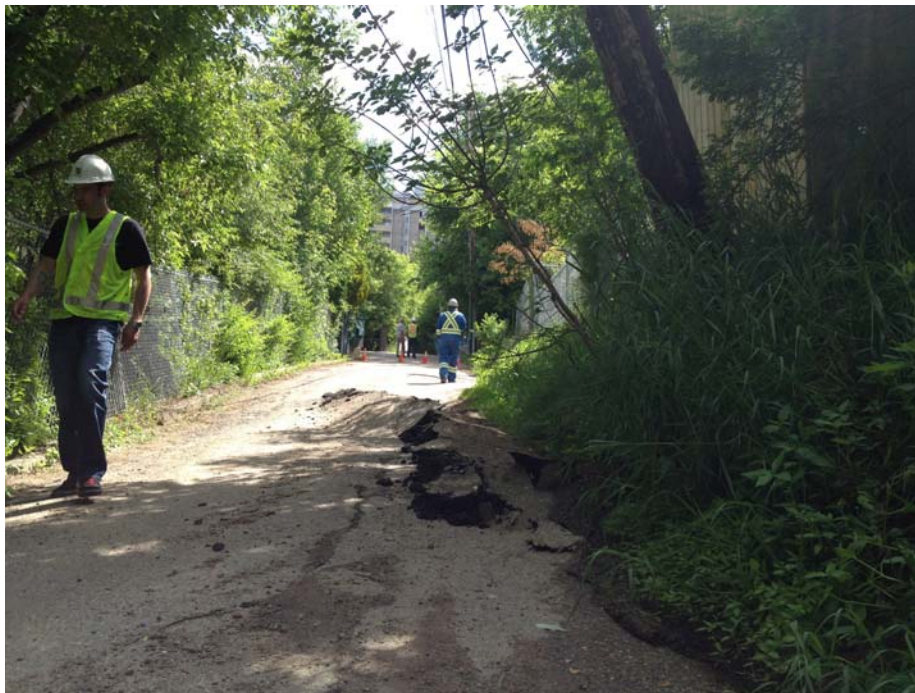
Photo C.6. Bulging Toe of Slide on Cherry Lane (June 21, 2012)

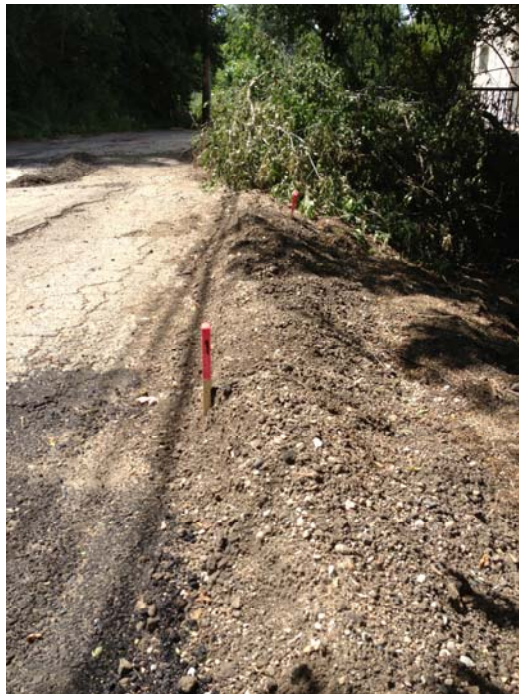
Photo C.23. Looking West at Berm Along North Edge of Cherry Lane, behind 306 Sask. Cres. E. (July 7, 2013)

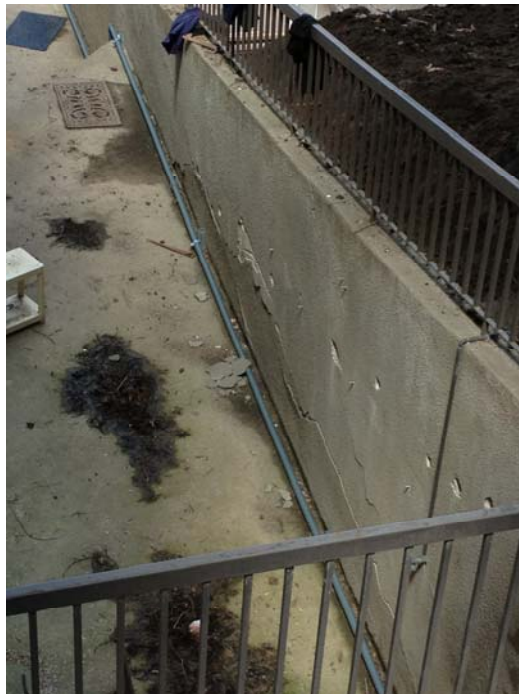
Photo C.25. Looking Northeast at Concrete Retaining Wall between 230 & 306 Sask. Cres. E. (July 7, 2013)

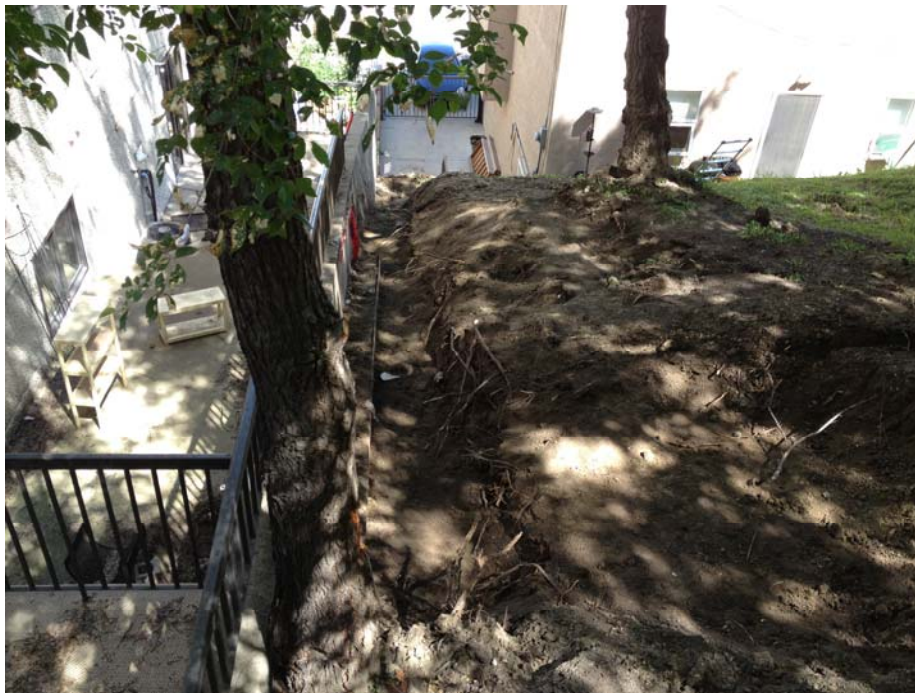
Photo C.28. Looking North at Partially Filled Trench (July 17, 2013)

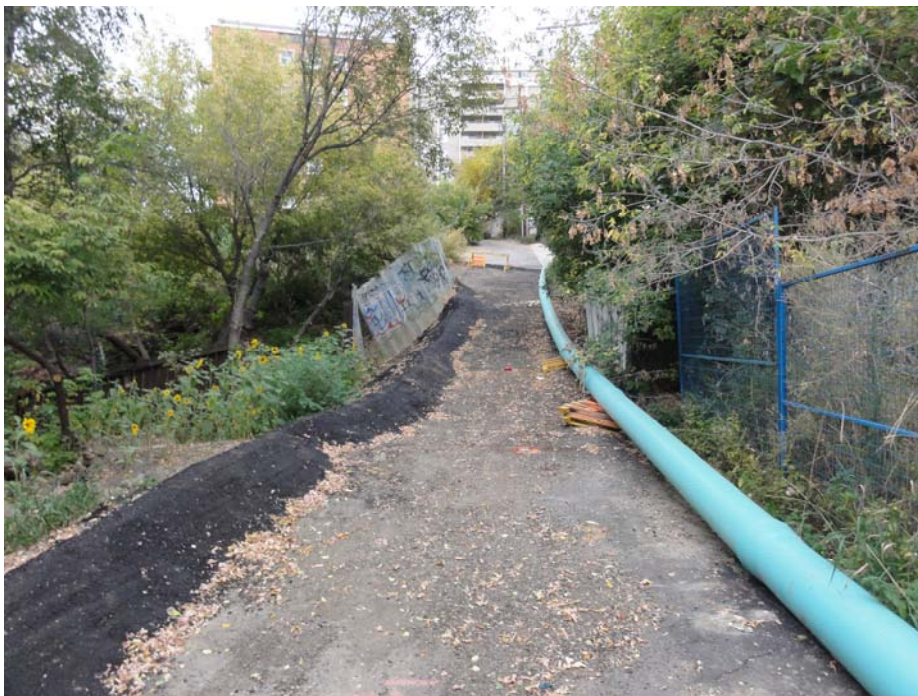
Photo C.29. Looking East at Above Ground Driantage System Installed on Cherry Lane (September 18, 2013)

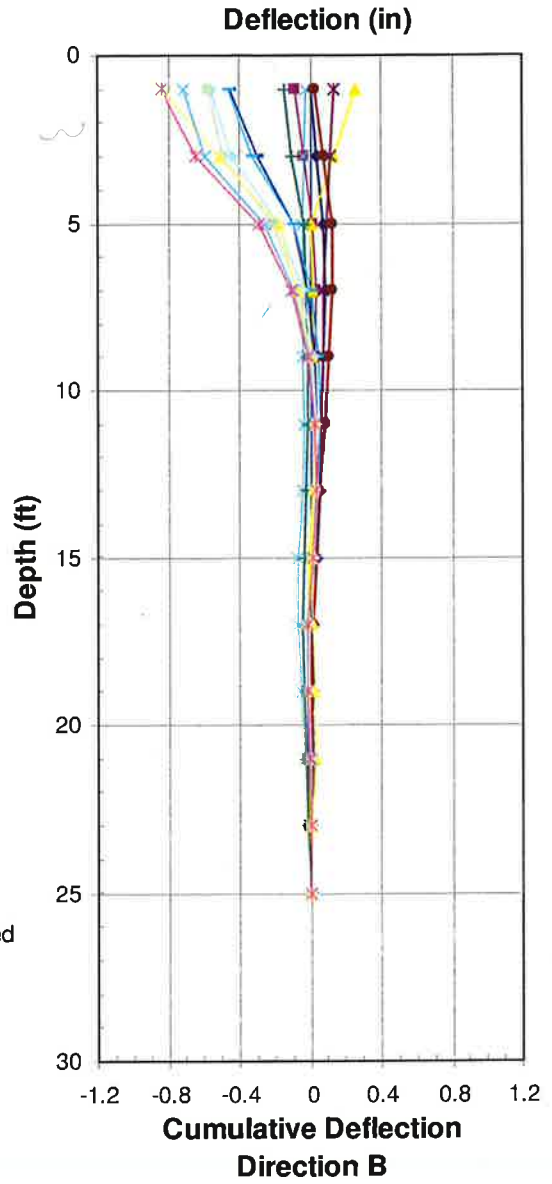
COS #11 - EAST RIVER BANK, Inclinometer 85-511 Cherry Lane (East Casing)

Note: Casing in need of repair since 2005

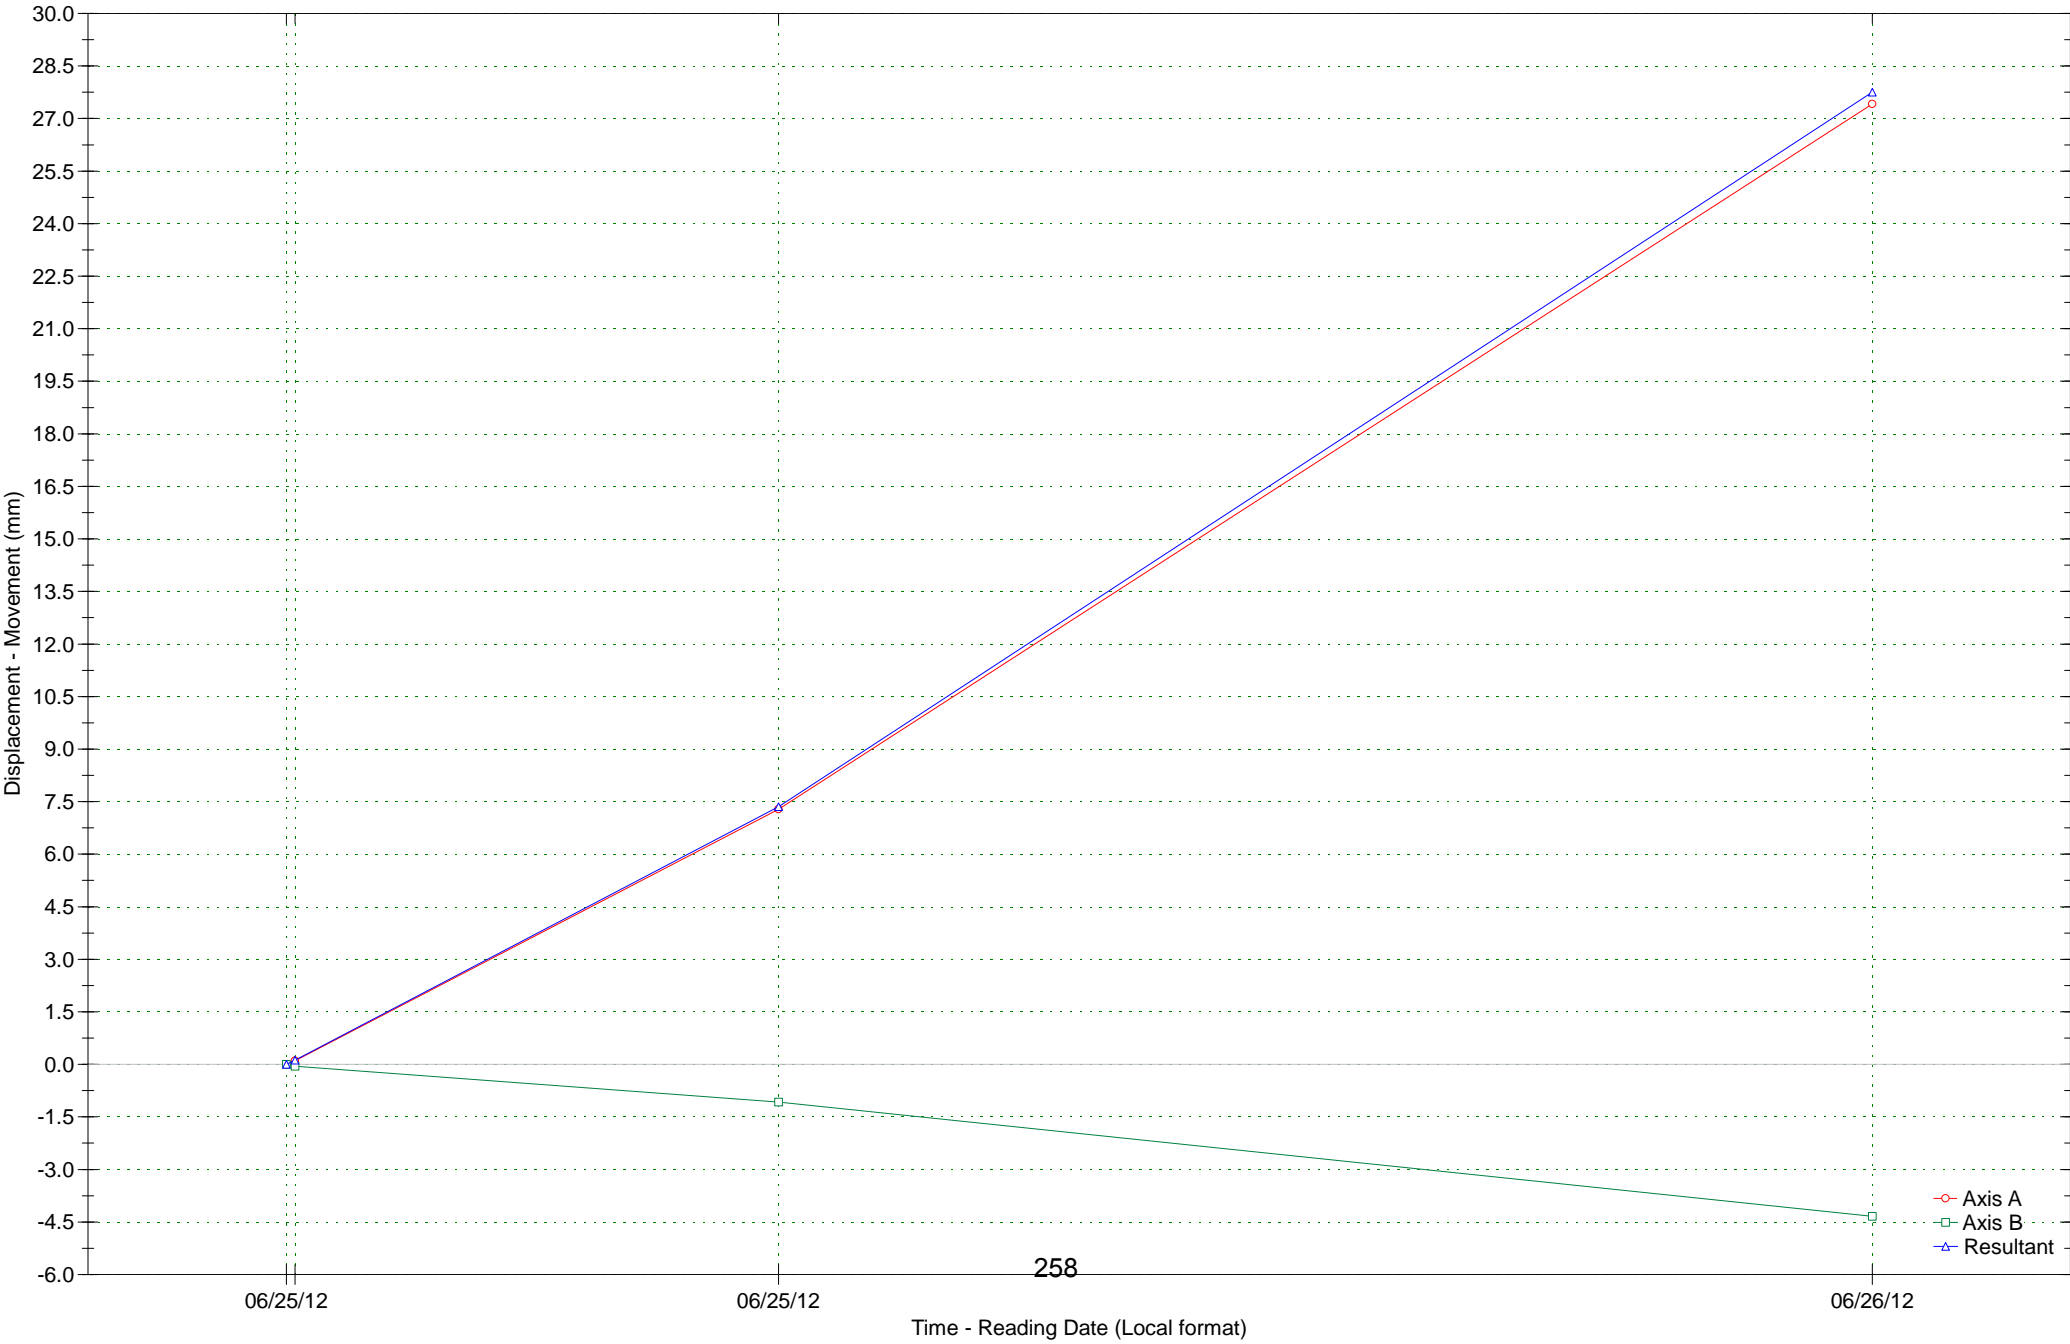
Time Plot : 2.0 - 3.5 meters

Spiral Correction : N/A
Movement Depth : 2.0 - 3.5 meters
Borehole Total Depth : 4.5 meters
A+ Groove Azimuth :
Latest Reading : 2012 Jun 26 09:02
Initial Reading : 2012 Jun 25 09:39
Applied Azimuth : 0.0 degrees
