TECHNICAL MEMORANDUM

Reference No. CA0029692.9234-TM-02-Rev1

NUTANA SLOPE STABILITY UPDATE – AUGUST 2024

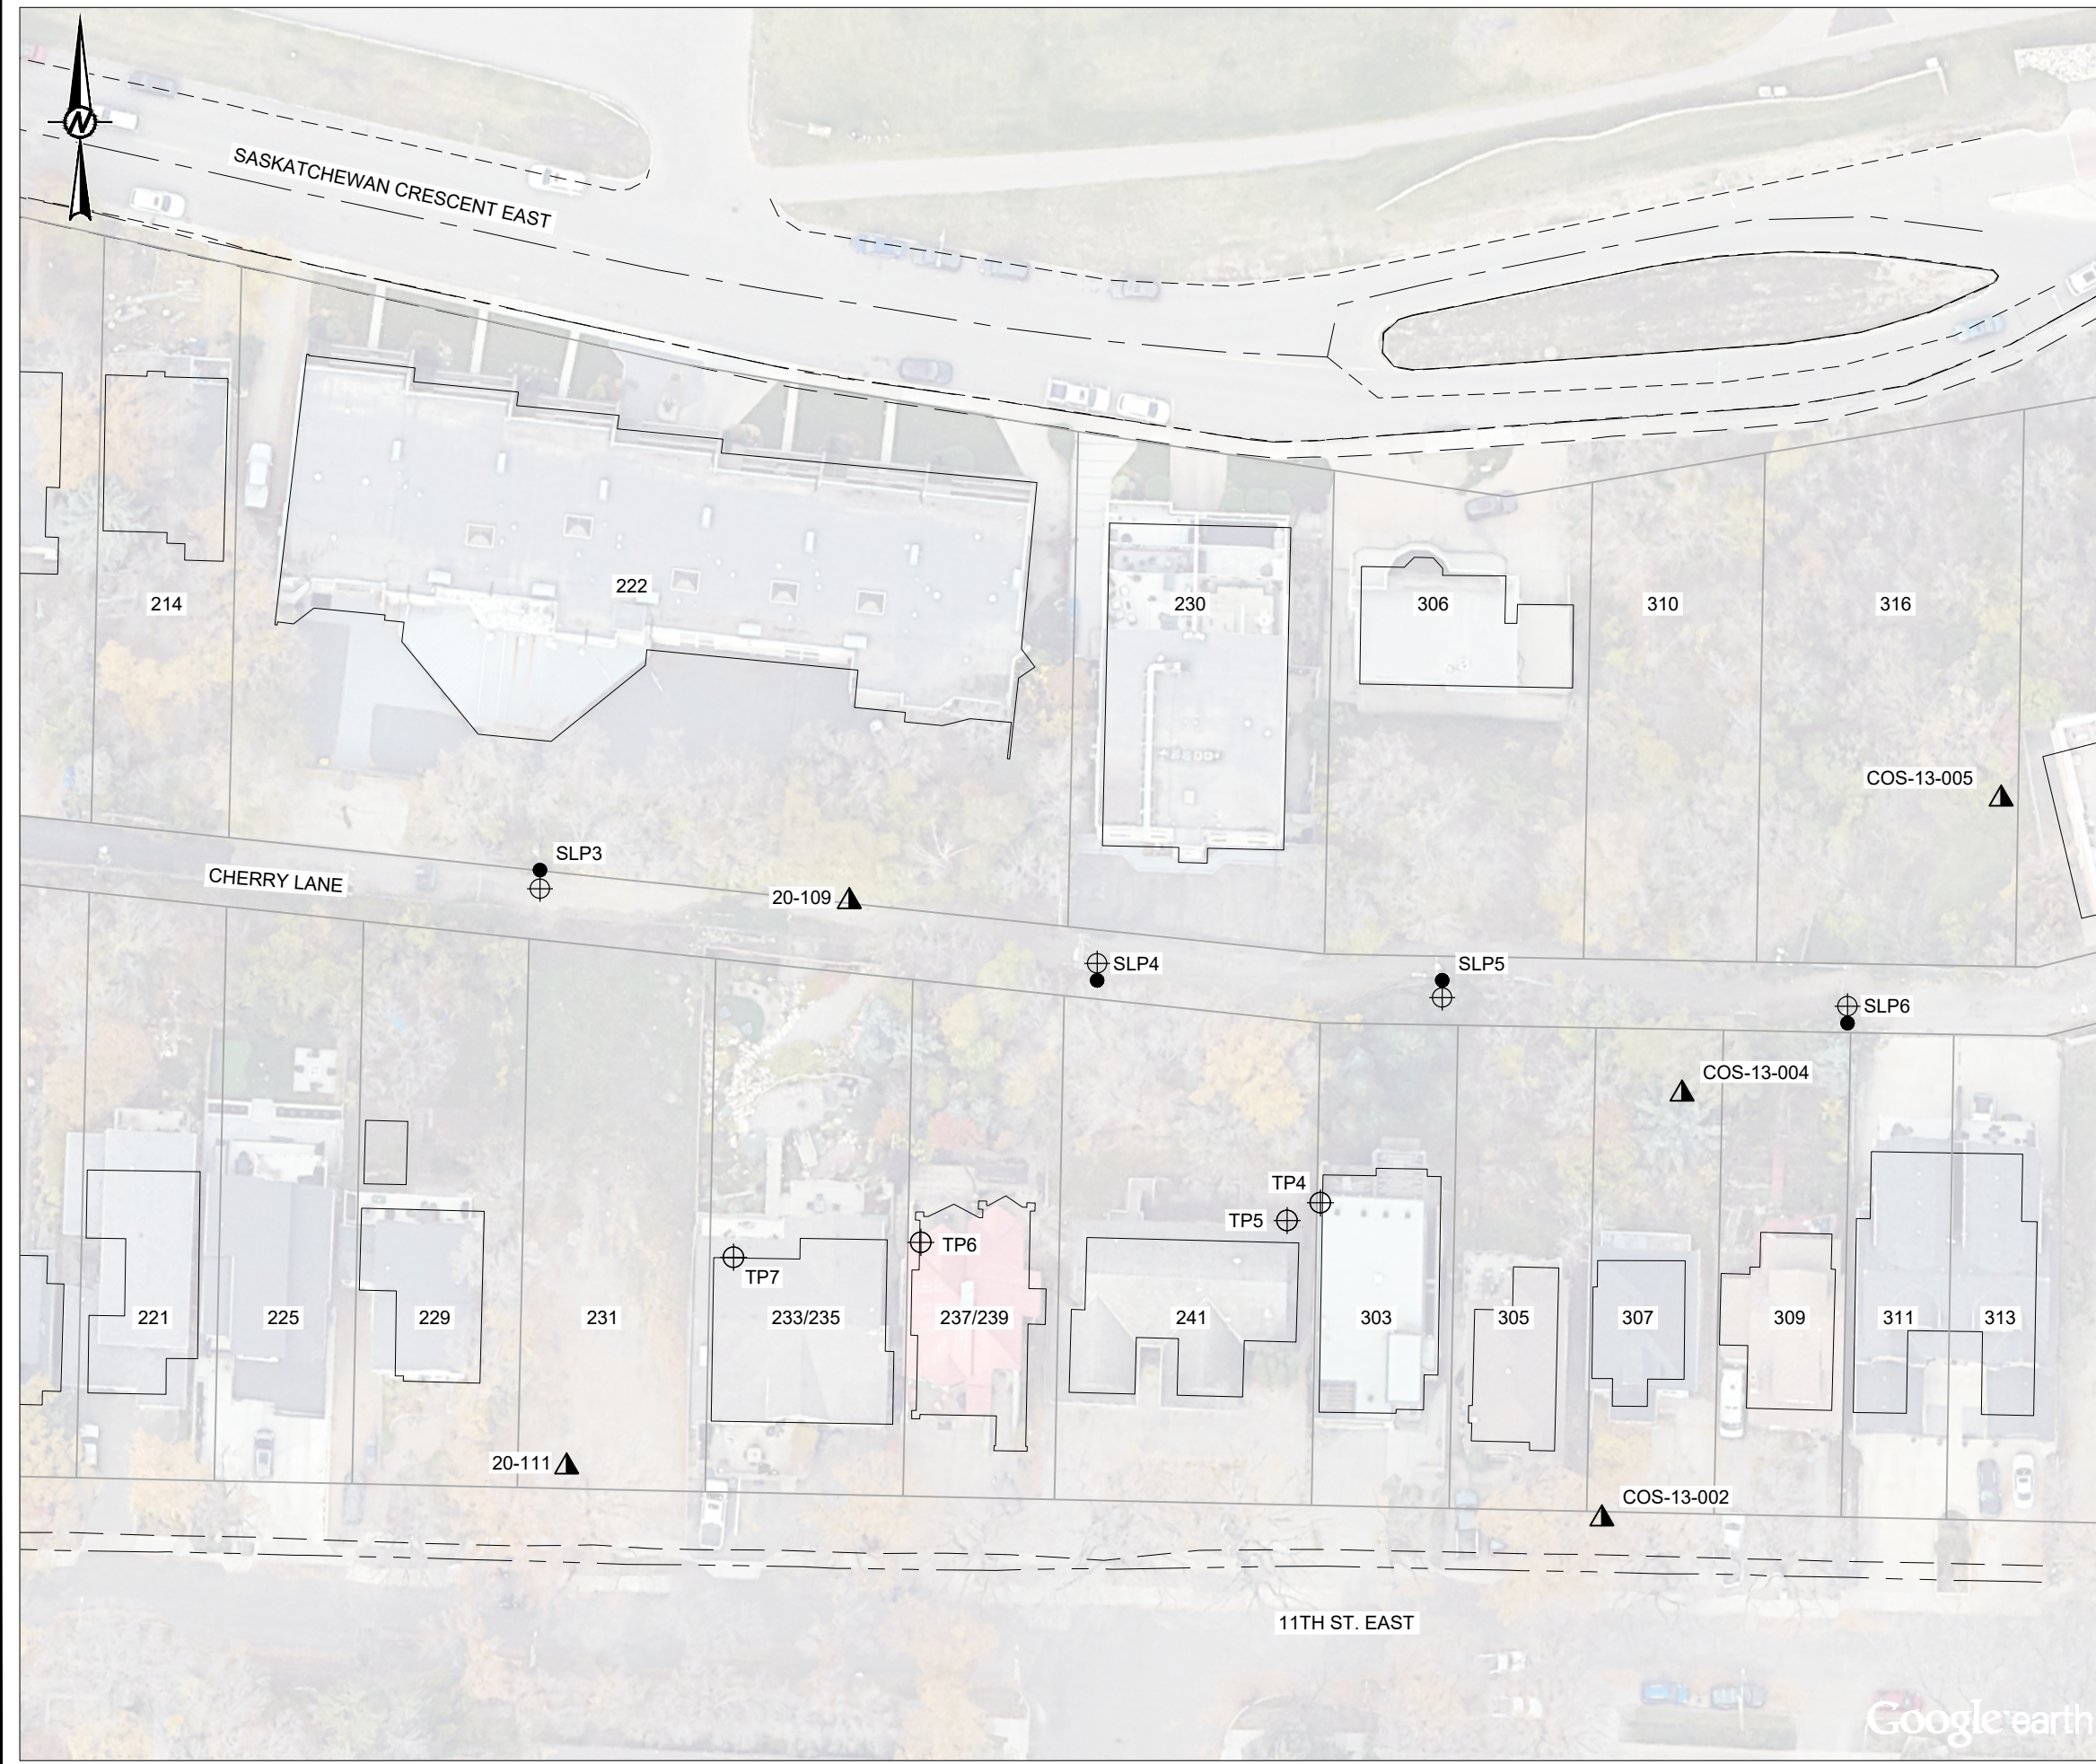
PROJECT NO. CA0029692.9234 CONTROL 1000 REV. 0 FIGURE 1

WSP Canada Inc. (WSP) was retained by the City of Saskatoon (COS) to complete the monitoring of select geotechnical instrumentation and provide the monitoring data results for the slope failures (referred to as the west slide and east slide) at the Nutana Slope Instability site. Locations of the slope inclinometers and tilt plates are shown in Figure 1.
