## Civic Square East

Saskatoon, SK

## **EXECUTIVE SUMMARY**

Bersch Consulting Ltd. was retained by the City of Saskatoon to conduct an asbestos assessment of the main floor at Civic Square East located at 202 4<sup>th</sup> Avenue North, Saskatoon, Saskatchewan. The assessment was performed by Bersch Consulting Ltd. which began on July 4, 2023.

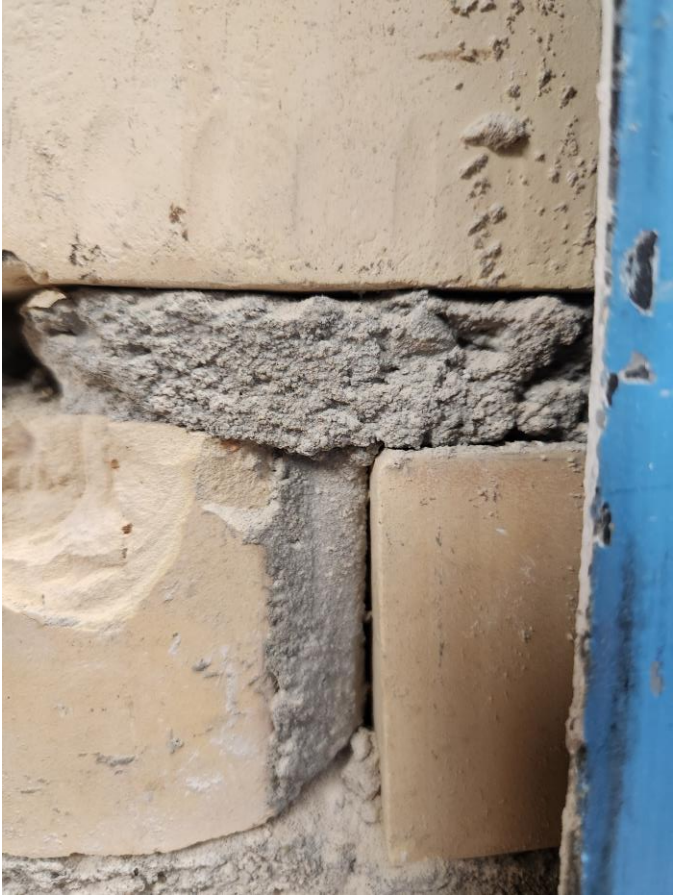
<p><b>Sample Number</b> B67AAG04M – 4</p> <hr/> <p><b>Description</b> Brick</p> <p>Vault Behind Wall Plaster in Door Jamb Beige</p> <p>Non-Asbestos Containing Material</p> <hr/>

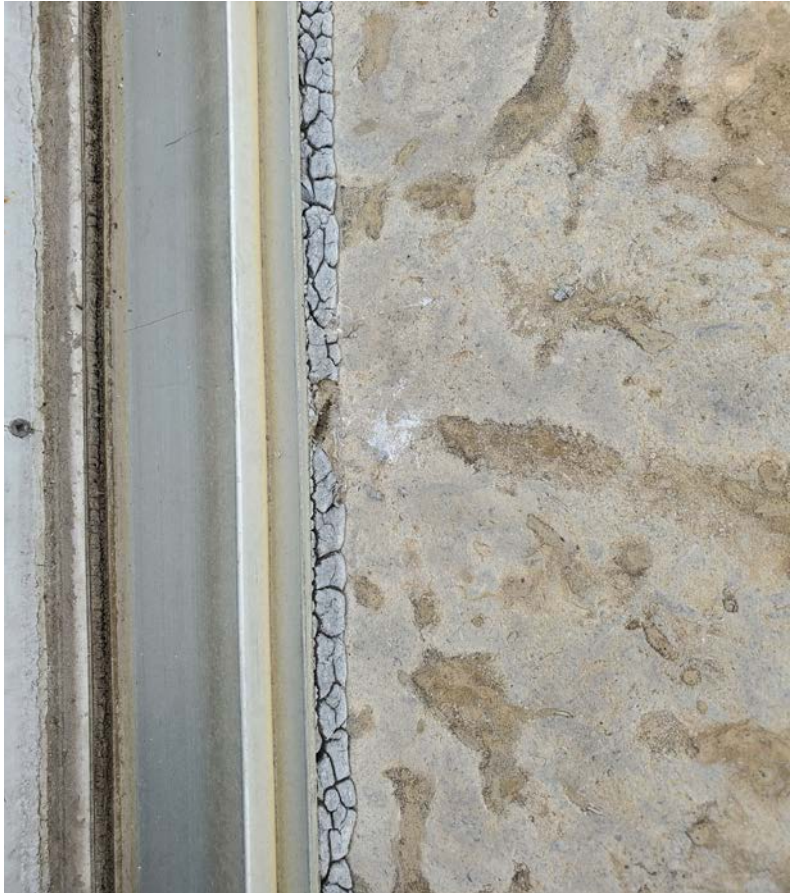
Caulking Between Window  
Frame and Stone.

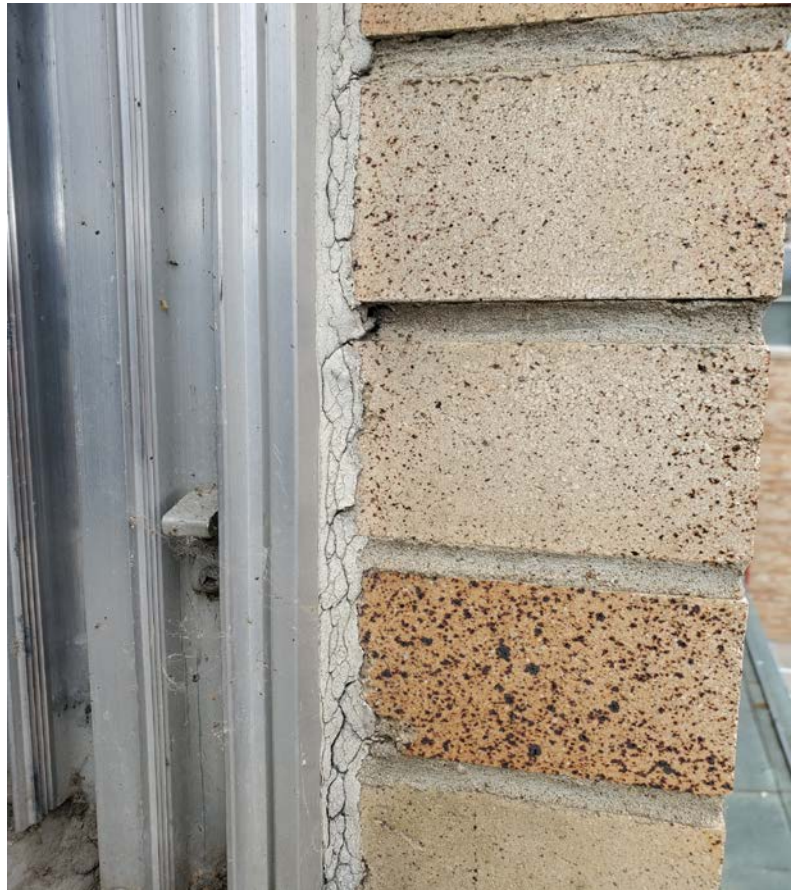
Caulking Between Window  
Frame and Brick.

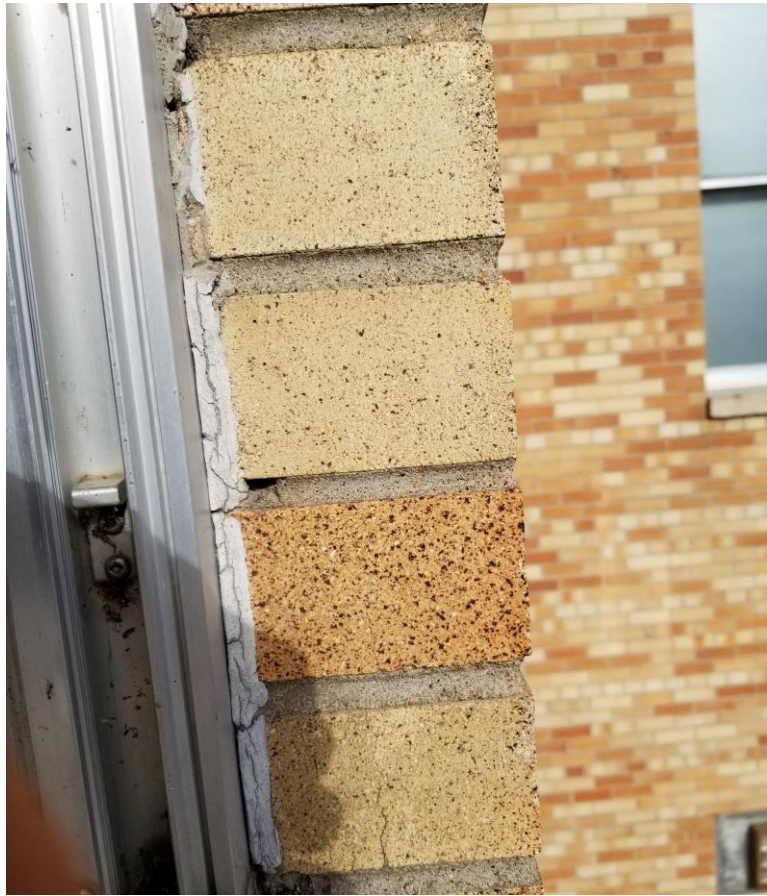
B67PRE25J - 002

Caulking Between Window  
Frame and Brick.

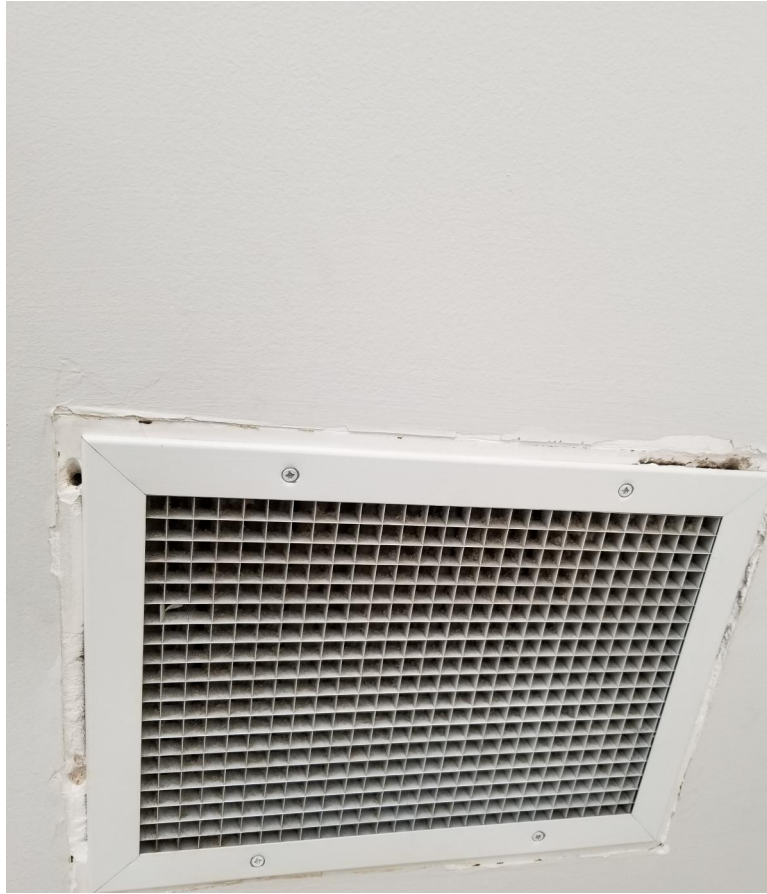
B67PRE21J - 004

Ceiling Skim and Base Coat  
Parging Around the Exhaust  
Grille.

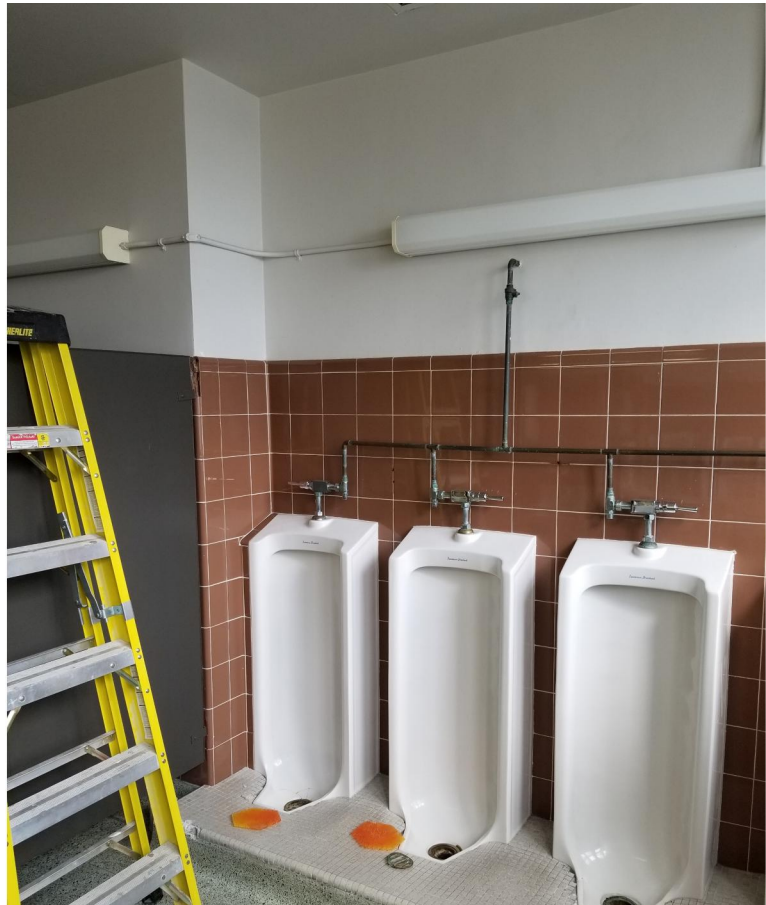
B67PRE21J - 007

East Wall

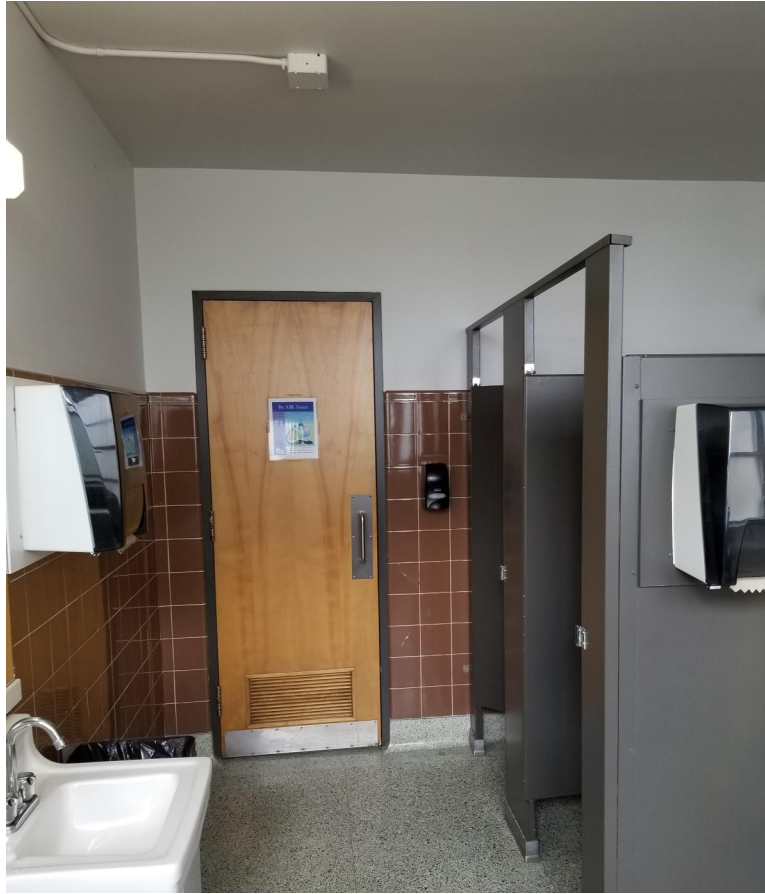
B67PRE21J - 008

North Wall

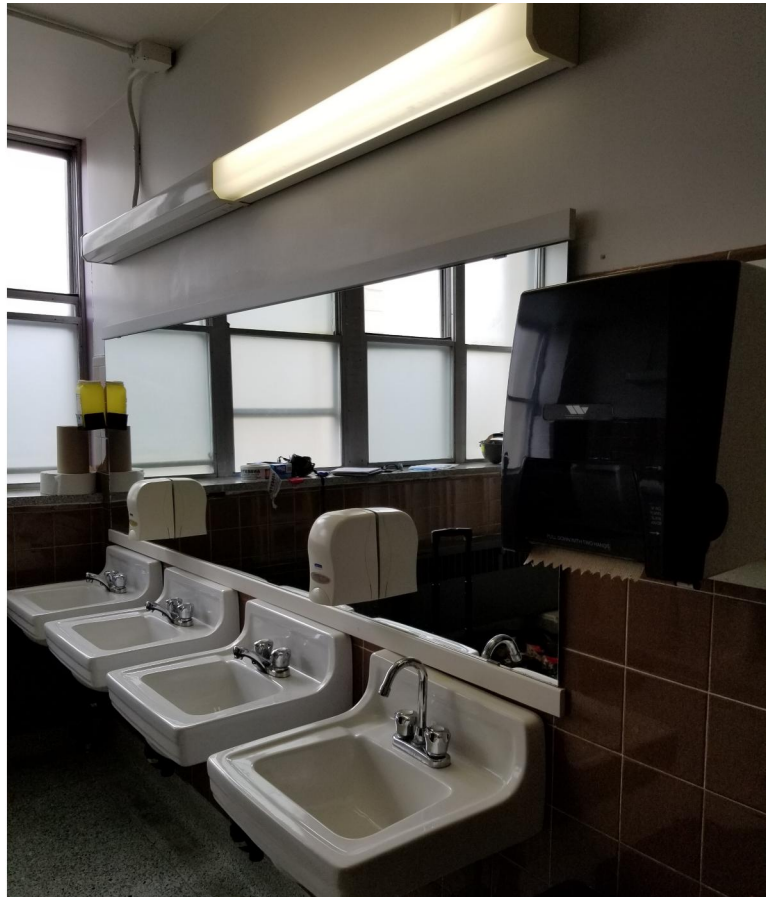
West Wall
